RISK TO LIFE, WARNING SYSTEMS, AND PROTECTIVE CONSTRUCTION AGAINST PAST STORM SURGES IN OSAKA BAY

Yoshito TSUCHIYA

Yoshiaki KAWATA

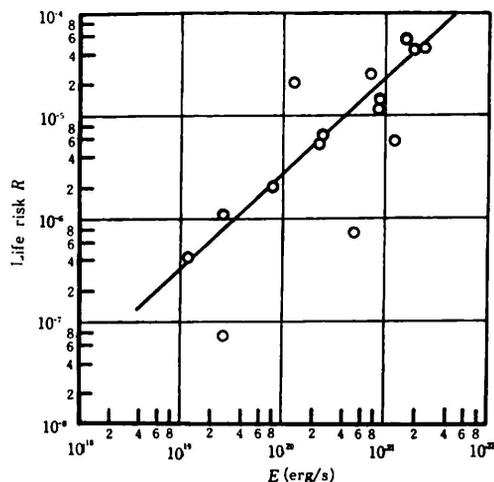
Fig. 1 Relationship between typhoon energy and life risk.

The relationship between risk to life due to the typhoons which hit the islands of Japan between 1934 and 1954 and the energies of these storms are shown in Fig. 1. The total population of Japan was used in the calculations. This figure shows that the approach, as presently employed, gives an approximately linear relationship between risk to life and typhoon energy. This relationship changes, however, when the factors of protective construction against typhoons and information systems are taken into consideration.

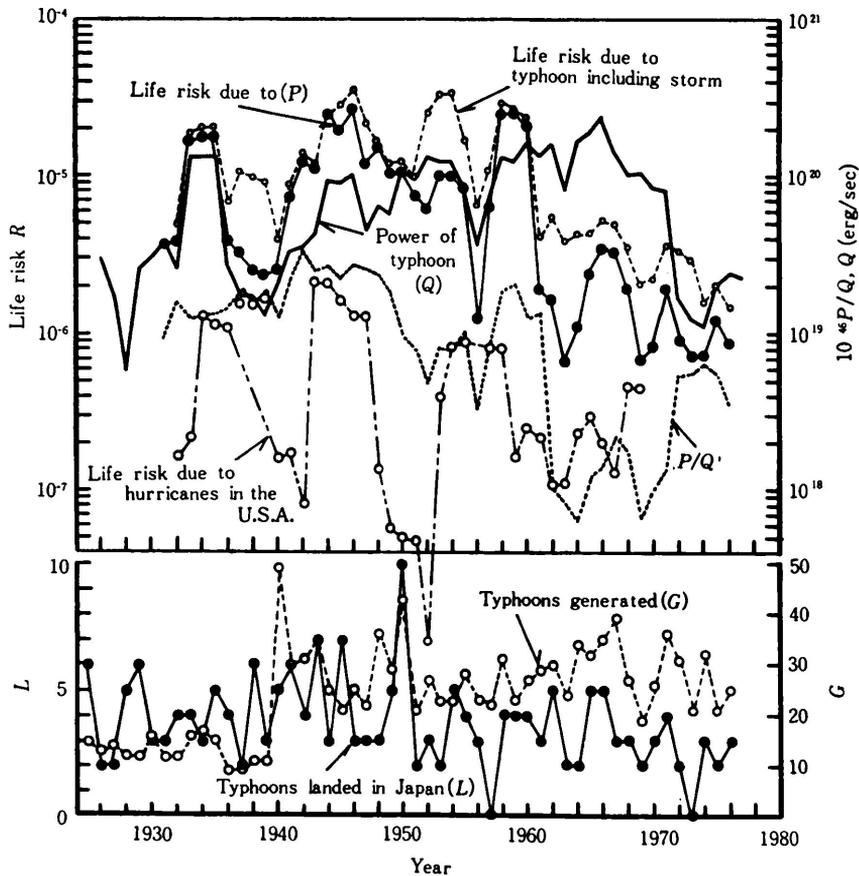
Fig. 2 Changes in life risk and characteristics of typhoons.

The annual changes in risk to life and the estimated energies of typhoons are given in Fig. 2. The values plotted are averages for three years, except for the number of typhoons generated or landed. Risk to life due to hurricanes in the U.S.A. also is shown for a comparison with the risk in Japan. The average value of E was a nearly constant 10^{21} erg/s before 1965, but after that date it varies in proportion to the decrease in the number of typhoons which landed. The risk to life due to typhoons in Japan is very large when compared with the values found for hurricanes in the U.S.A. The rapid decrease in the risk to life from typhoons after 1960 was brought about by refinements in forecasting and development of network systems of information for refuge warnings, as pointed out by Yanagida [4]. The ratio of R to E , in which R is the risk to life due to typhoons, also confirms the above results. Lately, however, there has been a tendency for this risk to increase. This corresponds with the results reported by Kurashima et al.[5], who characterized this phenomena as being similar to the behavior of a guerrilla under intensive urbanization.

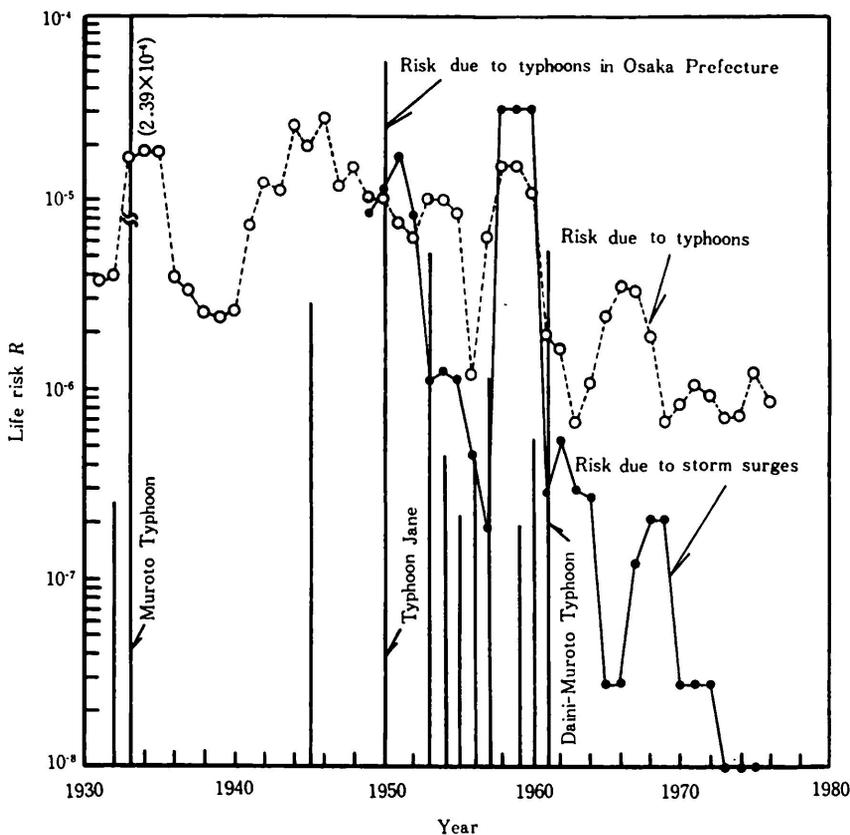
Fig. 3 Changes in life risk due to storm surges.

The average values for risk to life due to storm surges over a three-year period, are shown in Fig. 3. When risk to life was less than 10^{-8} , it was recorded as the minimum value, 10^{-8} . The population used for these calculations was chosen as follows. For storm surges, the population of 16 prefectures were used because surges occurred more than five times in each of these prefectures. In the past 50 years, since death tolls have been counted officially, the

life risk values for the three biggest storm surges (Typhoon Jane in 1950, Typhoon Ruth in 1951 and the Ise Bay Typhoon in 1959) have been greater than the values for typhoons. The effects of storm surge disasters are restricted to coastal zones and surrounding areas; thus the population which encounters storm surge disasters is inevitably smaller than the population of the entire prefecture. Therefore, life risk increases two fold or more, than the originally calculated values. Thus, the life risk for other years may be comparable to the risk due to typhoons coming after the Daini-Muroto Typhoon in 1961. The effects of storm surge disasters inevitably are smaller than the average life risk values in Japan. By contrast, life risk values for storm surges experienced in Osaka Prefecture are larger than those for the 16 prefectures. We concluded from this historical data on life risk due to typhoons that Osaka and neighboring areas constitute one of the most dangerous storm surge zones in Japan.

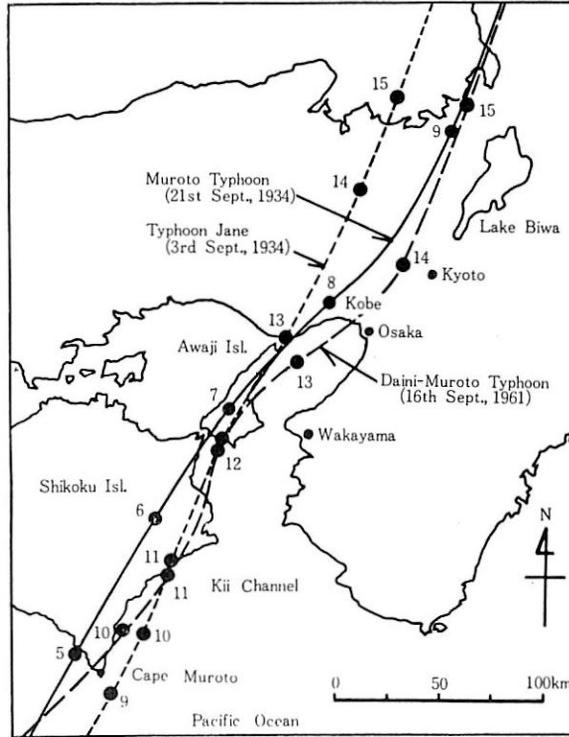
Fig. 4 Paths of Japan's three biggest typhoons.

The mouth of Osaka Bay is elliptical and opens southward the Pacific Ocean through the Kii channel (Fig. 4). Its north coast has been destroyed many times by storm surges. Osaka (once called Naniwa) and Kyoto, located about 40 km northeast of Osaka, were once capitals of Japan; therefore, there are very old and accurate records of storm surge disasters in this area. Unfortunately, the scales used to measure the old storm surges are not clear, but from about 1900, the characteristics of surges have been recorded with measuring apparatus.

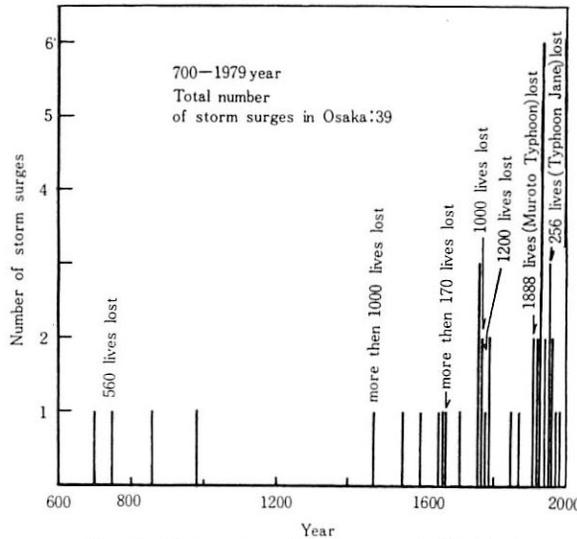
Fig. 5 Frequency of storm surge disasters.

The number of storm surges that have taken place over the centuries are shown in Fig. 5. Thirty-nine storm surges occurred in Osaka Bay area during this period, four of which could be described as serious in terms of a loss of more than 100 lives. Frequent surges have taken

place in both the 18th and 20th centuries. Although no remarkable storm surge disasters were recorded between the 11th and 15th centuries, this probably is not due to lack of storms but to the confusion caused by wars and political machinations.

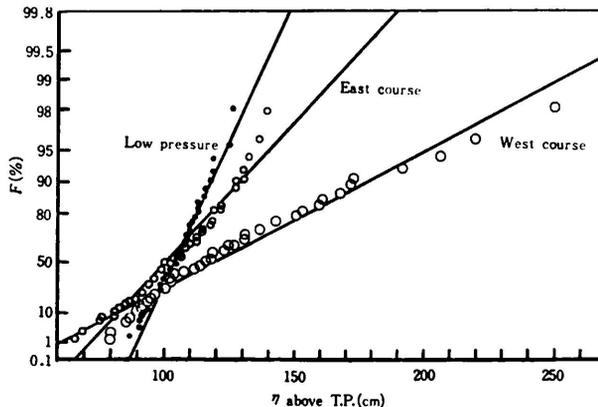
Fig. 6 Probability of the highest tidal level in Kobe.

The approach of the return period as analysed, by Gumbel's and other methods, did not produce the simple representation of an approximately linear relationship between extreme storm surges and their corresponding frequencies. The reasons why they did not fit this relationship may be due to the shortness of the sampling period for tidal records and to differences in the characteristics of storm surges due to the relative paths taken by the typhoons to the harbour or station in question. The classification of storm surges by cause and the relative paths of the typhoons are shown in Fig. 6. The highest annual tidal levels observed were reduced to the standard reference sea level of Tokyo Peil (T. P.). The storm surges could be divided into three groups. Large surges occurred when a typhoon passed to the west of Kobe; whereas, small scale surges occurred when a typhoon passed to the east. There also

seems to be a limit to the scale of the storm surges. Therefore, it was necessary to reexamine the return period of the storm surges based on particular probability density functions, as shown in Fig. 6. Our results show that Osaka is the most dangerous place for storm surges in Japan.

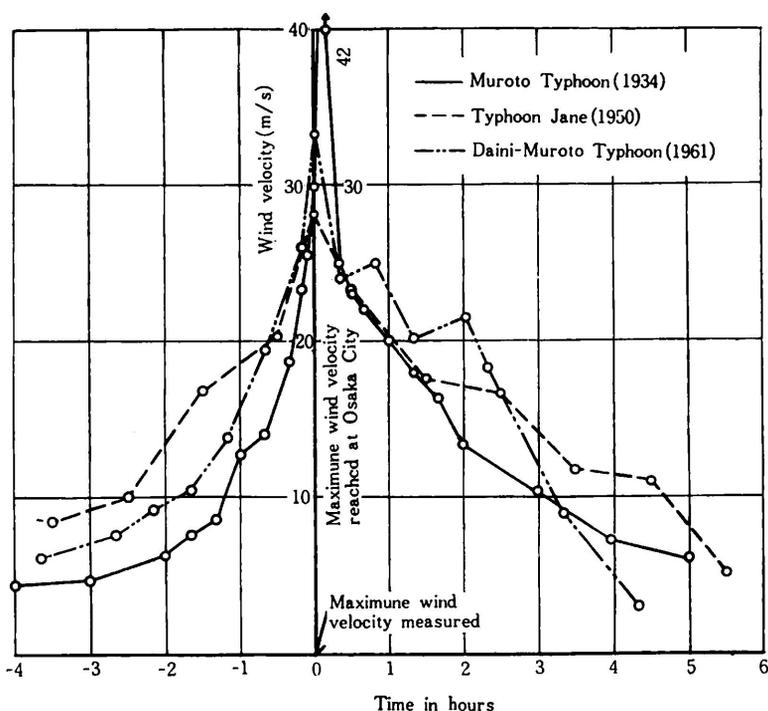
Fig. 7 Variations in maximum wind velocity.

An extra-large storm, called the Muroto Typhoon, landed at the point of Cape Muroto in Kochi Prefecture at 05:10 on the 21st of September, 1934 then passed near Kobe. The barometric pressure, which was almost 997 mb at sea level at 06:00 on the 16th of September, fell rapidly and reached a minimum of 911.9 mb just before the typhoon landed, but it recovered quickly and reached 973 mb at 18:00 near Miyako city in Miyagi Prefecture. Because of the close spacing of the isobars, the pressure of the resulting winds was severe. At the point of Cape Muroto, the instantaneous maximum wind velocity exceeded 60 m/s and the mean velocity for ten minutes was 45 m/s westerly. The time diagram in Fig. 7 includes wind conditions at Osaka. The mean wind velocity increased rapidly to more than 10 m/s east-southeasterly by 07:00 then to 29.8 m/s southerly at 08:05, by then having veered southwesterly to west-southwesterly. The lowest atmospheric pressure was 954 mb at 07:55 recorded at Osaka.

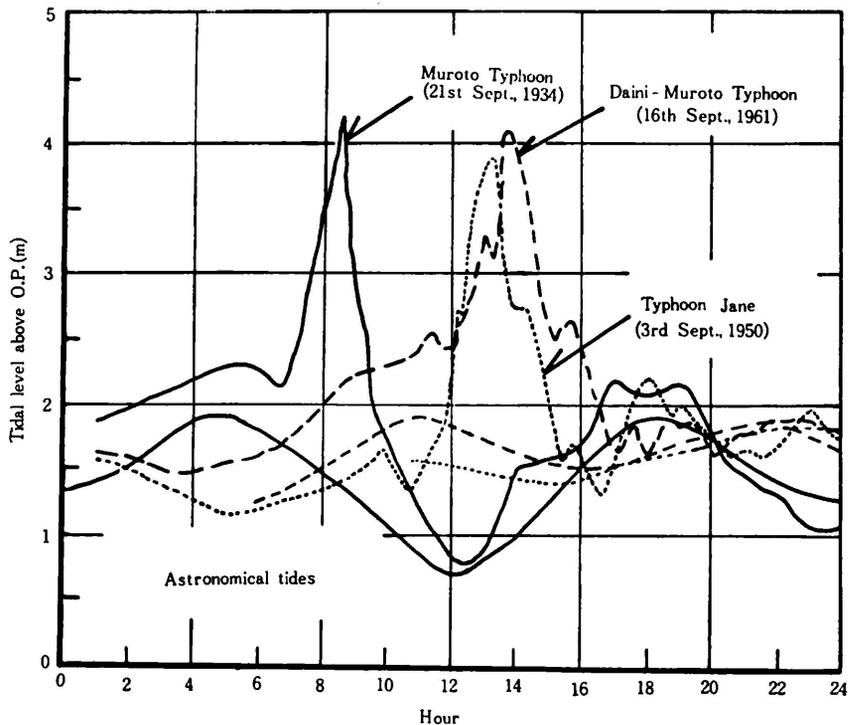
Fig. 8 Observed tidal curves in Osaka.

The three large typhoons described above caused storm surges all along Osaka Bay with accompanying high waves that produced disastrous flooding in low-lying areas along the coast. During the Muroto Typhoon, the sea level was too high to record with tide gauges. A survey of water traces left on the walls of some houses and buildings near Osaka Harbour, indicated that the highest tidal level and the maximum anomaly in Osaka were 4.2 m above O. P. and 2.92 m at 08:20 on the 21st of September, 1934. Moreover, a maximum anomaly of more than 2 m was estimated from Kobe to Kishiwada along the northeast coast of Osaka Bay. Tidal curves for Osaka during the Muroto Typhoon are given in Fig. 8. The drastic changes in sea level associated with the forerunning storm surge and resurgence can be seen from this figure.

Typhoon Jane also had an accompanying storm surge at 13:00 on the 3rd of September, 1950 (Fig. 8). The scale of the storm surge was smaller than of that which accompanied the Muroto Typhoon, but damage remaining from World War II and subsidence caused by the pumping off of groundwater in this area accelerated functional disorders in the countermeasures taken against the storm surge. Due to these unfavorable factors, disastrous flooding in low-lying areas of Osaka City lasted for some weeks. The highest tidal level and maximum anomaly in Osaka were 3.85 m above O. P. and 2.37 m, but these values were

not obtained by direct measurement with tide gauges. They were scaled out for about 1 hour after 12:40.

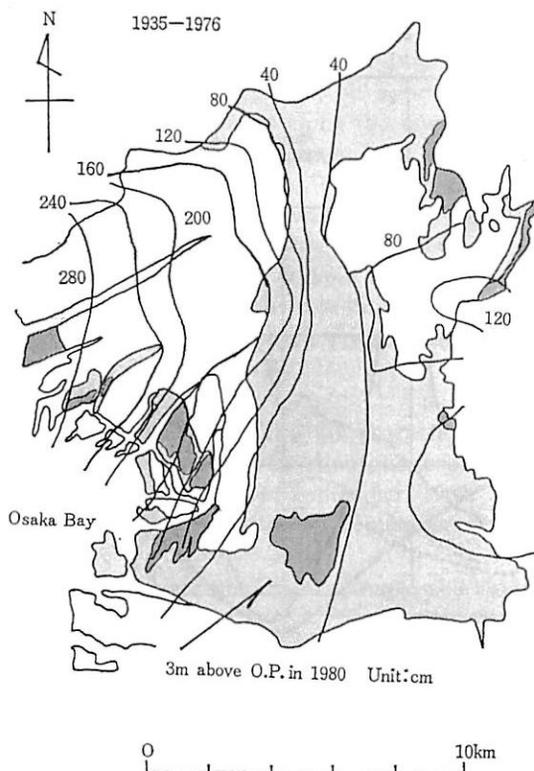
Fig. 9 Accumulated values for subsidence.

The low-lying land facing Osaka Port, located on the flood plain between the mouths of the Yodo and Yamato River, has been reclaimed by drainage over the past five hundred years. Since the 1920s the area has developed into industrial and commercial districts which depend chiefly on shipbuilding and on domestic and foreign trade. Enlargement of industrial activity accompanied by increases in the usage of water has resulted in severe ground subsidence due to the removal of ground water. The accumulated rates of ground subsidence over the forty-year period from 1935 to 1976 is shown in Fig. 9. The values for ground subsidence are plotted within coaxial circles which center on a point located near the mouth of the Yodo River. The ground level of the city area is below the mean sea level. Recently, however, subsidence has been reduced to less than a centimeter per year for most of the city area. This is due to regulations on the use of ground water and the installation of an

industrial water supply system in 1959 which have had good effects on retarding subsidence.

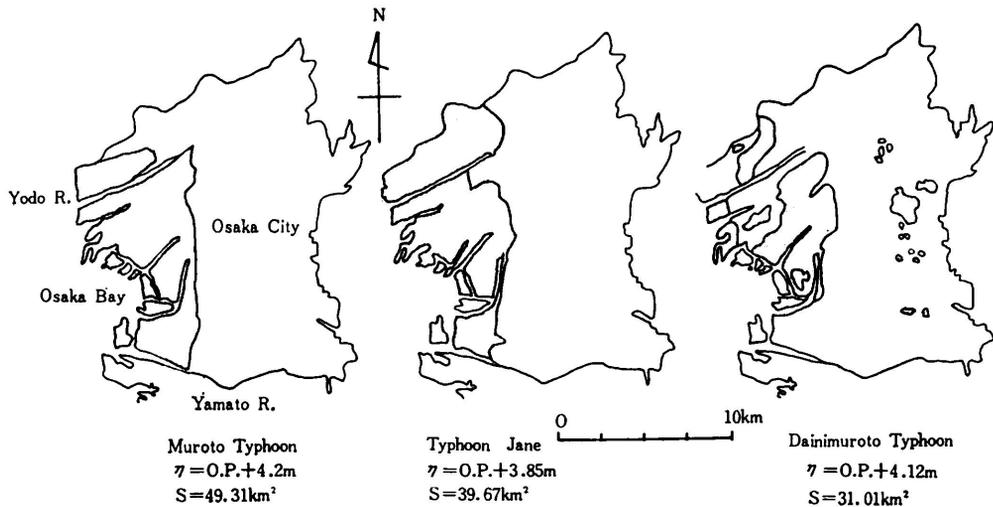
Fig. 10 Areas of submersion due to flooding.

The submerged areas produced by the three biggest storm surges are shown in Fig. 10. The average depth of submersion and its rate in relation to the total land area of each administrative district is shown in Table 4. A comparison of the two shows that

(1) The storm surge caused by the Muroto Typhoon resulted in the most severe submersion not only because of the large scale of the storm surge but because of the poor countermeasures taken against it.

(2) The greatest depth of submersion was recorded for Typhoon Jane, because ground subsidence had developed rapidly in coastal areas. Unfortunately, these areas had experienced many air-raids toward the end of World War II and most of the countermeasures against typhoons had been destroyed.

(3) In spite of the second biggest storm surges taking place during the Daini-Muroto Typhoon, the depth of submersion and the area it covered were relatively small. The lessening of damage caused by storm surges chiefly was due to the operation of drainage equipment, the partial completion of seawalls and dikes, and the building of embankments in low-lying areas along the coast after Typhoon Jane.

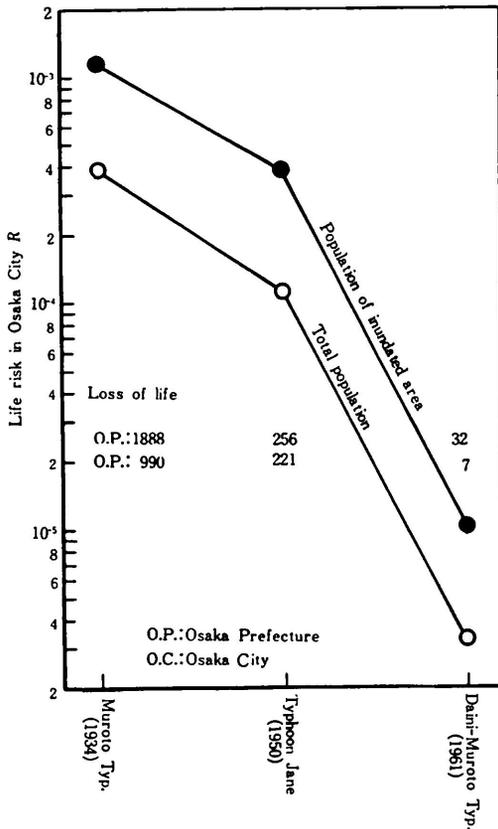
Fig. 11 Life risk in Osaka.

The number of fatalities from the typhoons Muroto, Jane and Daini-Muroto were 3066, 519 and 202, respectively. The statistics listed in Table 5 provide evidence of the loss of human life and houses destroyed in each administrative district in Osaka City. The loss of human life here includes both the numbers of dead and missing. These numbers reflect the population density of the areas listed. Therefore, the life risk, R , the number of human lives lost per unit of population was calculated and is listed in the table. The life risk in Osaka City is shown in Fig. 11; the values represented by the white and black circles were calculated from the population of the city and submerged areas, respectively. Only seven deaths from the Daini-Muroto Typhoon, were attributed to causes other than storm surge. Clearly the risk to life rapidly decreased with time in spite of the large scale storm surge.

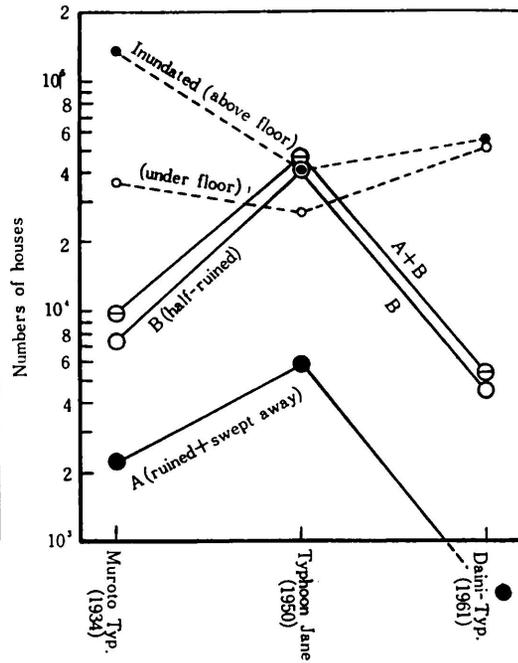
Fig. 12 Damage to houses in Osaka.

The characteristics of the houses destroyed by storm surges and typhoons are important because they are an indication of the strength of the external force. An outline of the destruction caused to houses by the three typhoons is given in Fig. 12. The following characteristics emerge

(1) The number of houses inundated by the overflow is proportional to the scale of the storm surge, inundation under the floor being greatest during the Daini-Muroto Typhoon. This damage mainly was due to severe ground subsidence in the east of Osaka City as well as in the coastal areas.

(2) Flooding from Typhoon Jane resulted in the most severe damage to houses. As the population of Osaka City in 1950 was about 1.96 million and in 1934 and 1961 about 3 million, this result was somewhat curious. This damage mainly was due to poor living conditions and lack of housing after World War II. This is well documented because the number of houses destroyed is nearly equal to the number inundated by overflow.

(3) The value for the number of houses ruined or swept away during the Daini-Muroto Typhoon is several orders smaller than the value for houses inundated. This is because flooding was not caused by the breakdown of dikes but by overflows on dikes along the rivers.

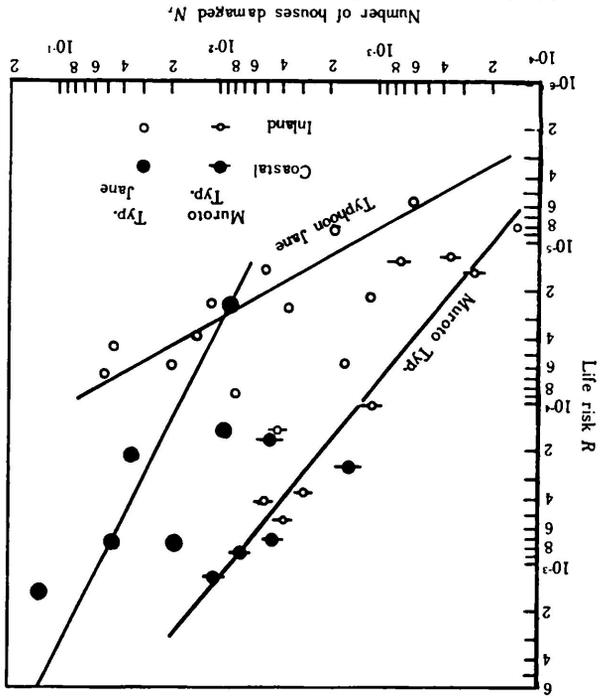
Fig. 13 Relationship between the ratio of houses ruined or swept away and life risk.

The relationship for each administrative coastal or inland district during the Muroto Typhoon and Typhoon Jane is presented in Fig. 18. This figure shows that although the maximum value of N_r^{-1} during Typhoon Jane is about ten fold the value during the Muroto Typhoon, the life risk in the former was one tenth that of the latter typhoon; inhabitants in submerged areas in 1934 were in a more perilous situation than those in the typhoon of 1950. This is due mainly to the qualitative difference in the warnings given during the storm surge disasters. In addition, during the Typhoon Jane the relationship between R and N_r for the administrative coastal districts differs from that for the inland districts. As stated, insufficient dikes had been constructed against the storm surges from Typhoon Jane. They might have prevented districts from being inundated during moderated storm surges but when overflow or wave overtopping took place because of a rise in sea level, the dikes immediately were broken at forty-five points.

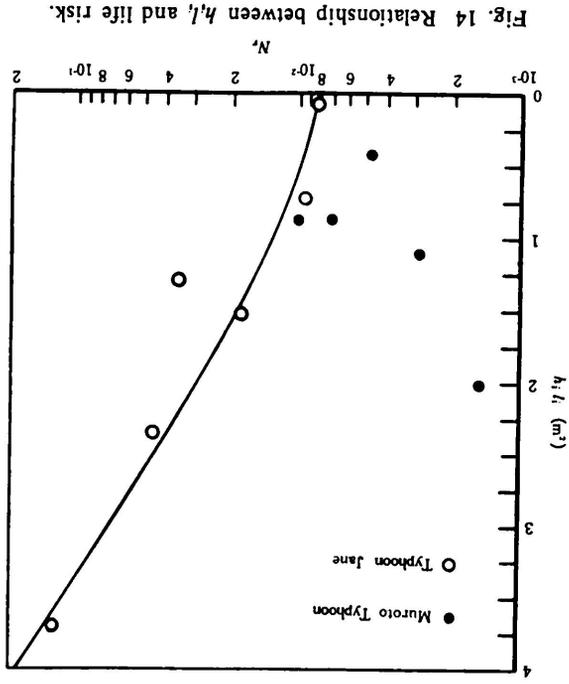
Rapid and vast flooding of sea water into administrative coastal districts could result in a catastrophic death toll from storm surge. In verification of this, the relationship between N_r and the characteristics of dikes broken at each administrative seaside district is shown in Fig. 14, in which l_i is the total length of dikes broken and h_i is the mean depth of submersion. It is evident that there is a relationship between them for Typhoon Jane, but not for the Muroto Typhoon.

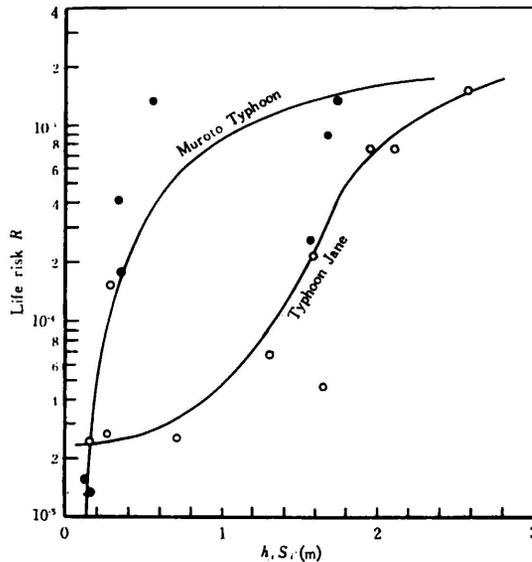
Fig. 15 Relationship between the ratio of houses ruined of swept away and $h_i S_i$.

The relationship between life risk and the characteristics of submersion is shown in Fig. 15, in which S_i is the ratio of the area submerged to the total area. Values on the abscissa, $h_i S_i$, correspond to the volume of flooding. Although in storm surge disasters the loss of human life depends on the extent of submersion, another factor, the soft countermeasures taken against storm surge disasters is very important. Their effects on life risk are shown at the stage when there was a small volume of flooding. The discrepancy in the relationships during the Muroto Typhoon and Typhoon Jane improves with the increment of $h_i S_i$ because in the latter typhoon many inhabitants who did hear the warnings had insufficient time to take safe refuge, or paid little attention to them.

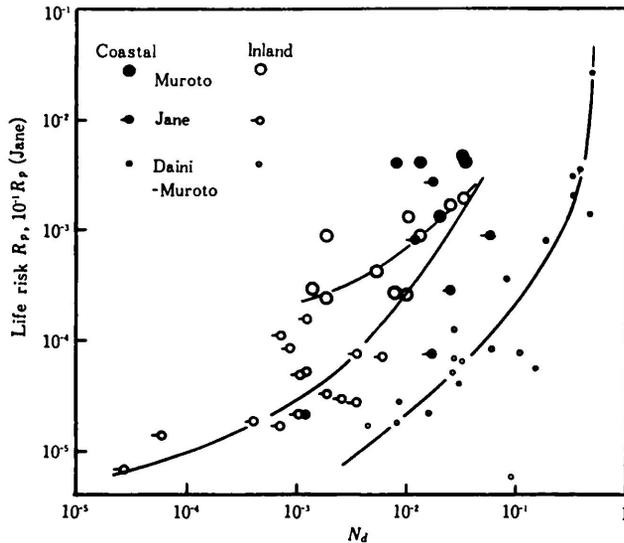
Fig. 16 Relationship between the ratio of houses damaged and the life risk that includes injured persons.

Fortunately, no deaths were attributed to the storm surges that accompanied the Daini-Muroto Typhoon because of early warnings and the resulting evacuation of about 100,000 people. Therefore, no estimation of life risk could be made. Thus a new life risk, which includes persons seriously and slightly injured, is newly defined by R_p . For that reason, houses half ruined were included with houses destroyed and estimated as N_d . Fig. 16 shows the relation between N_d and R_p in the three biggest storm surges. The following facts emerge.

Life risk R_p during the Muroto Typhoon was very large; the R_p in coastal districts is larger than that for inland districts for the same value of N_d . This is of course due to the sudden attack of the storm surge without warning and partly to violent winds of more than 60 m/s. The numbers of dead and injured caused by damage to houses and wooden schools in Osaka City were 257 and 1,076. The total value is twenty-seven percent of the entire death toll in the city.

The relation between N_d and R_p also may be applied to the Daini-Muroto Typhoon. But, in Typhoon Jane, warnings were insufficient quantitatively and qualitatively as compared with those for the latter typhoon; thus, life risk R_p was very large in the coastal

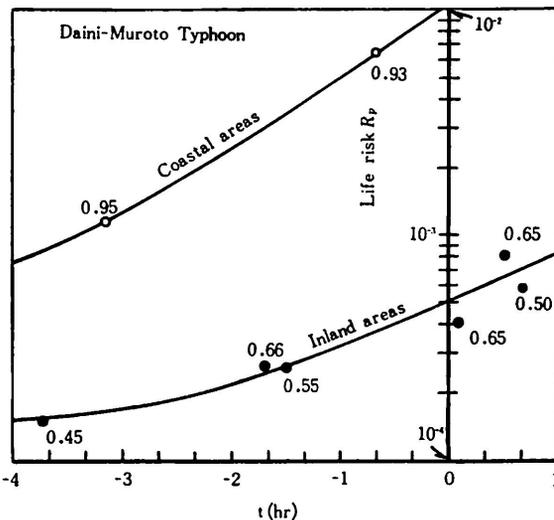
Fig. 17 Changes in life risk that includes persons injured correlated with the time when refuge was taken.

districts. In this relation, the so-called hard countermeasures also had some effect. The mean depth of submersion especially has a significant effect on the minimizing of life risk. The relationship between R_p and the time of taking refuge during the Daini-Muroto Typhoon is shown in Fig. 17. The numbers in the figure indicate the mean depth of submersion for each administrative district. The earlier the evacuation was initiated, the smaller the life risk.
