QUALITY ESTIMATION OF THE STONework BLOCKS IN BARBAR TEMPLE AND AL-KHAMIS MOSQUE, BAHRAIN

Abstract

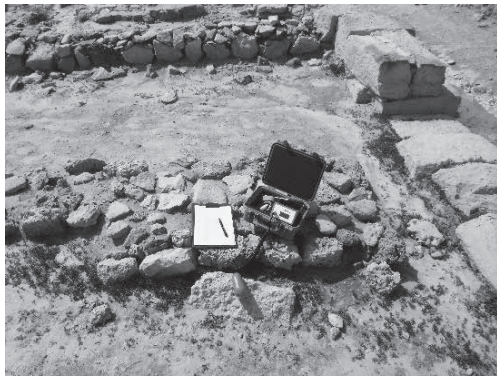
Fig.5 No.36 block in Temple I

The main test results are provided in Table 1. In Table 1, values accompanied by the * symbol are measurements taken on horizontal surfaces while the others are measurements taken on vertical surfaces. Comparing the results from the three construction periods, we found that the average predominant frequency in Temple I was somewhat low and the standard deviation was rather large, casting some doubt on the present quality of the stonework at these locations, but the overall differences between Temple I and the other construction periods were not very large. Because there were some values under 2,000 Hz in the Temple I and II areas, however, the authors concluded that some stonework blocks in these temple areas are of very low quality. Yet even these low-quality stones were not so degraded as to be on the point of failure; in fact, they were in better condition than the near-contemporary stone wall in the underground burial chamber of Mastaba Idout (c. 2360 BCE) in Egypt. Figs.5-8 show some examples of the situation of the stonework blocks that we assessed. The No.36 block shown in Fig.5, which was buried in the soil, generated a low-frequency wave of about 1,000 Hz. The No.12 block in Fig.6 and Fig.7 was an unstable block supported by small stones; when struck, it produced a sound like “poko poko”. The No.40 block shown in Fig.8 was located about halfway up an accumulated block wall, some parts of which had been repaired with mortar. These repaired parts generated waves with an average frequency of 1,700Hz, clearly demonstrating the deterioration of the repair materials. Overall, although some individual measurements indicated low quality, the quality of the stonework blocks in Barbar Temple was not very low.

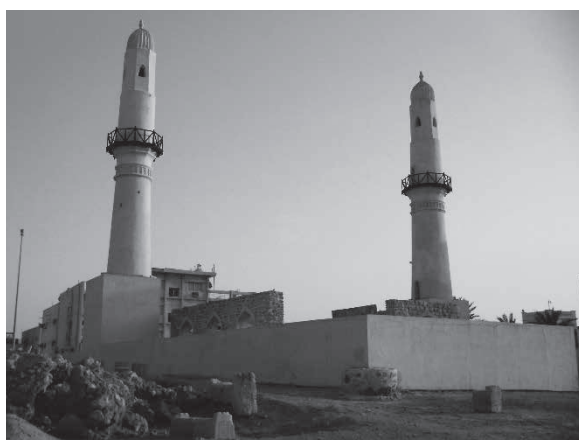
Fig.9 View of Al-Khamis Mosque

Fig.9 shows the Al-Khamis Mosque from the front while Fig.10 shows a bird's-eye view. We observed that some stonework blocks had repaired parts and stripping of repaired parts. Overall, the quality of the stonework blocks in Al-Khamis Mosque seems not to have deteriorated excessively.

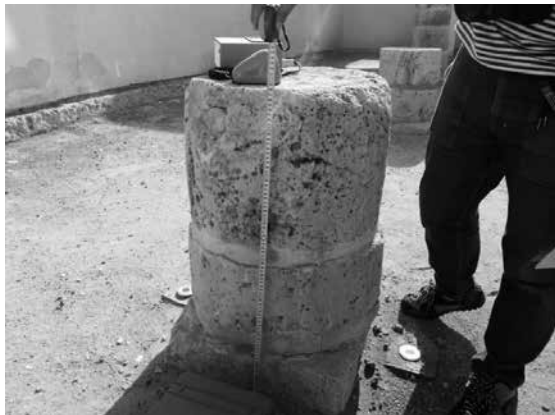
Fig.11 No.4 block

Our results are provided in Table 2. The average predominant frequencies indicated that the quality of the stonework blocks in general was not terribly low. In stonework blocks No.4 and No.6, however, the predominant frequency was relatively low, suggesting that the blocks' quality had deteriorated. Figs.11-14 show how the tested blocks were situation. At the place in Fig.14 where a repaired part has obviously been stripped, the predominant frequency was low, indicating that this repaired part had undergone more degradation of quality compared to other stonework blocks.

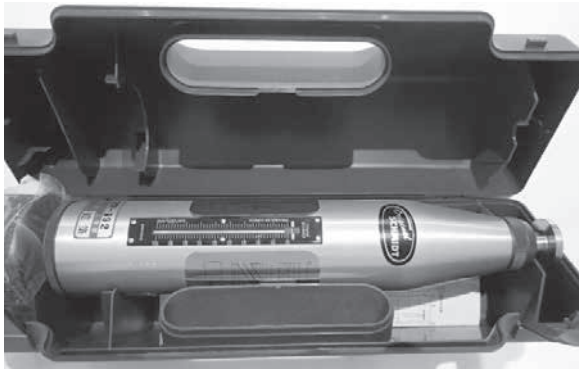
Fig.15 Test hammer for rock

The test method that we used in Bahrain required us to compare each block's predominant frequency to the measurements obtained for other stone blocks and thus to assess the blocks' quality relatively. We tested the validity of the results that we obtained using this method by comparing them to the results obtained using other test methods. In this portion of the experiment, we tested the quality of several stone blocks using three methods: the test device shown in Fig.3, a test hammer as shown in Fig.15 and a rebound type hardening meter (RHM) as shown in Fig.16. The test hammer and rebound type hardening meter yielded values measuring strength, such as Young's modulus and deformation coefficient.

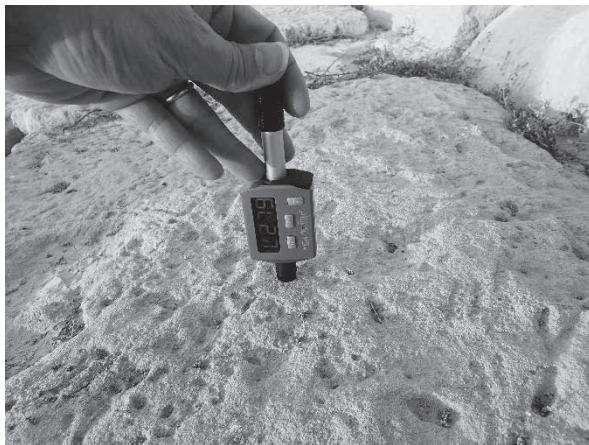
Fig.17 Measuring technique with rebound type hardening meter

The locations where we tested all three methods were 26 points on stonework blocks in the Temple II section of the Barbar Temple. The results of the three tests were compared for each point. Figs.17-18 show examples of how we tested the stones using the rebound type hardening meter and test hammer, respectively. The angle of each tested surface was calculated with reference to the vertical. Although measurements with a rebound type hardening meter are usually repeated five times at the same point, our measurements were performed five times at five different points, which meant that the standard deviation was greater than it would have been otherwise. The angle of the test surface was automatically revised when the rebound type hardening meter was used, but when the test hammer was used, the angle of the test surface was measured in terms of the angle of the hammer to the horizontal direction. Each test was repeated three times, and the average value and standard deviation were calculated after the maximum and minimum measured values had been excluded from the data.

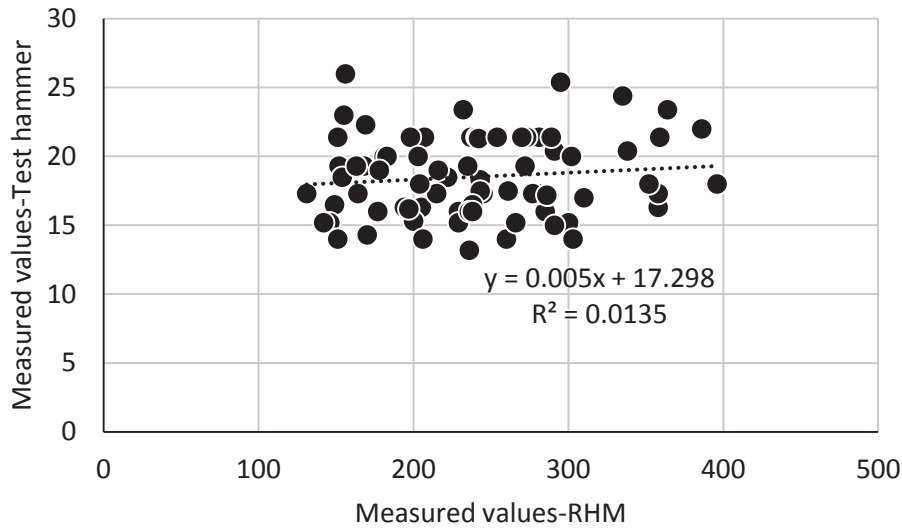
hardening meter and those obtained using the test hammer. Figs.20-22 show the relationships among the three test methods in a plot of all data. Together, the results depicted in our figures show that there was not a strong correlation between the results obtained by the three test methods. There was some correlation between the average values obtained using the rebound type hardening meter and those obtained using the test hammer, but this correlation was not strong. It remains difficult, therefore, to determine which of the three methods is most suitable for quality evaluation of ancient stonework blocks. It must also be noted that our results contain errors related not only to the different test methods but also to variation in the experience of the human testers. Accordingly, we think it is necessary to estimate stone quality with stocking data hereafter.

Fig.21 Relationship between values obtained with rebound type hardening meter and those obtained with test hammer (all data)

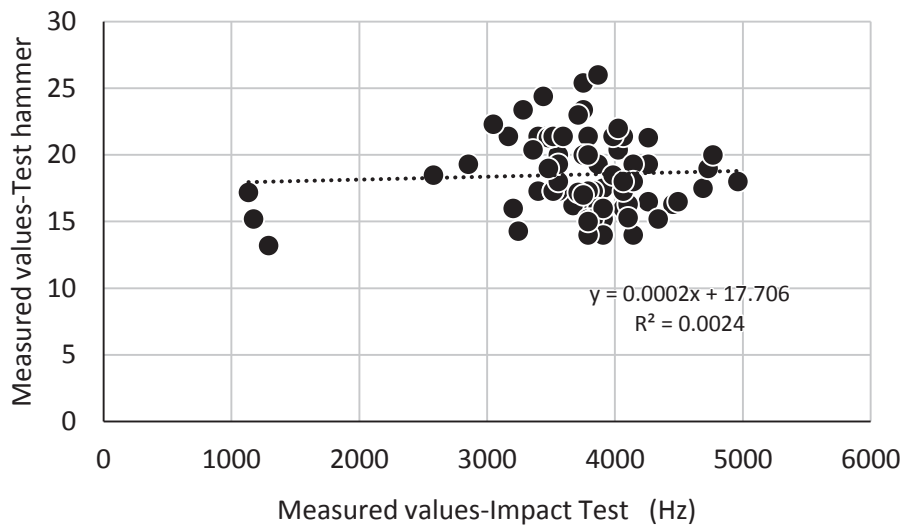
Fig.22 Relationship between values obtained with impact hammer and those obtained with test hammer (all data)
