# STRENGTHENING COUNTERMEASURES AND QUALITY ESTIMATION OF BEDROCKS IN MASTABA IDOUT, EGYPT

As part of the conservation and restoration work of the Center for the Global Study of Cultural Heritage and Culture (CHC), this study explores the strengthening countermeasures and the quality estimation of rock at Mastaba Idout in Saqqara, Egypt.

The Mastaba Idout was built around 2360BC. The bedrock of this unique underground burial chamber is known to be weak and, as such, an investigation of its condition and quality and an examination of various strengthening methods are reported herein. The results of quality testing for four kinds of strengthening agents for stone in Japan are also examined. The results of quality testing and repairs for the bedrock in Egypt and the results of the quality testing of strengthening agents for dirt in Japan are reported. Quality testing measures the frequency of the accelerating wave generated by striking a rock surface with an impact hammer. The repair methods involve strengthening by coating with a strengthening agent for stone and injecting non-shrink cement slurry into cracks.

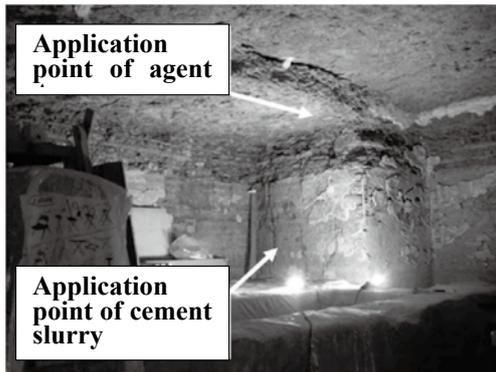
Fig. 1 Application point in burial chamber

Fig. 1 shows the roof-ceiling assembly and the side wall part of the underground burial chamber of Mastaba Idout where the above-mentioned two kinds of materials were applied. A reinforcement preservation agent for dirt and stone was used for the roof-ceiling assembly, and cement slurry was used for a crack in the side wall.

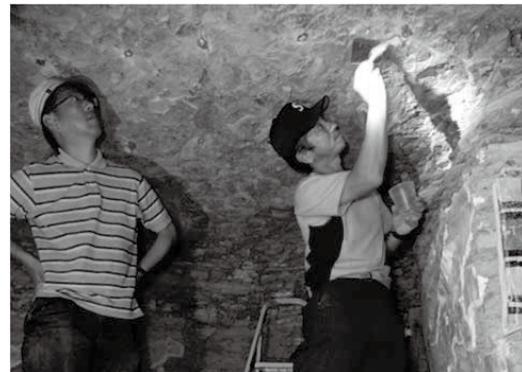
Fig. 2 Construction status of Agent A

Agent A was applied repeatedly using a brush until the coating reached  $3 \text{ kg/m}^2$  on the rock surface of the roof-ceiling assembly of the underground burial chamber (Fig. 2). The application shape was a square of  $100 \text{ mm} \times 100 \text{ mm}$ , as shown in Fig. 3.

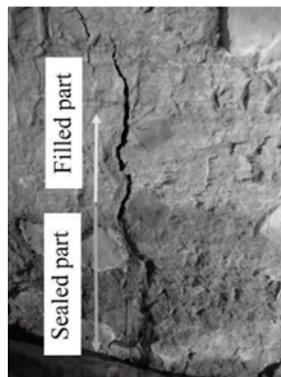
Fig. 4 Application point of cement slurry

A cement slurry water-binder ratio (W/B) of 18% was achieved by mixing 0.2 kg of non-shrink cement and 0.036 kg of water. The application area was the crack shown in Fig. 4, the width of which was, at most, approximately 10 mm. The day before the application, water was poured into the crack, and the part where water leaked (sealed part in Fig. 4) was sealed with cement slurry via a syringe on the day of application. The slurry was poured into a hose placed in the upper part of the crack (the filled part on Fig. 4), as shown in Fig. 5. When the cement slurry overflowed from the upper part of the cracked portion, the crack was deemed to have been filled with the cement slurry.

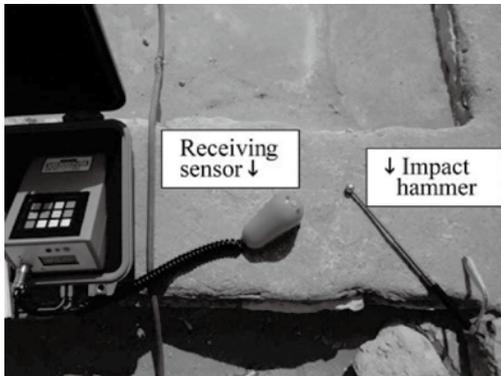
Fig. 6 Frequency measuring equipment

Fig. 6 shows the commercial measuring device for frequency and wave shape (product of C company) that was used to confirm the effect of the repair and reinforcement at the application areas for Agent A and cement slurry. By striking the target surface with the impact hammer and recording the wave with an acceleration sensor, this device captures the predominant frequency and wave shape at the main device. Fig. 7 shows an example of the location of the acceleration sensor and the striking points by the impact hammer in the main test. In the figure, “※” indicates the location of the acceleration sensor and “×” shows the striking points by the impact hammer. In the test, the distance between the acceleration sensor and the hitting points differed from the test conditions, and was almost 10 cm. A large frequency value indicates that the texture of the measured object is dense and of high quality, and a small frequency value indicates that the texture of the object is coarse and of poor quality.

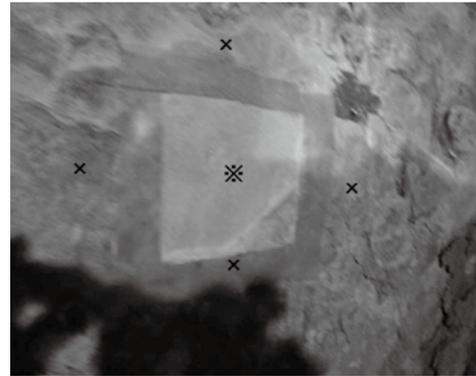
Fig. 7 Example of striking location in measuring frequency

Testing was carried out on the ceiling bedrock examined in Section 2.2. Measurements were conducted before and after coating with Agent A to examine its effects. The receiving sensor was set to “\*”, as shown in Fig. 7. Measurement was carried out by striking “\*” using an impact hammer. Table 2 shows the results. The measured frequencies were increased by 1.4 times after coating. The quality of the bedrock surface improved slightly as a result of coating with Agent A, and a stiffening effect was observed.

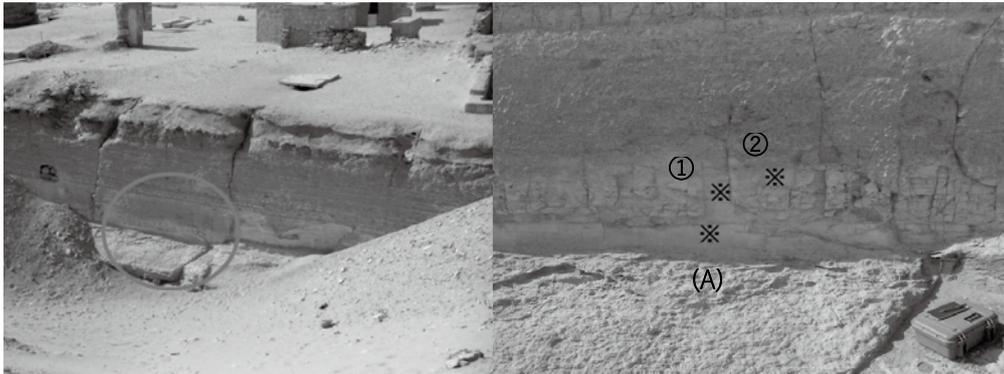
Fig. 8 Outdoor measurement point (Right picture: Enlargement of circle in left picture)

Before conducting testing in the underground burial chamber, preliminary tests were performed on the surrounding aboveground bedrock. Fig. 8 indicates the area where we took measurements from—it was of similar height as the underground burial chamber. (A) was high-quality bedrock, ① was slightly deteriorated bedrock, and ② was very weak bedrock. A receiving sensor was set at “\*”, and measurement was conducted by striking with an impact hammer at a point 5 to 15 cm away from “\*”. Table 1 shows the measurement results. According to the table, the measured values grew smaller in the order of (A) high-quality area, ① slightly deteriorated area, and ② weak area. The tendency in which variations increase was determined from the standard deviation, and increased in the order (A), ①, and ②. This also indicates the quality deterioration in the bedrock.

(A) High-quality part	① Slightly degraded part	② Vulnerable part
Measured predominant frequency (Hz)	3,984	3,652	1,349
	3,633	3,144	1,505
	4,336	2,956	576
	3,516	2,820	1,281
	3,867	2,507	2,562
Average values (Hz)	3,867	3,016	1,455
Standard deviation (Hz)	286	380	639

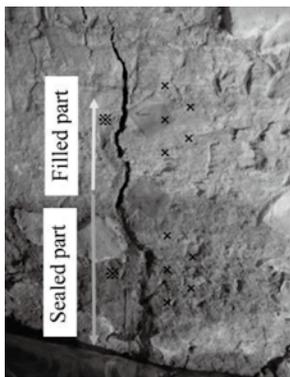
**Fig. 9** Status of measurement point

The wall that was being restored was also tested, and the measured predominant frequency was 3,406 Hz, which was not low quality. This was judged from the relationship between the appearance of the bedrock and the predominant frequency of the high-quality area shown in Table 1. A repair with non-shrink cement slurry was performed, and its effect was examined by frequency measurement of the wall area where a large crack had generated (Fig. 1). The receiving sensor was placed in the left side of the crack, hitting five points on the right side of the crack, and the frequency was measured as shown in Fig. 9. “※” indicates the location of the receiving sensor, and “×” indicates the part that was struck in this figure. Table 3 shows the measured results, and Fig. 10 shows the crack that was filled with cement slurry. The table shows that the predominant frequency was changed before and after filling with cement slurry. It was also found that the surface was filled with cement slurry densely and the propagation of waves was improved. An increase in frequency was not, however, evident at the sealed area. The filling of the non-shrink cement slurry gradually moved to the upper part while small amounts were gradually poured in from the upper part of the sealed part. Therefore, it is considered that only the surface of the sealed portion was filled, and both the surface and the inside of the filled portion are filled with cement slurry.

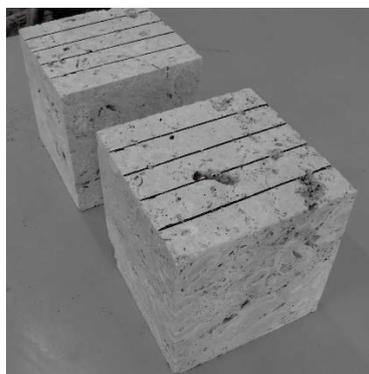
**Fig. 11** Ryukyu limestone specimens

Here, specimen manufacture was carried out in accordance with JSCE-K571 2010, “Test method of surface penetrant materials,” which addresses testing for surface protection methods for concrete structures. Three kinds of tests were conducted, namely, the water penetration test, moisture transmission test, and compressive strength test. Three kinds of test specimens were used for each test. The original specimens were Ryukyu limestone cubic specimens (100 mm × 100 mm × 100 mm) (Fig. 11), which were used as-is for the water penetration test. In the moisture transmission test, specimens were cut to 100 mm × 100 mm × 20 mm with a diamond cutter. For the compressive strength test, Φ20 × 40 mm of cores were extracted using a core drill from the cubic specimens. Table 4 shows the shape and size of specimens for each test. Ryukyu limestone was selected as the rock species closest to the target bedrock of Egypt.

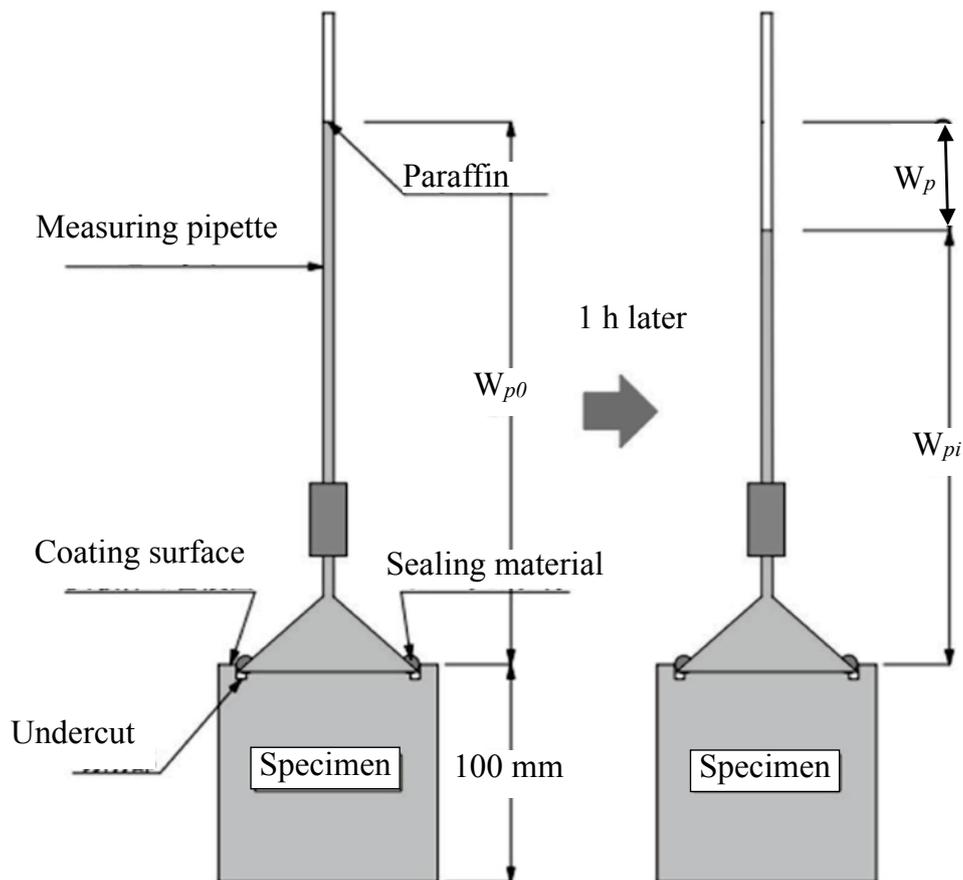
Fig. 12 Water penetration test device

The equipment for this test consisted of an infundibulum and a 50 ml measuring pipet. The funnel and measuring pipet were glued together by underwater bonding, fixed by vinyl tape, and were then glued to specimens by underwater bonding (Fig. 12).

The test was carried out by following Section 7.12 of JIS A 6909. The infundibulum and the measuring pipette were placed on the test surface so that there was no gap between them. The diameter of the infundibulum was 75 mm, and the minimum scale of the measuring pipette was 0.05 ml. Distilled water was added to the apparatus, and it was kept at a constant

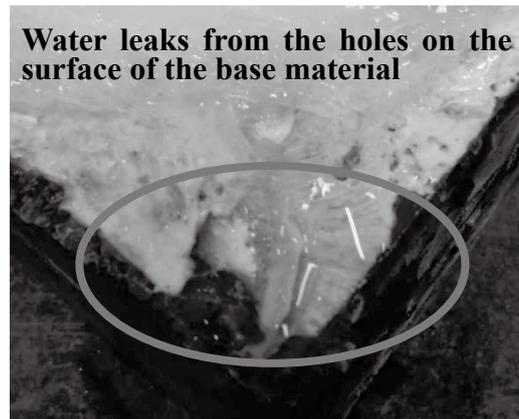
Fig. 13 Leakage

temperature ( $20^{\circ}\text{C} \pm 2^{\circ}\text{C}$ ) and humidity ( $60\% \pm 5\%$ ) for the 7 days of the testing procedure. In the concrete test, the amount of water penetration over 7 days was minimal. As Ryukyu limestone has many voids and uneven surfaces, the water penetration speed is very fast and the test method was thus changed as follows. In the case of high water penetration, water leaked from the bottom of the specimens soon after starting the test. To address this, specimens were placed in a vat, and the amount of water penetration was measured by controlling the amount of leaked water and time. The many voids in Ryukyu limestone are connected to the interior of the specimens, and water started leaking from different voids as a result of changing the water in the fixed-height test equipment. Fig. 13 shows the water leakage. In this test, the test time was 1 h not 7 days.

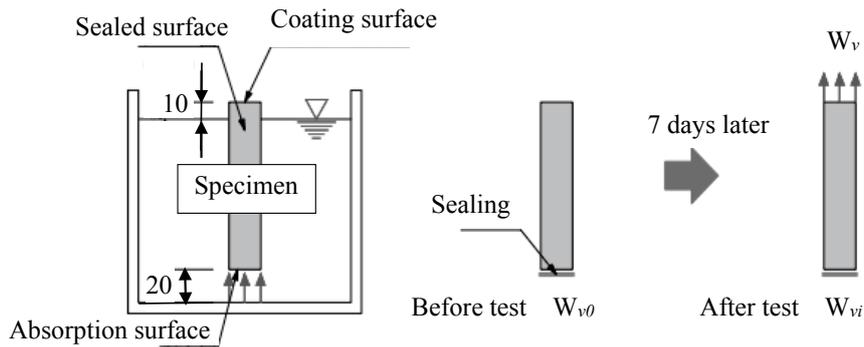
Fig. 14 Moisture transmission test flow

This test was carried out by the method shown in Fig. 14. Test specimens were soaked in water, and water was absorbed from the bottom surface for 72 h. After finishing the water absorption, test specimens were wiped with a dry towel, and the water-absorbed surface was sealed with adhesive tape. The mass of the sealed specimens was measured to the nearest 0.01 g, and this value ( $W_{v0}$ ) was considered to be the mass of specimens before the moisture transmission test. Next, the specimens were placed on a test surface for up to 7 days under constant test surface conditions (temperature of 20°C, relative humidity of 60%). After 7 days, the mass of the specimens ( $W_{vi}$ ) was measured and the moisture transmission ( $W_v$ ) value was calculated.  $W_v$  was determined as the average of three test values and was rounded to two decimal points.

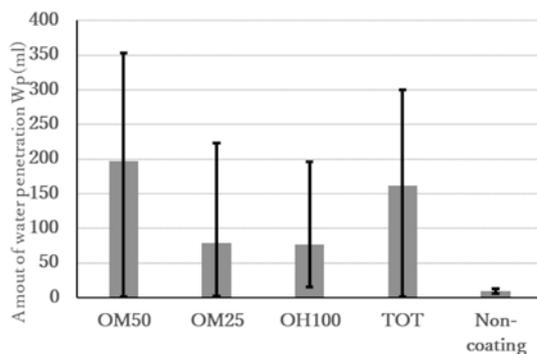
Fig. 15 Water penetration test results

Fig. 15 shows the results of the water penetration test. The average values are shown by a bar chart, and maximum and minimum values are shown by black lines. Fig. 16 shows the most effective results among all four cases. The results reveal that the test data varies widely. This is because Ryukyu limestone has a highly porous character and many voids. The average values of coated specimens were bigger than that of non-coated specimens, and OH100 or OM25 showed the best resistance for water permeability. Aiming at the lowest values, TOT showed the most excellent water permeability resistance.

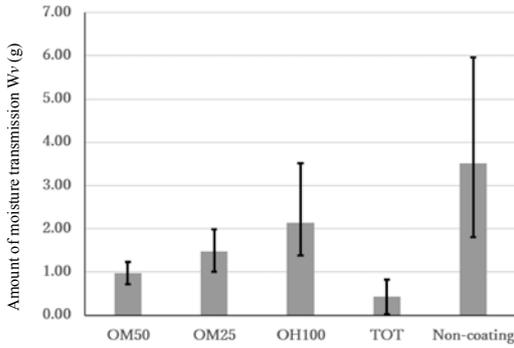
Fig. 17 Moisture transmission test results

Fig. 17 shows the results of the moisture transmission test. The average values are shown by a bar chart, and the maximum and minimum values are shown by black lines. Fig. 18 shows the best data among the results of the moisture transmission test. In OH100 there is a large moisture transmission value for a non-coated specimen. TOT has the biggest resistance for moisture permeability.

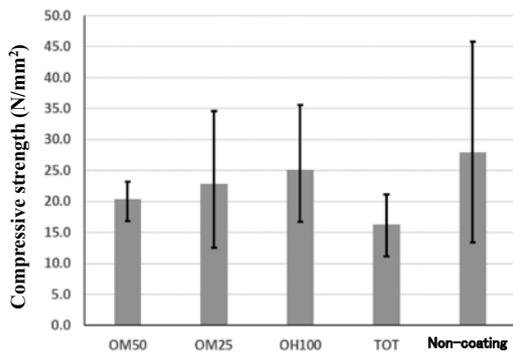
Fig. 19 Compressive strength results

Fig. 19 shows the results of the compressive strength test. The average values are shown by a bar chart, and the maximum and minimum values are shown by black lines. The results reveal that the strength of coated specimens is lower than that of non-coated specimens. This is thought to be the chemical effect of the agent, but the exact cause has not been identified. The decrease in the strength of OH100 was the lowest of all agents. The strength of coated specimens can be considered mostly equal, however, because it is dependent on the difficulty of making core specimens for Ryukyu limestone, the number of test specimens, and the large variations in strength. It is thus necessary to make a judgment in consideration of improved molding accuracy and an increased number of tests.

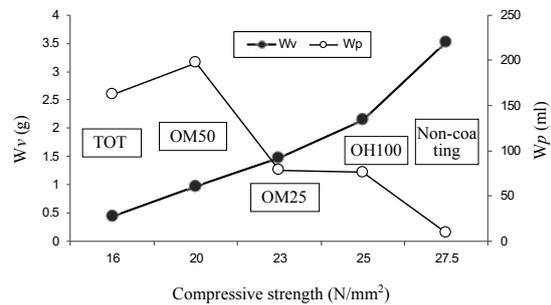
Fig. 20 The relationship among compressive strength, Wv, and Wp

Based on Sections 4.4.1 to 4.4.3 above, Fig. 20 shows the relationship among compressive strength,  $W_v$ , and  $W_p$ . The figure shows that OM25 or OH100 are suitable repair materials because they offer a good balance of suppressing water permeability, ensuring moisture permeability, and having minimal adverse effects on strength.

- (4) In a quality test conducted with Ryukyu limestone in Japan, OM25 and OH100 were considered to be suitable repair materials because they have a good balance of suppressing water permeability, ensuring moisture permeability, and having minimal adverse effects on strength.
