Removal of the White Marine Deposits Disfiguring the Granitic Monumental Objects of Alexandria Lighthouse, Alexandria, Egypt

[Abstract]

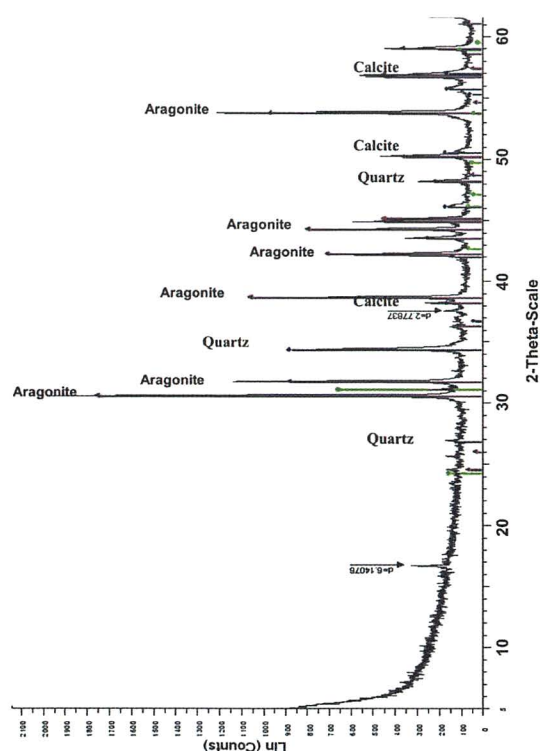
white marine deposits are accumulated on the surfaces of the monumental objects due to the impact of the sea organisms. They range from white to yellowish white in color, relatively hard (about 3-4 by the Mohs scale) and their thickness ranges from millimeters to about 1 centimeter (Fig. 1). Polarizing microscope examination shows the impregnation of these deposits inside the exfoliation of the stone mineral (biotite) of the granitoid monumental objects (Fig. 2). The XRD analysis indicated that the main components of these incrustations are the calcium carbonate minerals, mainly aragonite with calcite, in addition to quartz (Fig. 3).

Fig. 3 XRD analysis of the white deposits disfiguring the Lighthouse monumental objects

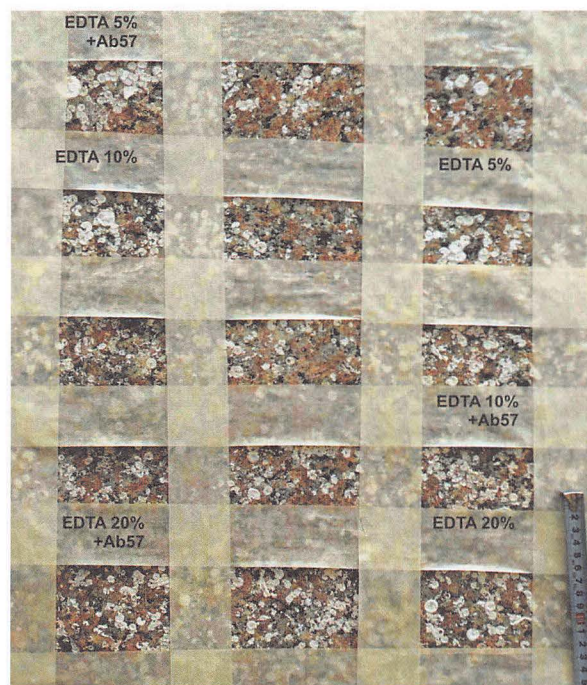
The six different poultices were applied on the back surface of the monumental objects; each in a square measuring about 10cm x 10cm (Fig. 4). A cotton tissue and plastic sheet were used with adhesive tape to cover the compress. Pieces of cotton tissue (measuring 10cm x 10cm) were used as compresses. Each poultice was applied to its selected area by using a brush, after the area was wet by desalinated water. A plastic sheet covered the paste and the cotton tissue was fixed by using adhesive tape. A label was written above each poultice. The complete duration of the applied cleaners remained for seven days (one week). During these days, four investigations were carried out to record the result of each case (after 24h, after 48h, after 72h and after 7 days). After three hours, the results of observation were negative in all the six cases. The field temperature at the time of the tests was up to 18 °C during the day.

Fig.4 Showing the areas of the applied six poultices

For the present cleaning field work two groups of cleaner agents in the form of poultices (six poultices) were applied. The three poultices of the first group were prepared by using EDTA in three concentrations (5, 10, and 20%) together with carboxyl methyl cellulose (CMC, 6%). The three poultices of the second group of cleaner agents were prepared using the same concentrations of EDTA and CMC, used in the first group, in addition to a modified mixture of what so called AB57 given by Mora et al., (1984). The used modified mixture of AB57 is formed only of sodium bi carbonate (4%) and ammonium bicarbonate (4%). CMC was added to the proposed cleaner agents to produce a paste and its concentration (6%) is similar to the amount introduced by Mora et al., (Op. cit).

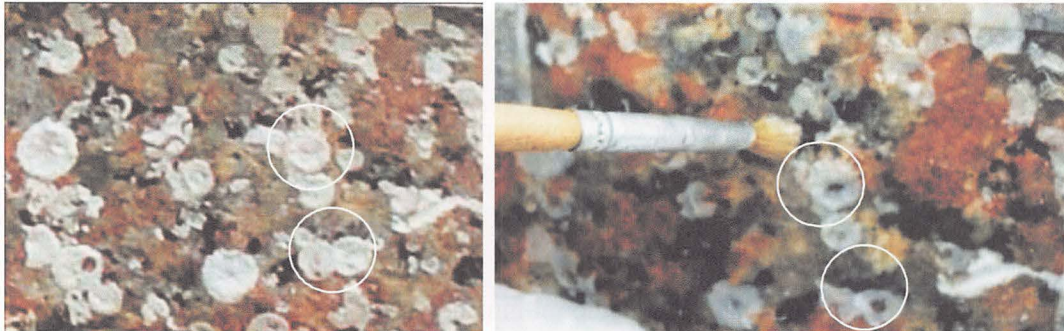
The results after 24h were almost negative except for EDTA 20%; which provided the etching for the thin concretion deposits (Fig. 5).

Fig. 5 Results of EDTA 20% after 24h

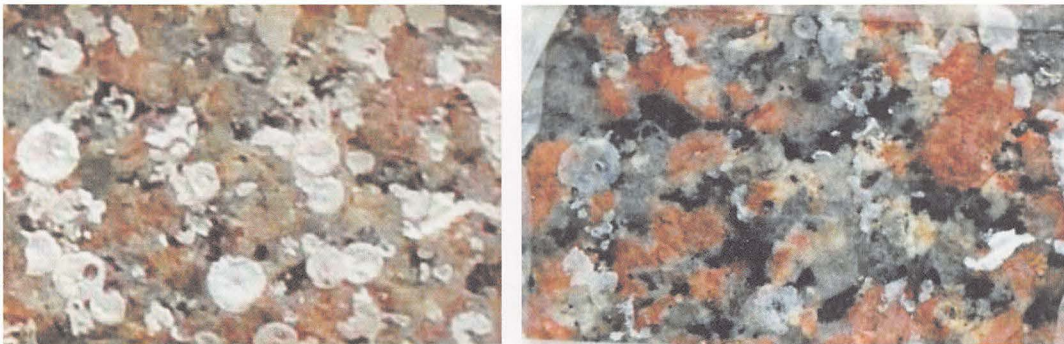
The second investigation was took place after 48h. The results were quite considerable in some cases. EDTA 20% (Fig. 6) and AB57+EDTA 20% (Fig. 7) showed the deposits were moderately cleaned. The thin deposit layers were etched, but the thick deposit layers were became less thick. EDTA 10% (Fig. 8) and AB57+EDTA 10% (Fig. 9) started to show progress in etching the deposits, and the thin deposits began to be removed. However, EDTA 5% and AB57+EDTA 5% (not shown here) showed only slight progress in removal of the deposits.

Fig. 6 Results of EDTA 20% after 48h

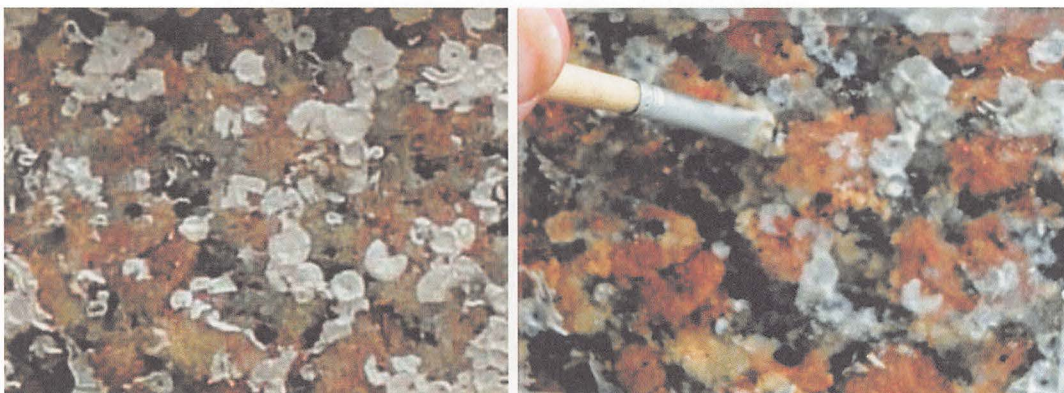
Fig. 7 Results of AB57+EDTA 20% after 48h

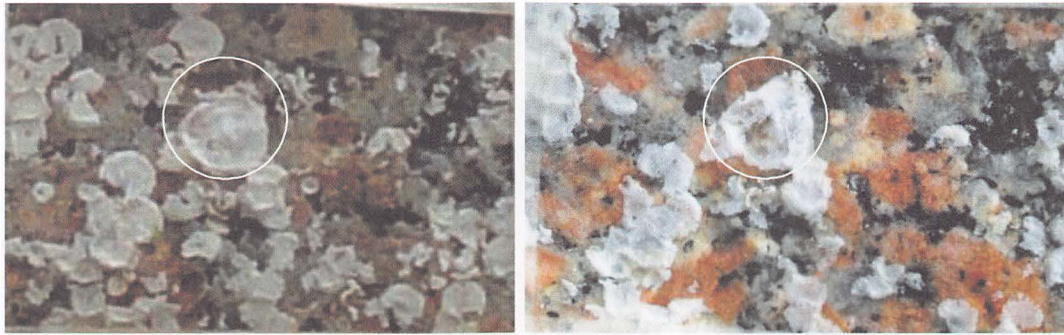
Fig. 8 Results of EDTA 10% after 48h

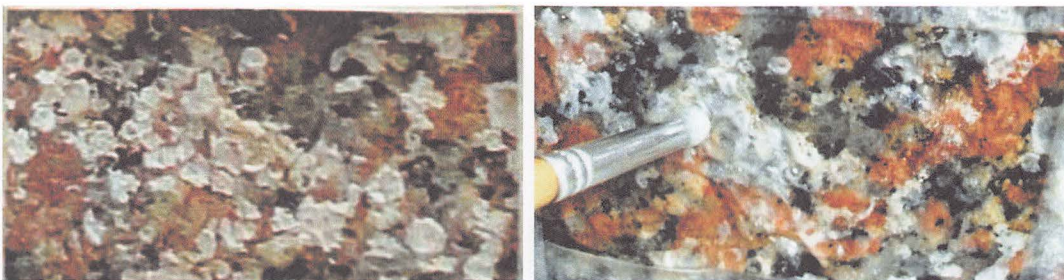
Fig. 9 Results of AB57+EDTA 10% after 48h during cleaning with a short-haired brush

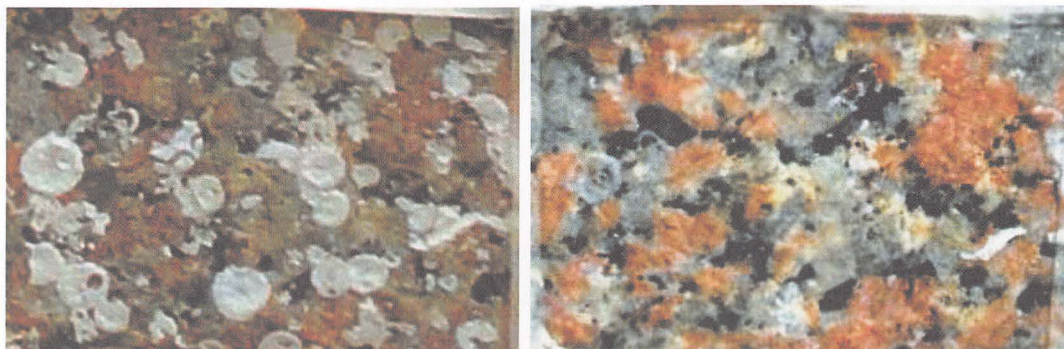
The third investigation was done after 72 h (three days). This investigation showed the progress of cleaning in all the cases with varying degrees. EDTA 20% (Fig. 10) and AB57+EDTA 20% (Fig. 11) showed considerable progress in removing the deposits. Only the thickest deposits are still visible, while the very thin layer of deposits were completely removed. EDTA 10% (Fig. 12) and AB57+EDTA 10% (Fig. 13) also showed a visible change in the removal of the deposits but less than in the case containing EDTA 20%. EDTA 5% and AB57+EDTA 5% (not shown here) showed a slight (poor) progress in the removal of the deposits, even the thin ones.

Fig. 10 Results of EDTA 20% after 72h

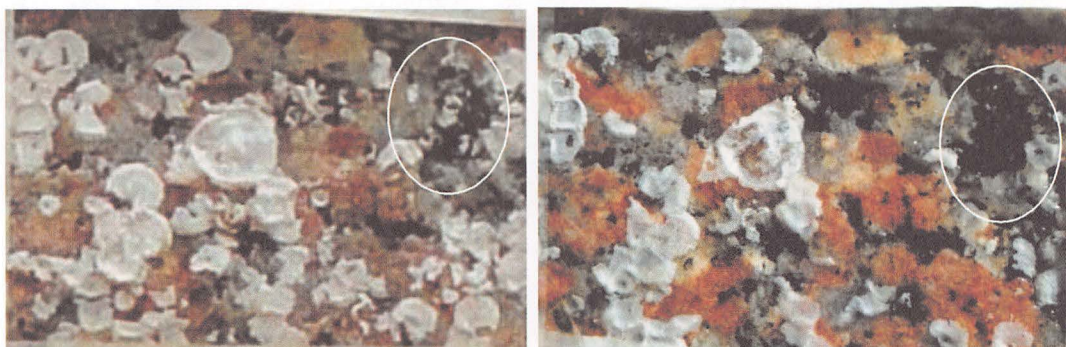
Fig. 12 Results of EDTA 10% after 72h

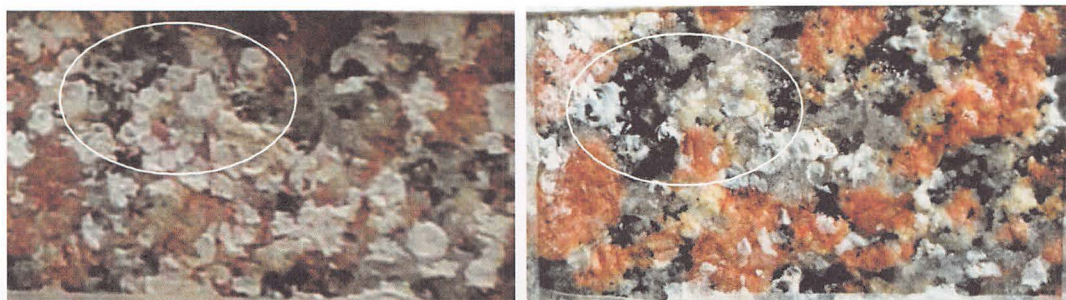
Fig. 13 Results of AB57+EDTA 10% after 72h

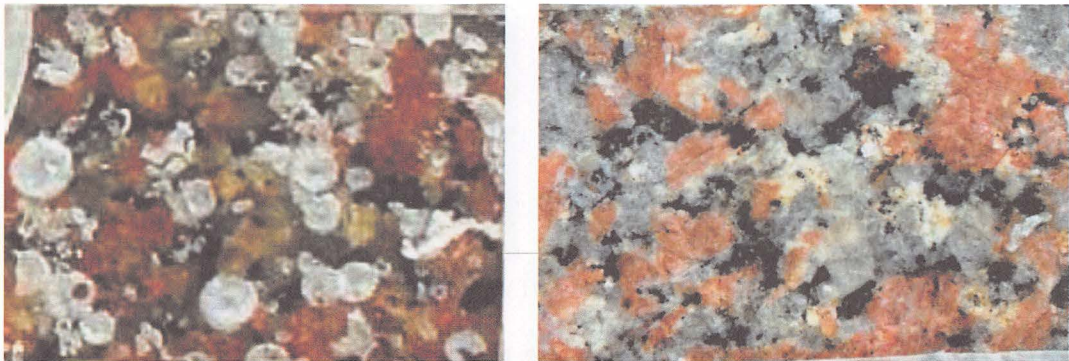
The fourth investigation was carried out after one week (seven days); it showed progress in the removal of the deposits for all the cases with various degrees. EDTA 20% (Fig. 14) and AB57 + 20% EDTA (Fig. 15) showed considerable results in removal of the white deposits. EDTA 10% (Fig. 16) and AB57+EDTA 10% (Fig. 17) came in the second level in the progress of removing the deposits. EDTA 5% (Fig. 18) and AB57+EDTA 5% (Fig. 19) gave a poor results in the cleaning the white deposits.

Fig. 14 Result of EDTA 20% after seven days

In sum, cleaning by using EDTA di sodium salt 20% in the form of a poultice with the help of brushes and/or fiberglass is a successful and safe method for removing the white marine deposits accumulated on the monumental granitic objects.

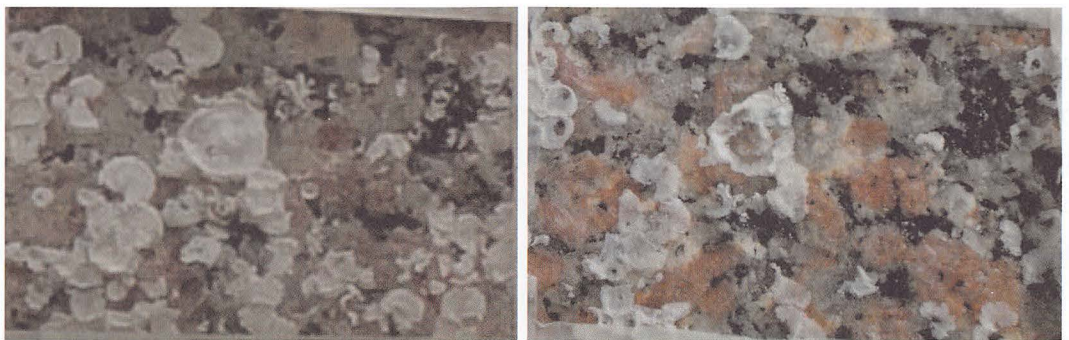
Fig. 16 Results of EDTA 10% after seven days

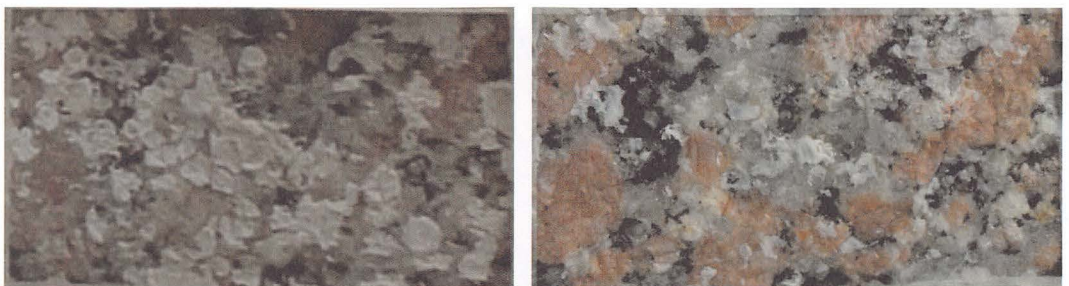
Fig. 17 Results of AB57+EDTA 10% after seven days

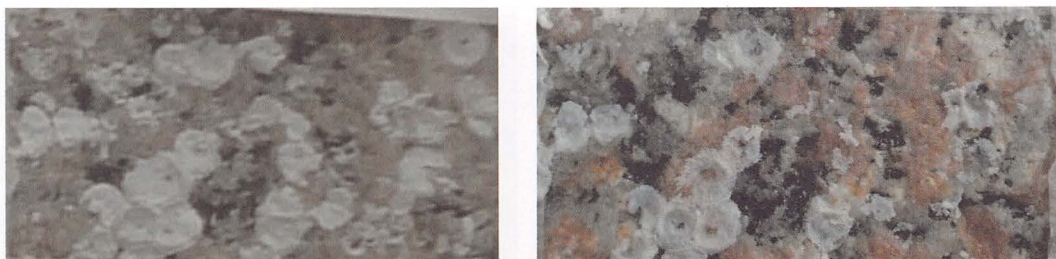
Fig. 18 Results of EDTA 5% after seven days

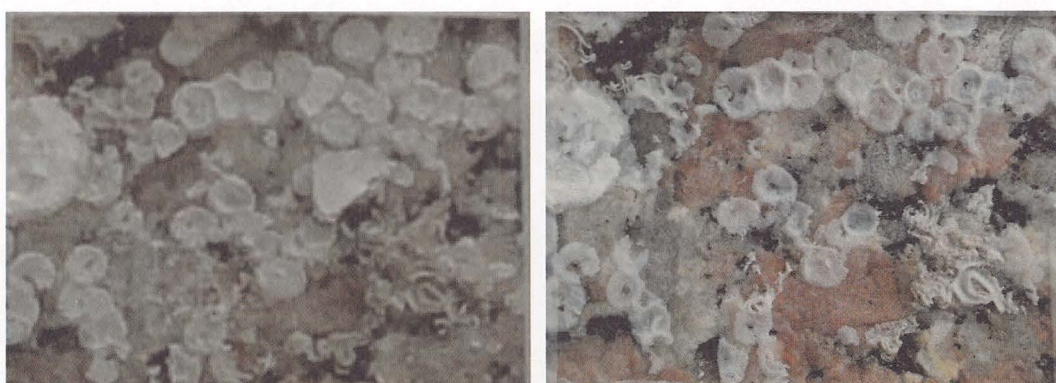
Fig. 19 Results of AB57+EDTA 5% after seven days
