Mural Paintings in the Burial Chamber of Mastaba Idout: Cause of Deteriorations, Material Analysis, and Conservation Works

1 Causes of deterioration of the Wall Paintings¹

2 Pigments and Plasters

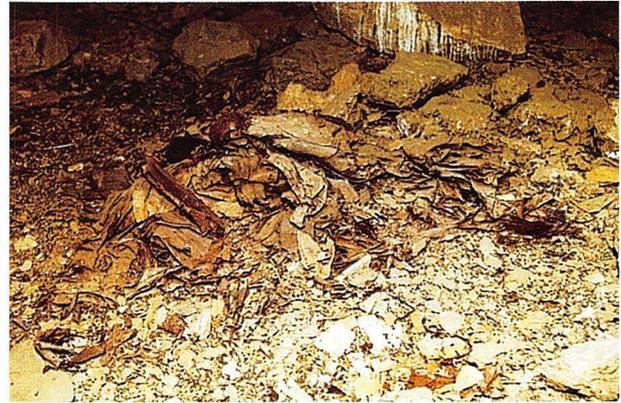
Fig. 3 Shows big pile of the fallen fragments having various sizes.

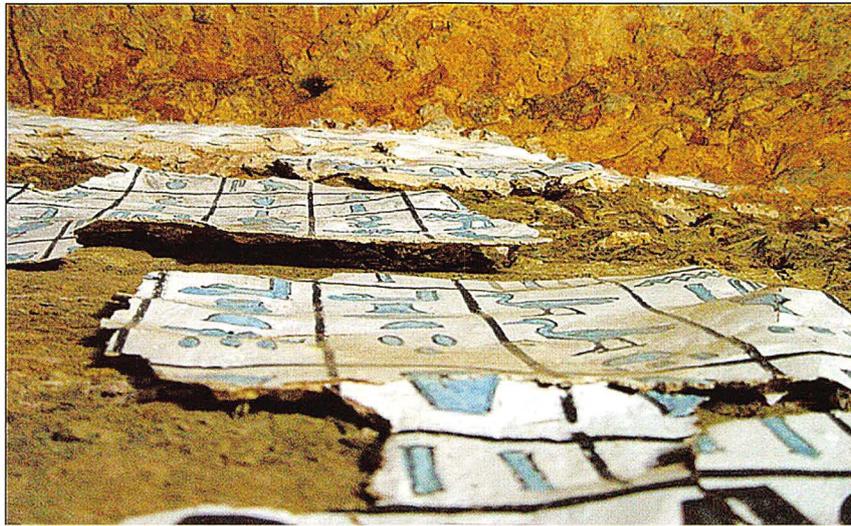
Fig. 4 Painting fragments highly separated from their wall support and being fallen down.

danger of being lost as a result of the separation of the painted plaster from the clayey limestone support (Fig. 3 and Fig. 4) was also apparent. There were signs of discoloration, color fading and salt crystallization, as well as mechanical deterioration caused by people. It seemed that a main reason of the deterioration of the wall paintings was the bed-rock composition, plaster, and paint layers.

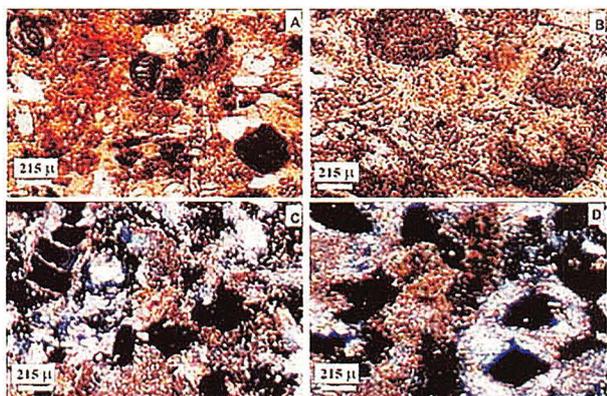
Fig. 5 A-Biopelsparite, limestone lithotope, P.P.L. B- Rounded peloids embedded in sparite matrix, P.P.L. C&D- Pore spaces (both inter- and intraskeletal) having various size and shape, biopelsparite association, C.N.

Petrographically, the limestones are classified into biopelsparite [Folk 1959] or bioclastic peloidal grainstone [Dunham 1962]. The peloids and bioclastics are present in varying proportions (Fig. 5A and Fig. 5B). The bioclastic constituent is 15-25% of the rock volume and is formed of mollusc fragments echinoid debris, benthic and planktonic foraminifera, together with algae. Some of the fossil

chambers are recrystallised and/or infilled with sparite, but have mostly been leached out. Peloids (20-35%), composed of structureless micrite, range in size from 20-110 μ m, and are rounded, ovoid, well-sorted and organically rich (Fig. 5B). They are formed due to fecal pelleting by certain organisms, such as molluscs and worms. The allochems are embedded in a sparitic matrix that is generally sub-translucent with a faint brownish cast in thin section. Pore spaces (both inter- and intraskeletal) are abundant (average 13%), having various size and shape (Figs.5C, D). They may have developed as a result of post-depositional diagenetic (dissolution) processes. The non-carbonates are represented by fine nodules of clay and fine detrital quartz grains (~8%).

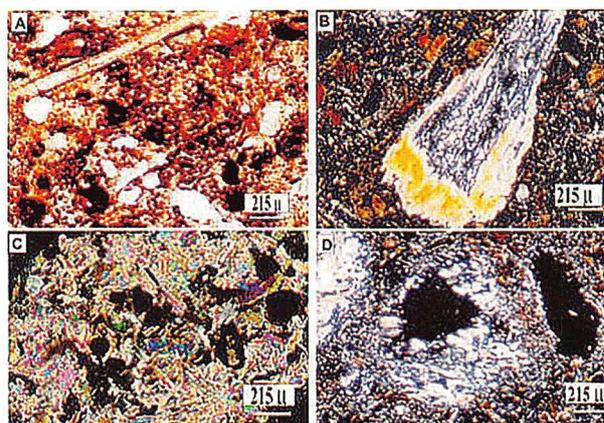
Fig. 6 A- Clayey fossiliferous micrite, micrite matrix commonly recrystallized into microsparite, marlstone lithotope, P.P.L. B - Coarse gypsum crystals (partly dehydrated) in fine grained gypsum groundmass, plaster preparatory layer, C.N. C - Well developed anhydrite crystals characterized by higher relief and stronger birefringence, C.N. D - Well developed pores in plaster layer, C.N.

A plaster preparatory layer was applied directly onto the bedrock with varying thickness. Plaster over the limestone is fine enough to allow relief carving or other manipulation. The rock surface was smoothed and covered by a reinforcing rough mortar layer, formed of coarse gypsum, in which thin limestone flakes powder, together with fine sand, was added as filler material. Over this coarse layer, a fine layer composed mainly of gypsum was applied. Therefore, the plaster layer was used to treat irregularities and smooth the surface of the bedrock [Lee and Quirke 2003]. Microscopically, the plaster layer is texturally heterogeneous. The groundmass consists mainly of finely grained gypsum in which coarse gypsum crystals are widely distributed (Fig. 6B). These crystals are occasionally dehydrated into anhydrite; characterized by higher relief and stronger birefringence (Fig. 6C). Voids (Fig. 6D) of various size and shape with sharp outlines, are occasionally delineated by fine gypsum grains, are additionally present. Some fine-to medium-sized quartz grains were also observed. Patches of iron oxide (hematite) occur as staining, with a red to blood-red color (Fig. 6B).

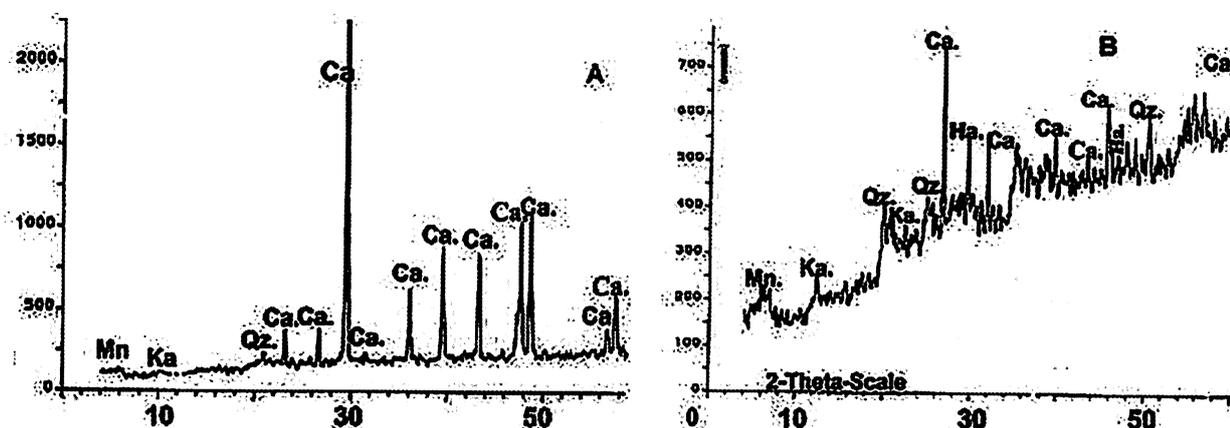
Fig. 7 X-ray diffraction patterns of some bulk samples of the bedrock, A- argillaceous limestone, B - marlstone. Qz =Quartz, Ca= calcite, Mn=montmorillonite, Ka= Kaolinite Ha= halite.

X-ray analysis of the bedrock indicated that calcite and little quartz are the main non-clay minerals recorded in all samples (Fig. 7A and Fig. 7B), whereas halite and/or gypsum are revealed in some marlstone samples. The clay mineral assemblages identified within the clay fractions (Fig. 8, as an example) include montmorillonite, kaolinite and

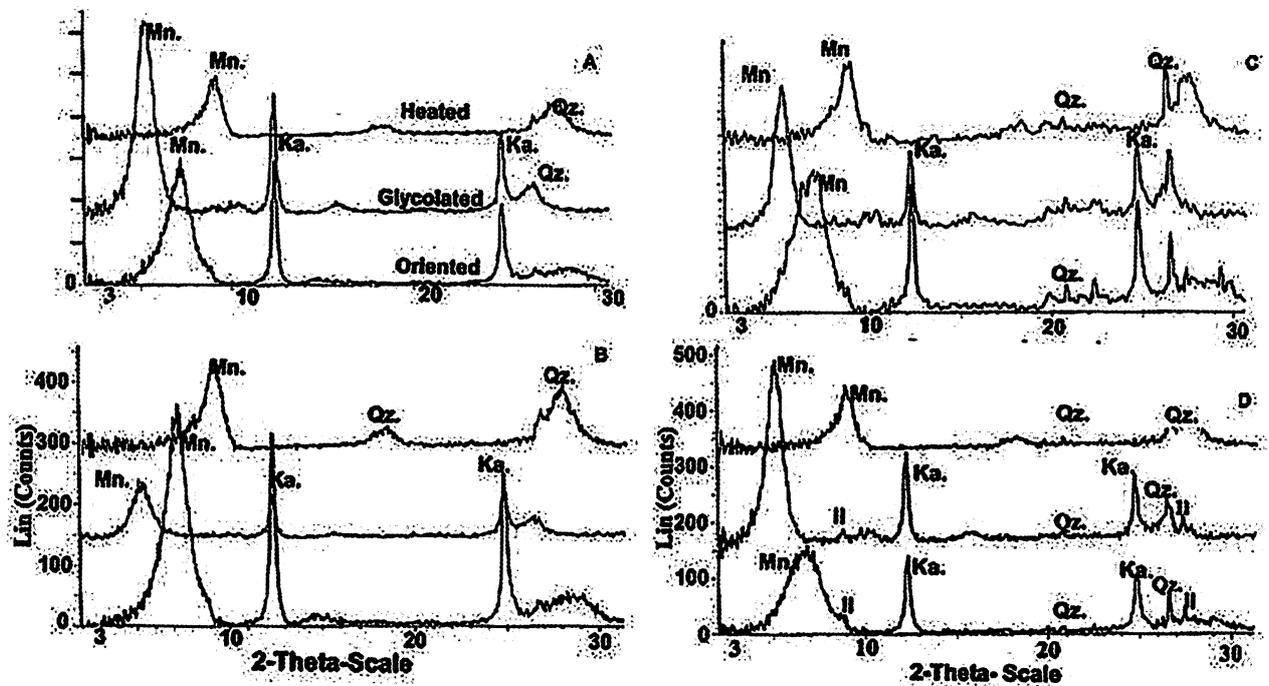
Fig. 8 X-ray diffraction patterns of some clay fractions of the bedrock. (A,B), argillaceous limestone, (C,D), marlstone; Mn=montmorillonite, Ka=Kaolinite, Il=illite Qz=Quartz.

illite, in order of decreasing abundance. Both types of montmorillonite (Ca-,montmorillonite and Na-montmorillonite) were encountered in the studied Upper Eocene sediments. The semi-quantitative estimation of the recorded clays implies that montmorillonite (the expandable clay mineral) is the predominant clay, ranging from 61%- 70% with an average 66%. Kaolinite is the second in abundance, ranging from 23%-31% and averaging 26%, whereas illite averages 7%.

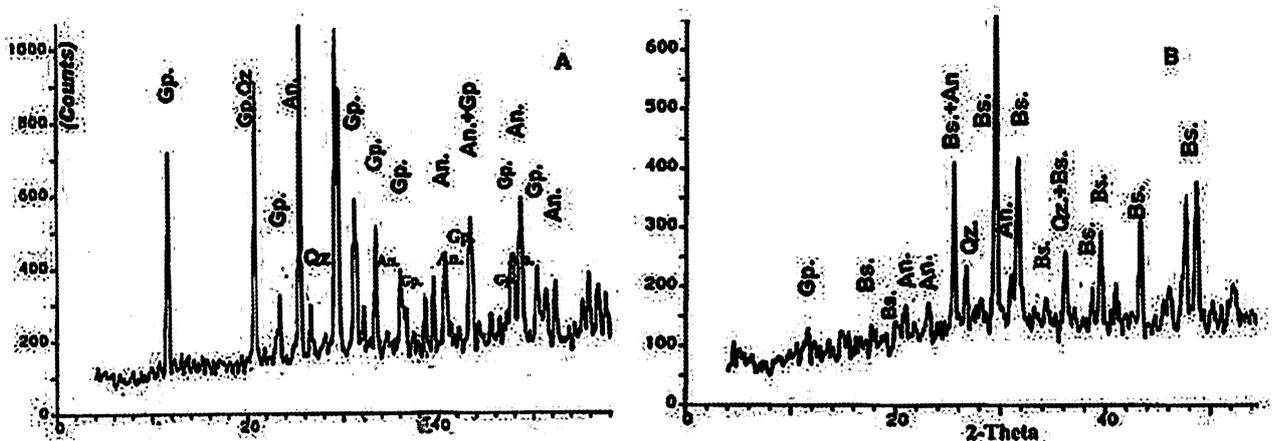
Fig. 9 Show X-ray diffraction patterns of the studied plaster, Gp.= gypsum, An.= Anhydrite, Bs.=Bassanite Qz=Quartz.

X-ray diffraction of the plaster (Fig. 9A and Fig. 9B) indicates that gypsum with subordinate anhydrite, in addition to bassanite and a little quartz are the main components. The differential thermal analysis (DTA) of the plaster is shown in Fig. 10. The DTA curves show the presence of two large endothermic peaks and one small endothermic peak. The first large endothermic peak occurs in the range of 145°C - 155°C, implying the formation of a hemihydrate phase [Flek *et al.* 1960]. The weight loss corresponding to this peak, as revealed from the TGA curve (Fig. 10), is about 9-12%; this represents about 75% of the total weight loss (~16%) of the sample; i.e. about 1.5 moles of the combined H₂O. The second large endothermic effect occurs in the vicinity of 185°C - 188°C, indicating a dehydration of hemihydrate to soluble anhydrite and loss of the remaining 0.5 mole of H₂O. Such total loss (~16%) implies that the present plaster layer is not formed of pure gypsum (theoretical total weight loss ~21%) but contains an amount of anhydrite and/ or bassanite; corroborating the re-

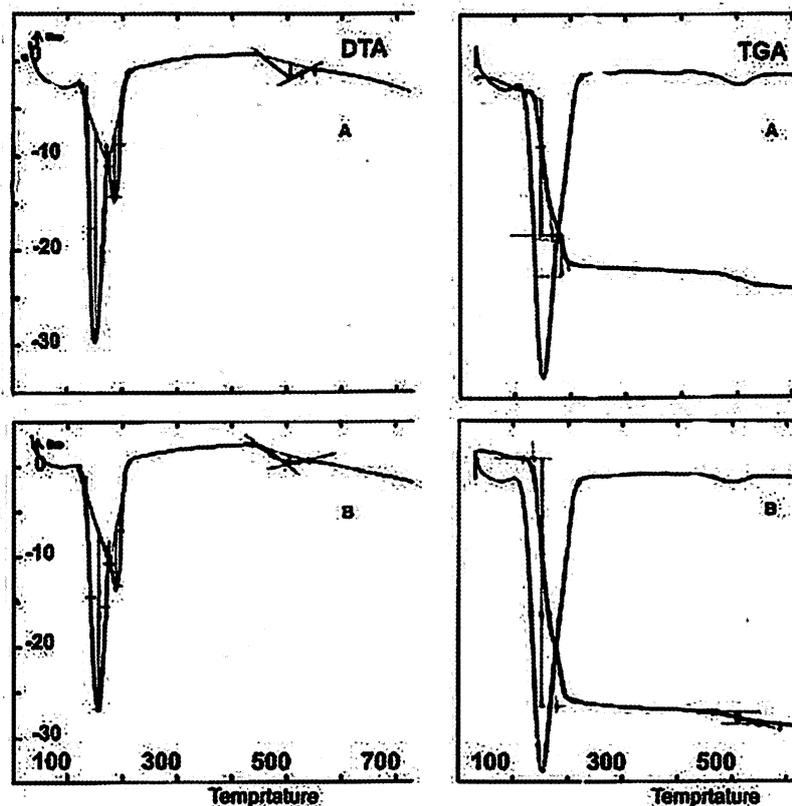
Fig. 10 DTA and TGA curves of the studied plaster.

sults obtained from the petrographic studies, as well as the X-ray analysis. The very small endothermic effect may be attributed to the loss of the last traces of water held in the hemihydrate structure [Kuntze 1962].

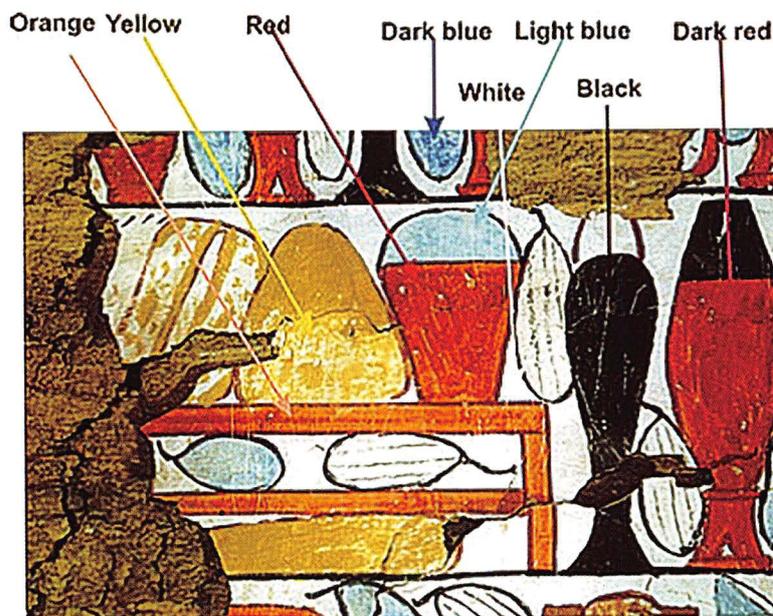
Fig. 12 Inorganic pigments used in Old Kingdom decoration of Idut's burial chamber.

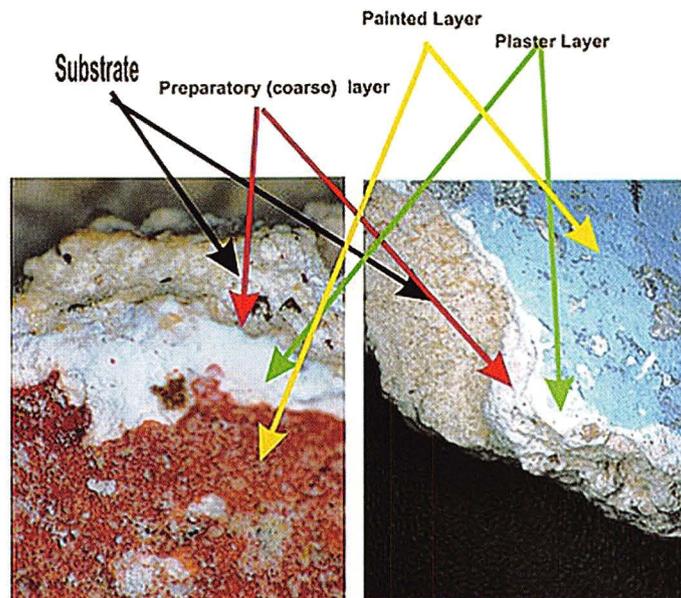
Fig. 13 Microscopic observation of the two plaster layer and the painted layer produced on the limestone substrate.

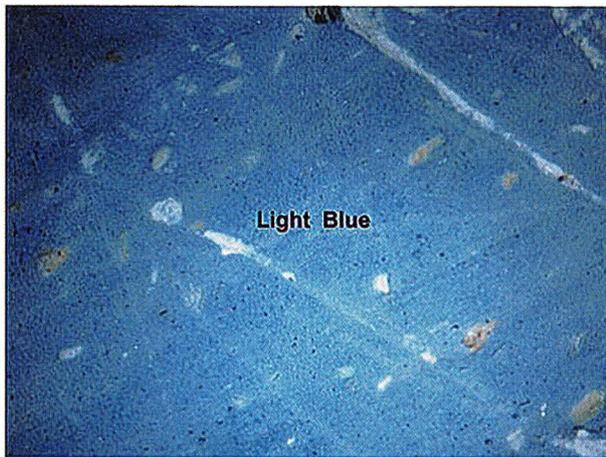
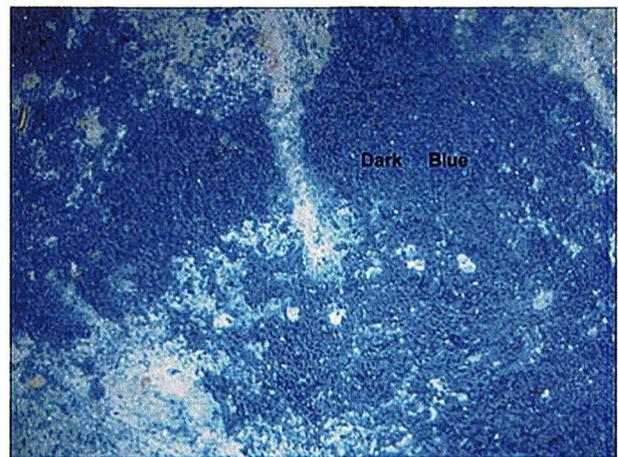
Fig. 14 Microscopic view for light blue formed of fine particles (left) and dark blue formed of coarse particles of caprorivaite(Egyptian Blue pigment).

The shade of blue, as revealed in our study, was related to the coarseness and fineness of Egyptian Blue as it was determined by the degree of aggregation of its particles. Coarse Egyptian Blue, has a thick form, due to the large clusters of crystals, which adhere to the unreacted quartz.

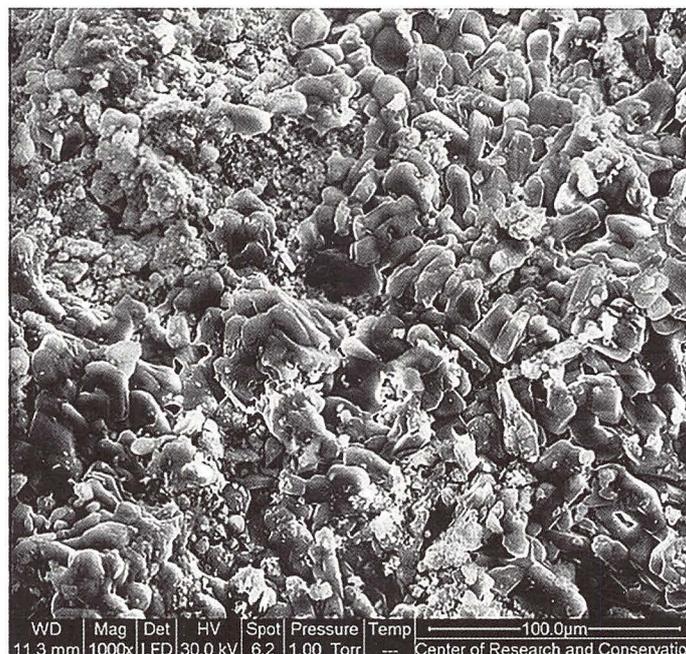
Fig. 15 SEM photomicrograph showing coarse tabular crystal of the dark blue color.

This clustering resulted in a dark blue color that was the appearance of coarse Egyptian Blue. Alternatively, fine-textured Egyptian Blue consisted of smaller clusters that were uniformly interspersed between the unreacted quartz grains and tended to be light blue in color [Tite *et al.* 1987]. The hue of the colors also depended on the level of alkali added to the mixture and, therefore the more alkali, the more glass-formed, the more the diluted ap-

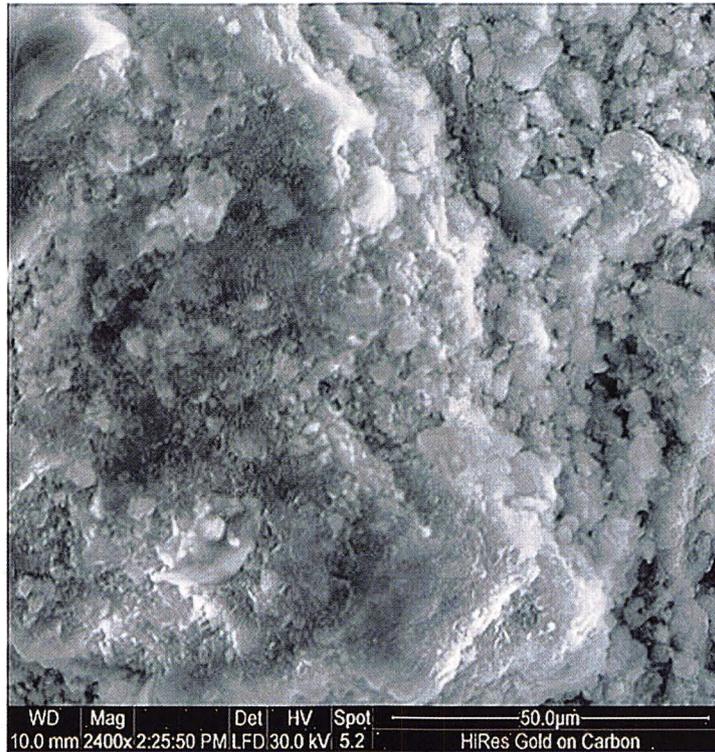
Fig. 16 SEM microphotograph showing thickly applied layers of coarse dark blue crystals.

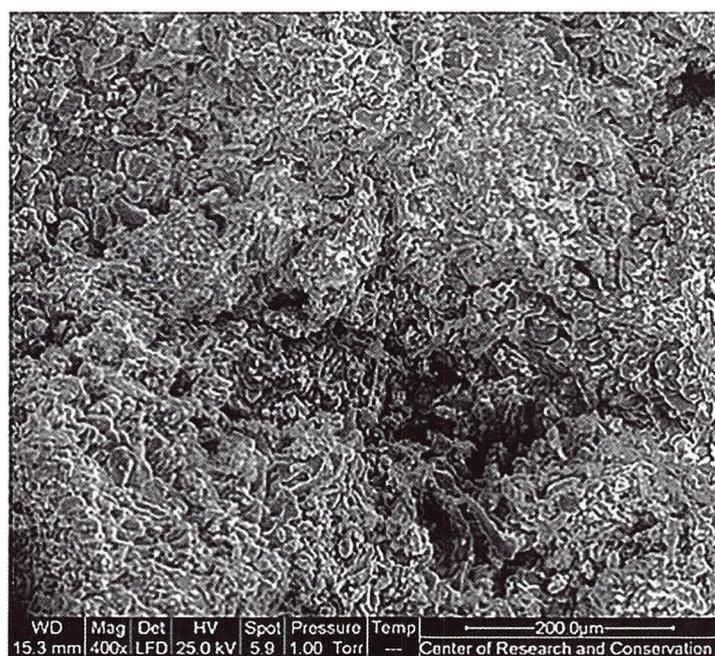
Fig. 17 SEM photomicrograph showing fine crystals of light blue color.

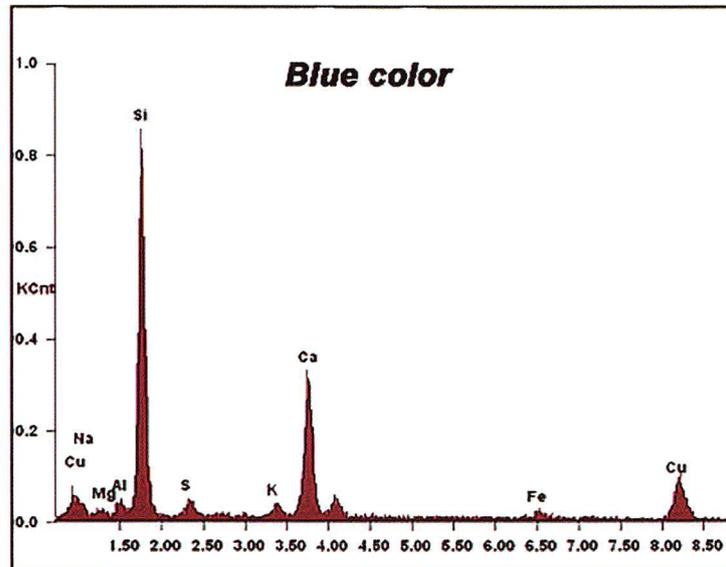
Fig. 18 Micro chemical analyses of blue pigments.

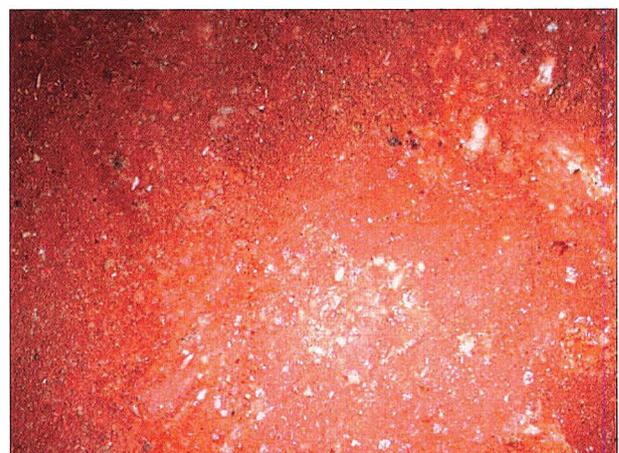
Fig. 19 Microscopic view massive granular aggregate particles appear to be uniform of red pigments.

Red pigments show the massive granular aggregate particles appearing to be uniform (Fig.19). The results obtained from the XRD analysis indicate that the red color was formed mainly of hematite (red iron oxide, Fe₂O₃). The EDX analysis (Fig. 10) confirmed the presence of iron oxide by the presence of the iron peak (~37%). Presence of aluminium and silicon detected by EDS analysis suggests the existence of aluminosilicate materials (clay minerals etc.), together with the presence of traces of minerals (Ti, V, Co) (Fig. 20), judging that the red ochre was used as red pigments in Idout tomb. Red ochre is a natural mineral pigment colored by the presence of the anhydrous, iron oxide, hematite. Ochre forms a very wide class of natural inorganic pigments. Ochre is characterized by having a wide

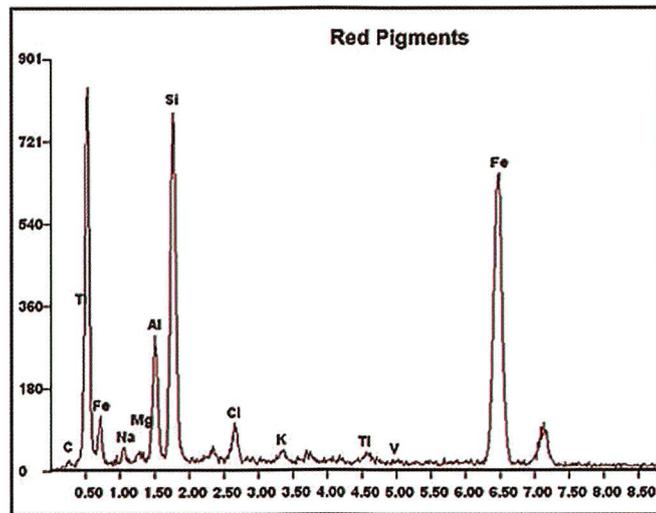
Fig. 20 EDX analysis of the red pigments.

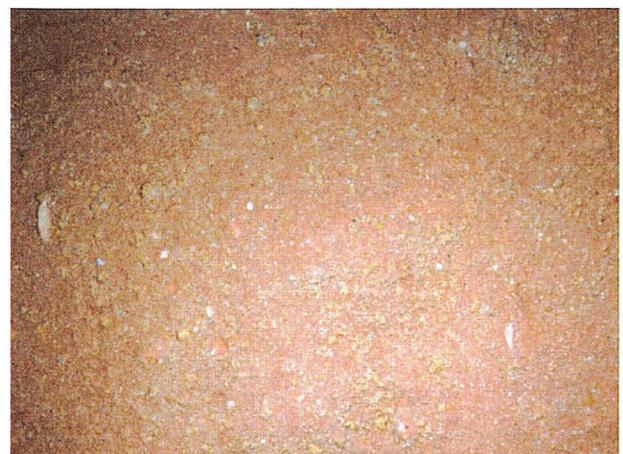
Fig. 21 Microscopic view massive granular aggregate particles appear to be uniform of brown pigments.

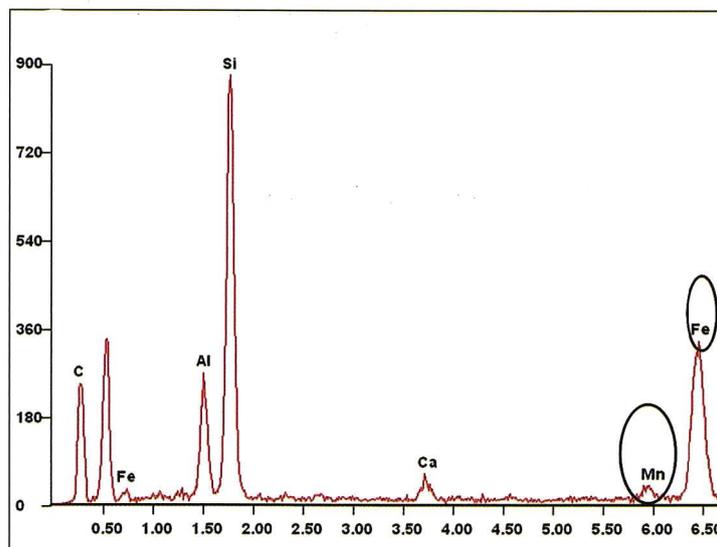
Fig. 22 EDX analysis of the brown pigments.

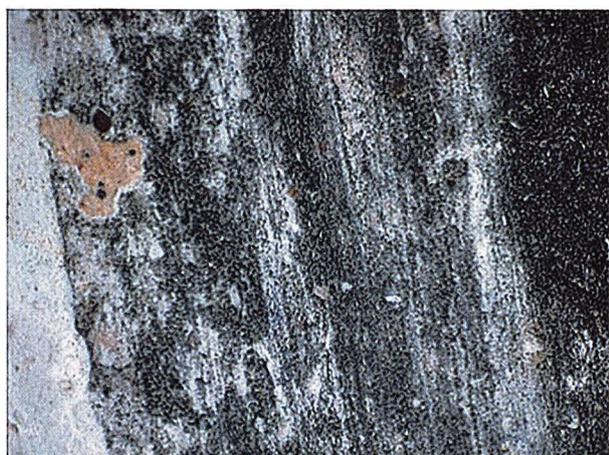
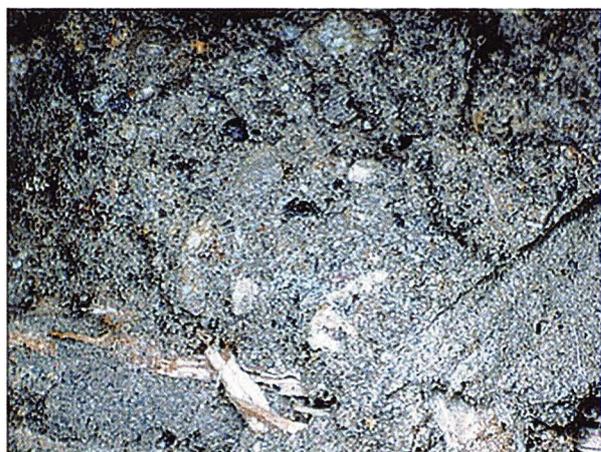
Fig. 23 Microscopic view show grey pigments prepared by applying black carbon over white (left) and dark grey pigment may be applied over an unprepared surface, note, the fibrous present.

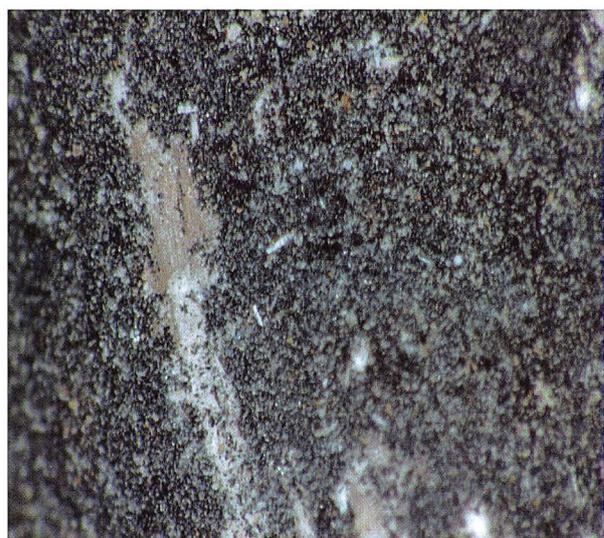
Fig. 24 Microscopic view show the uniform black pigments, note the fibrous particles of the wood charcoal.

The black pigment layer is uniform and contains fibrous particles, sometimes being applied directly on the coarse irregular plaster layer (Fig. 24). The presence of fibrous particles suggested that the black color was produced using carbon black, deriving from wood charcoal [Pallecchi et al 2009] indicating that the anatomical structure of wood was one of the first characteristic elements that stood out in the fibrous particles. Black charcoal was found to be mixed with white or applied over white in grey samples.

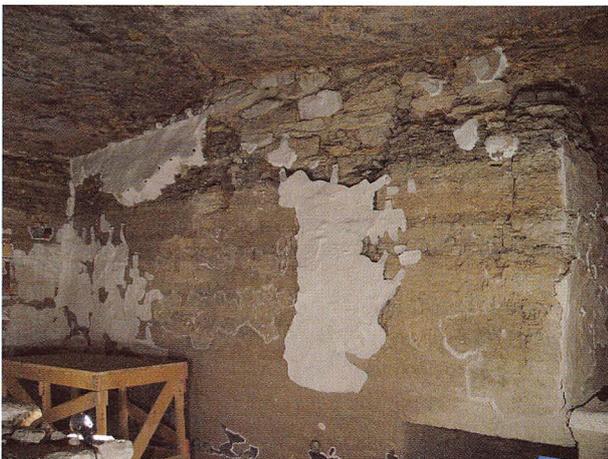
Fig. 26 Facing Layers (Kozo, Rayon and Cotton Materials Laminated with Funori glue)

pared surface was covered by facing. The Japanese paper carriers were applied with Funori glue. First thin Rayon Paper was applied, followed by thick Rayon Paper and Kozo Paper. The last layer was an Egyptian cotton canvas (Fig. 26).

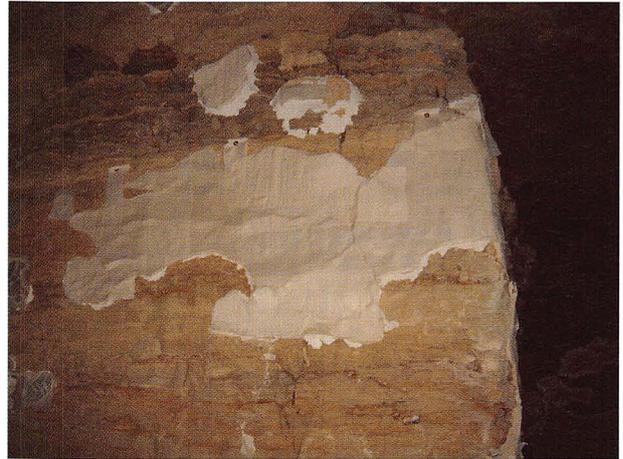
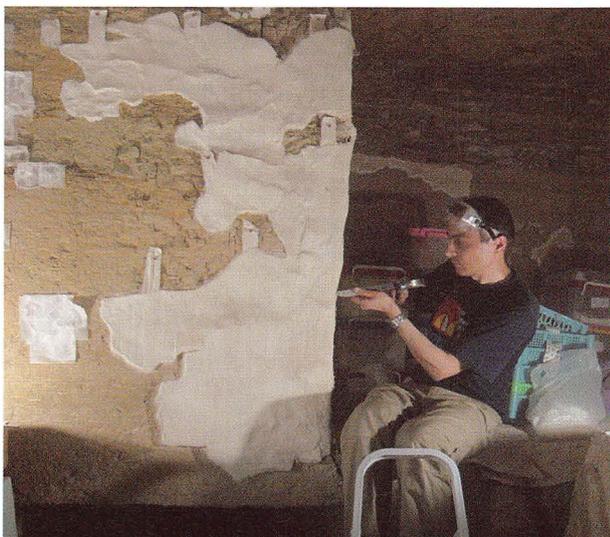
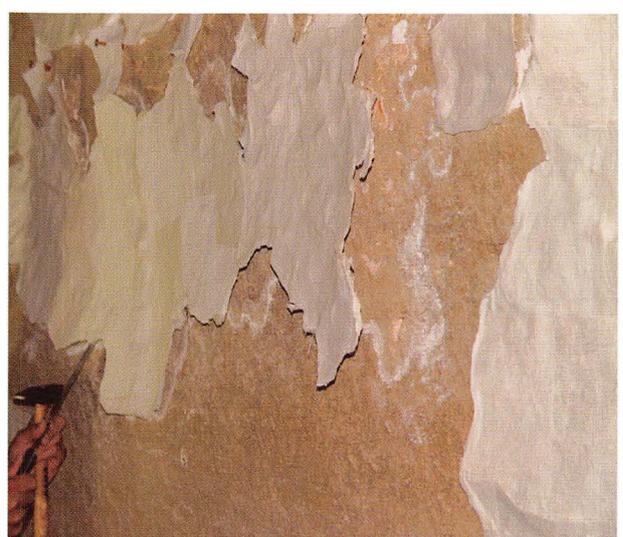
Fig. 27 Detaching of a painting fragment (left) and paintings are hanging on the straps of canvas (right).

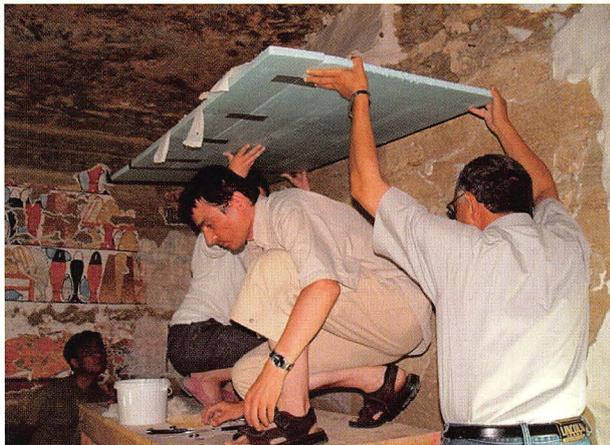
Fig. 29 Transferring the detached Paintings from its walls support to a working table.

The paintings were transferred to a working table in an upside down position (facing down). The next stage was to smooth the back side. Excessively protruding fragments were sanded down and the cavities were filled with new mortar. The flatter the surface of the back, the easier it is to bind it with subsequent layers. Partial removal of the mortar helps to reduce the thickness and the weight of the paintings, which is in return beneficial for mounting them back in to their original location. The flatter the surface of the back, the easier it was to bind it with subsequent layers. The smoothed surface was covered with an insulation layer of ARGE-ARD, or Primal AC-33. Next, the cotton canvas was attached on the back side using a dispersion of polyvinyl acetate as a lining layer

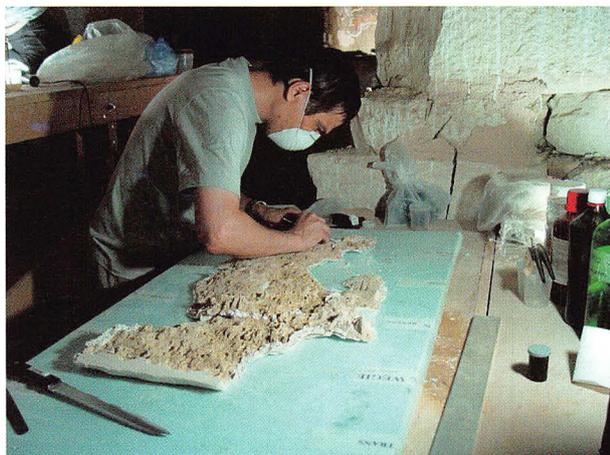
Fig. 30 Back side treatments: reducing plaster, smoothing the back side and filling cavities with new mortar.

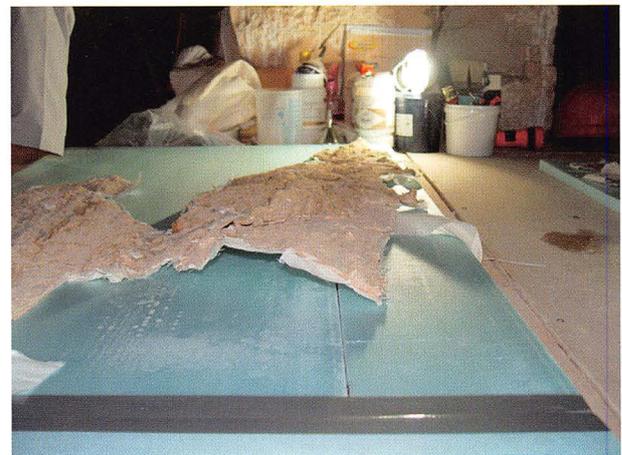
Finally, handles were stuck to the back of the piece with epoxy resin, and the paintings were mounted back, tentatively, to their original location

on the wall support (Fig. 34). This way, we were able to isolated the paintings from the influence of their original destructive support.

Fig. 34 Reattaching (tentatively) in the Right Order, to its original locations.

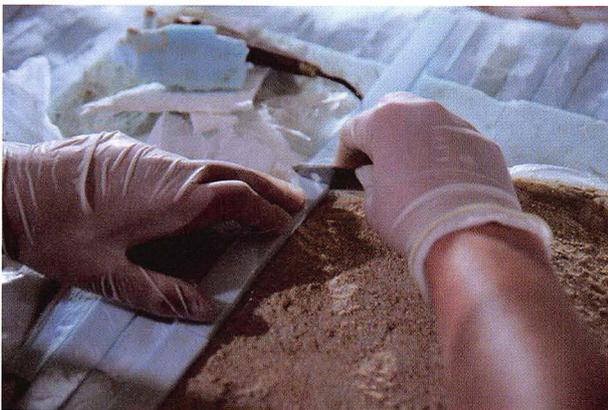
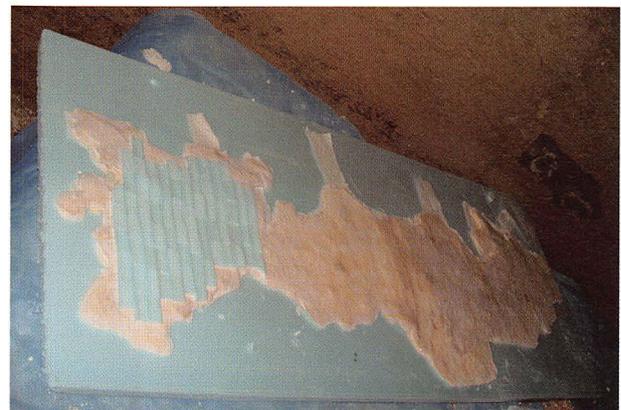
Fig. 31 Polystyrene as an intervention layer.

To assure the reversibility of the treatment, a polystyrene foam (as an intervention layer) was glued on the lining layer with thermoplastic glue. The paintings were placed on a sandwich-type support, light and durable, which consisted of three layers. First, a layer of carbon fiber, saturated with epoxy resin, was attached. Next, a core-layer of polyester non-woven tissue, Firect Coremat, was attached, followed by a second layer of carbon textile. All the layers were saturated with the same resin. Firect Coremat in contact with the resin became ductile and could be shaped easily. Afterward, the excess of the auxiliary support was cut off, the border of the pieces (consolidation with 20% aqueous dispersion of Primal AC 33) was protected, and the cavities were filled with white, acrylic mortar (Fig. 31 and Fig. 32).

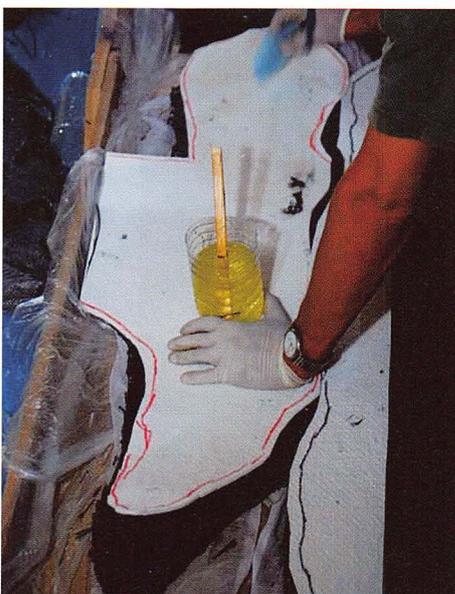
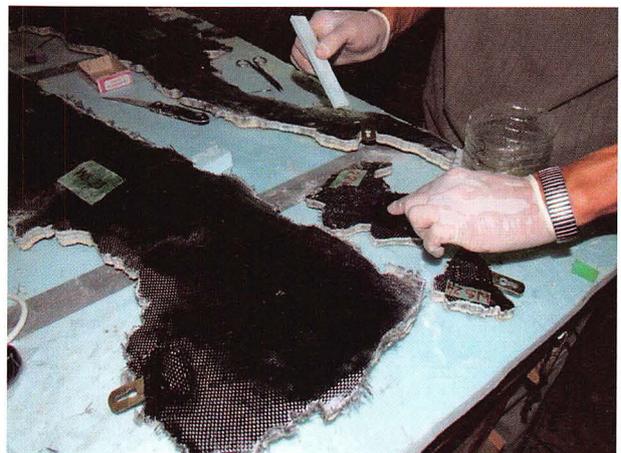
Fig. 32 Execution of new "Sandwich" type of auxiliary support: separation sheet made out of a fire coremat (left), a layer of carbon fiber (right).

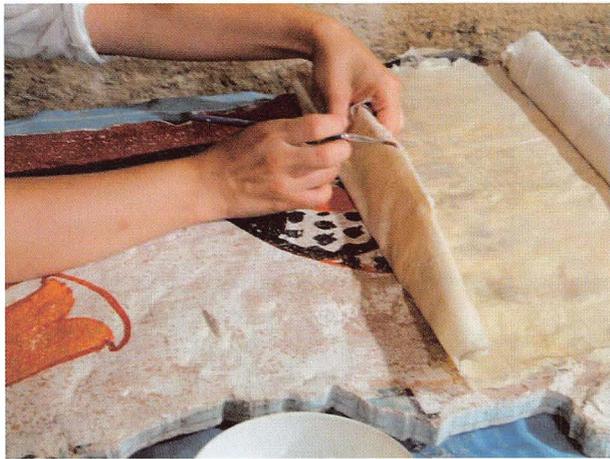
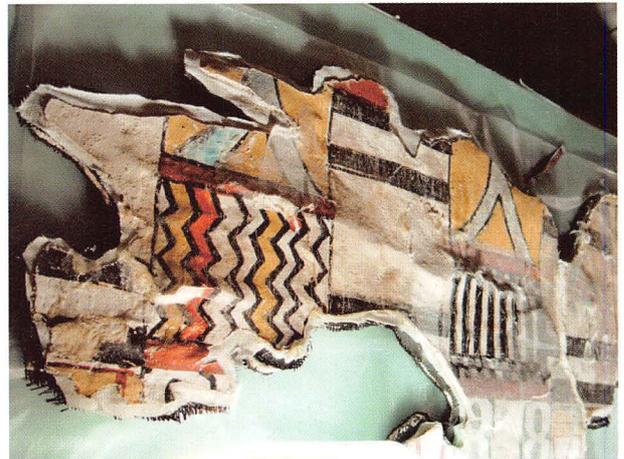
Fig. 33 Removal of the Funori facing from the surface of painting.

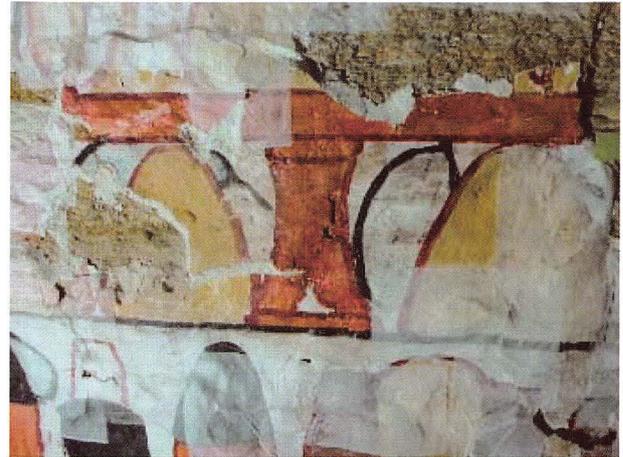
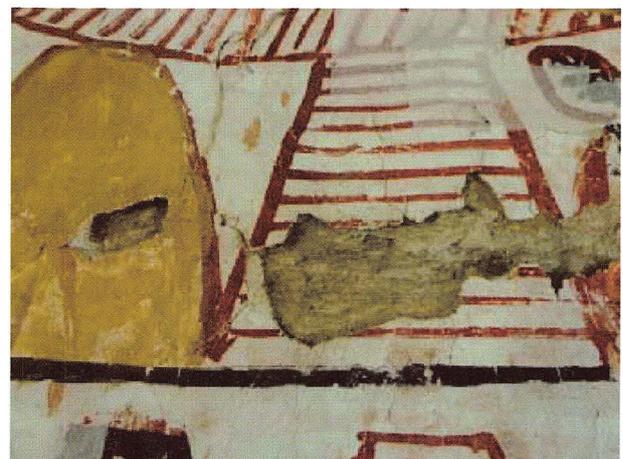
[see Shoeib *et al.*, 2011]. However, the painting has suffered from several problems. The support has a large absorptivity, meaning that the mortar has bent which caused the painting to become slightly separated from the support. Also, the plaster ground was fragile; it had a lot of fine fractures and required strengthening (Fig. 35). In many places, the ground was separated from the wall and some places, brown patches are present on the surface of painting layer (Fig. 36), probably due to the effect of microorganisms. The pictorial surface showed many fractures. For these reasons, the South wall also required some conservation such as (1) strengthening the support, the ground and the painting layer, (2) replacing some of the mortar bends with new ones, (3) removing the rayon paper, and (4) increasing the adhesion of the paintings to the support. In addition, the causes of the ob-

Fig. 35 Mortar bends slightly separated from the support plaster upper and Fine fractures on plaster ground lower.

D) The existing mortar bends, separated from the support and the painting, were replaced with new ones (Fig. 38). Some of the mortar bends which had good adhesion to the painting were left,

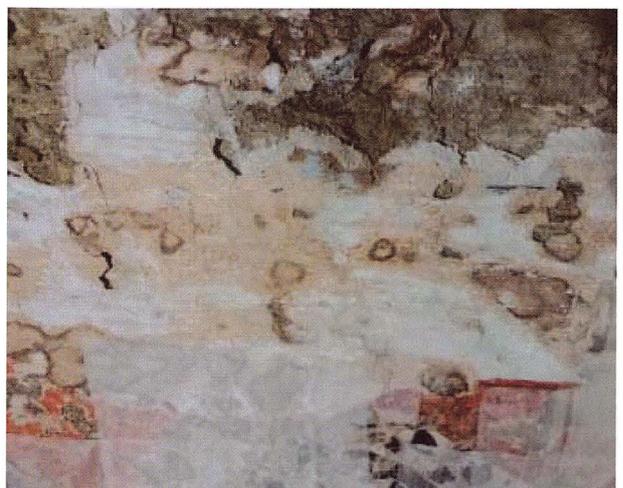
Fig. 36 Brown patches on the surface of painting layer.

A) Microorganism treatment: Preventol RI 80 biocide was tested as an antifungal treatment and produced good results. Therefore, the biocide was used as an antifungal to disinfect the brown patches present on the surface of painting layer. Preventol RI 80 (3% in water) was normally applied three times on the surface of the brown patches through spraying.

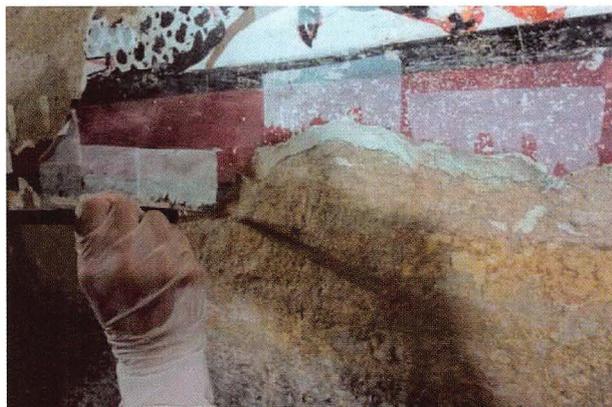
Fig. 37 Mortar bends covered by Nanorestore five times by brushing.

B) As mentioned above, Nanorestore was used as an inorganic consolidation material for conservation of the South wall. Nanorestore was applied using the injection method at the back of the painting. The application was done four times and did not cause any color change of the painting layer and was enough to strengthen the painting. Nanorestore was also used to strengthen the support (applied three times). The injection was done specifically through the existing fractures and holes. Mortar bends were also covered by Nanorestore, by brushing it five times (Fig. 37).

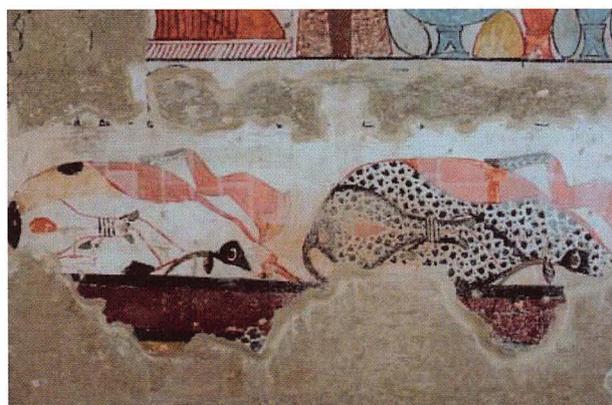
Fig. 38 New mortar bends

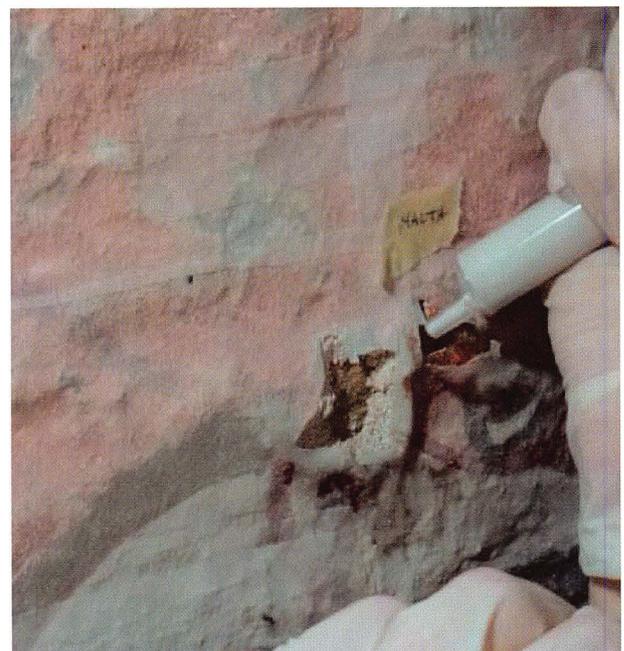
Fig. 39 Air pockets filled with Malta 6001 and Preventol using injection.

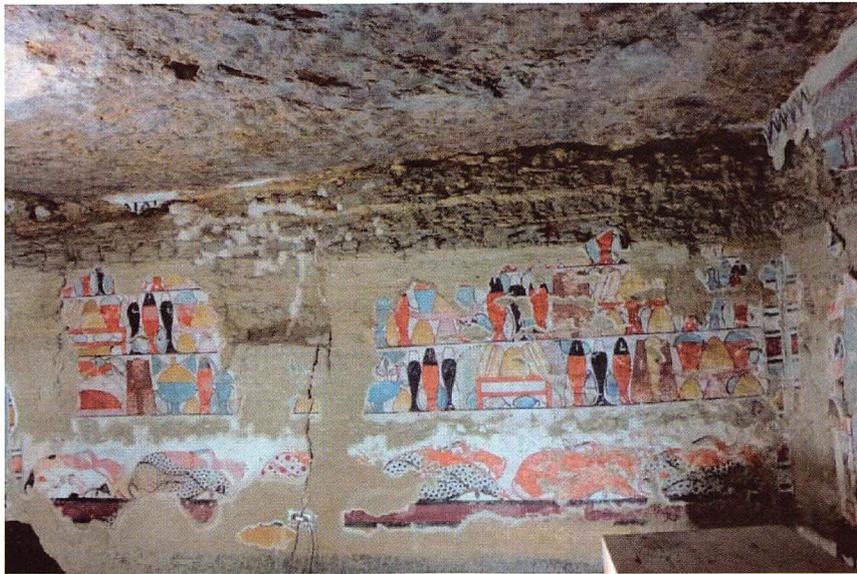
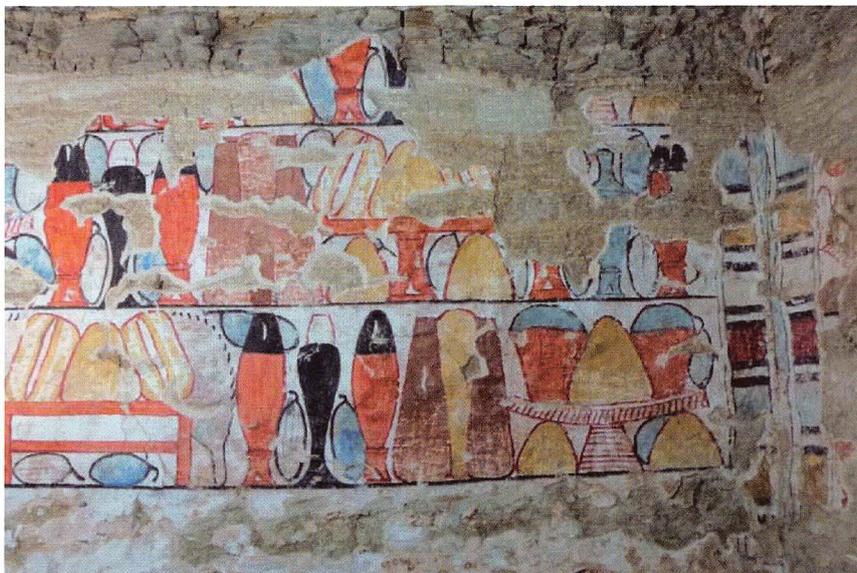
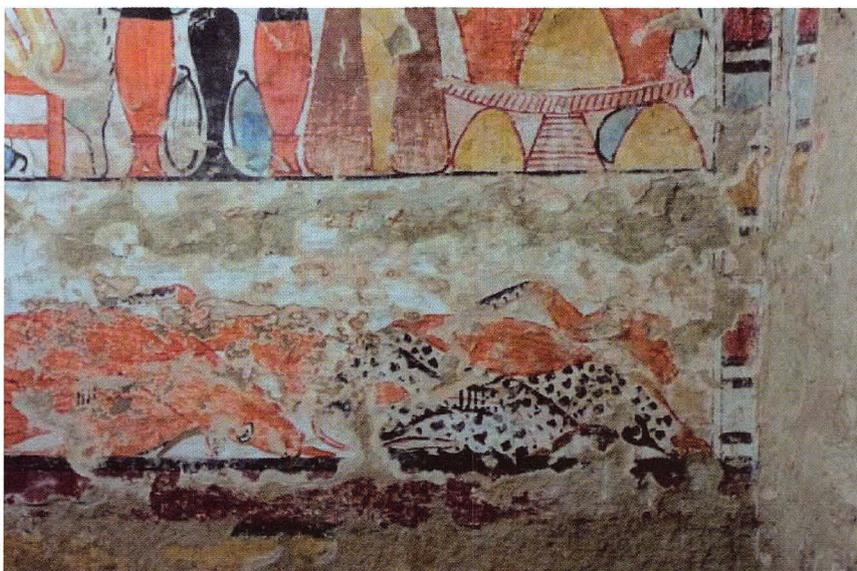
Fig. 40 The paintings of south wall after treatment processes.

The condition of the paintings on the South wall were better than on the other walls. Accordingly, an in situ treatment using Nanorestore, as an inorganic consolidant, for conservation of the South wall was carried out. Nanorestore was applied to consolidate both the paintings and the support by using the injection method. Paraloid B-72 with a different concentration was also used to reduce absorptivity, to help in the consolidation of the support, and to improve the adhesion of Malta 6001 to the support and to fill cleavages. Malta 6001 was also used to fill the air pockets. Preventol RI 80 biocide was used as an antifungal to disinfect the brown patches present on the surface of painted layer and biocide was applied through spraying, three times, on to the surface of the brown patches.
