バーレーン王国、バルバル神殿の 保存・活用に関する基礎研究

Preliminary Survey for Conservation of Barbar Temple, Kingdom of Bahrain

バルバル神殿における 文化遺産の保護を目的とした現状調査および環境調査

Survey on Current Conditions and Environment of Barbar Temple

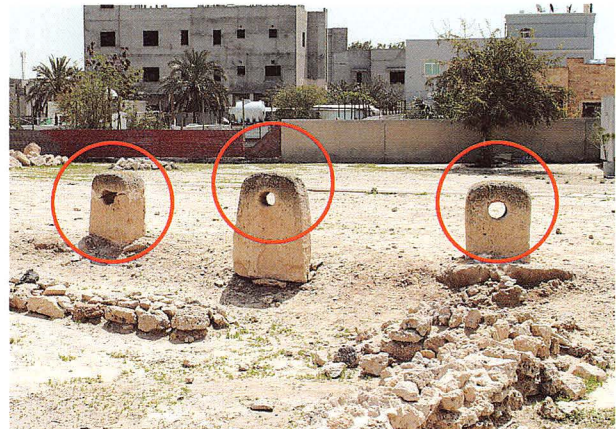
Fig. 5 発掘報告書に掲載された写真との比較照合例
(左：1955年撮影 [Andersen and Højlund 2003: 99]、右：2017年3月撮影)

- 1) 報告書の各写真とその説明から、写真に記録された範囲を推定する。
- 2) 推定した範囲を基に、過去の写真と現状に共通して確認される箇所 (石材の形状・配置) を複数特定する。
- 3) 特定した箇所と、写真の距離・画角の関係から、撮影地点を特定し、報告書と類似した現状の写真を撮影する。
- 4) 撮影地点を図面上に記録する。
- 5) 撮影した写真と報告書内の写真を比較し、外観上の変化を検証する (Fig. 5)。

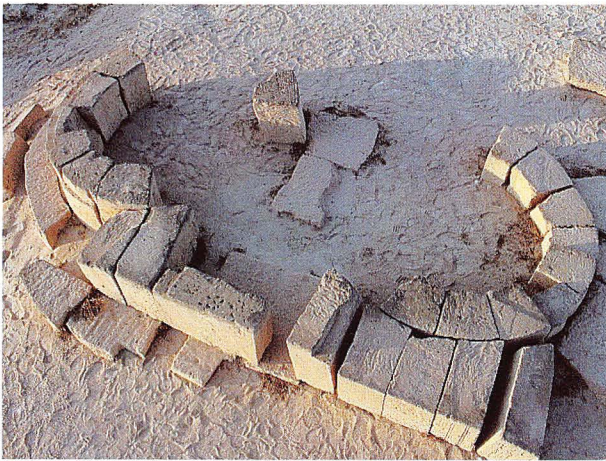
Fig. 9 A区の写真比較照合の例 (II期の供物台) (左：1955年撮影 [Andersen and Højlund 2003: 95]、右：2017年12月撮影)

A区の中央にあり「3」の字型の供物台を比較した結果、発掘調査時と現在では、供物台の石材に変化が見られた (Fig. 9)。特に、供物台の中央部分の石材は現在確認することができず、また、供物台を取り囲む石材にも本来の位置から移動しているものや、欠落が見受けられる。1950年代、60年代の発掘調査では、下部層の発掘をおこなうために、部分的に石材が取り除かれており、これらの変化は石材を再配置した際に生じた可能性も推察される。

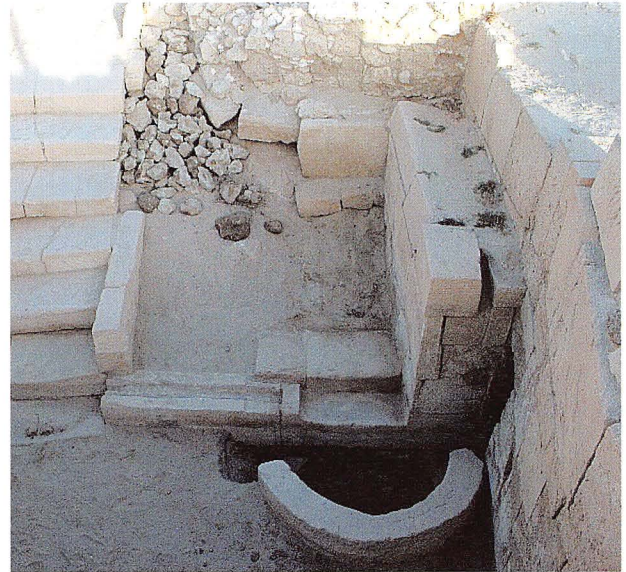
Fig. 10 B区の写真比較照合の例（水槽）
（左：1960年撮影 [Andersen and Højlund 2003: 152]、右：2017年12月撮影）

B区は、重要な儀礼施設である神殿の水槽周辺にあたる。発掘時は、水槽内に湧き水が溜まっており、水をすくい取るための石製容器も設置されていた (Fig. 10)。一方、現在は、水は溜まっておらず、土砂の堆積が見られた。現地の担当者によると、これらの土砂は遺構を保護するために人為的に入れられたものであること、また、石製容器は、近年何者かに盗難されたことが知られる。今回の調査では、土砂に埋もれた箇所の状態を把握するために、土砂を

一部取り除いて調査を実施した。堆積していた土砂は湿っており、埋もれていた箇所の石材には塗れ色が確認されたが、露出部分との劣化の進行度合いに差は見られなかった。また、半円形の石材は、土砂の圧によってか、若干移動していた。本区域では、詳細な三次元データとの取得による比較もおこなっている。それらについては、本報告書2-2を参照されたい。

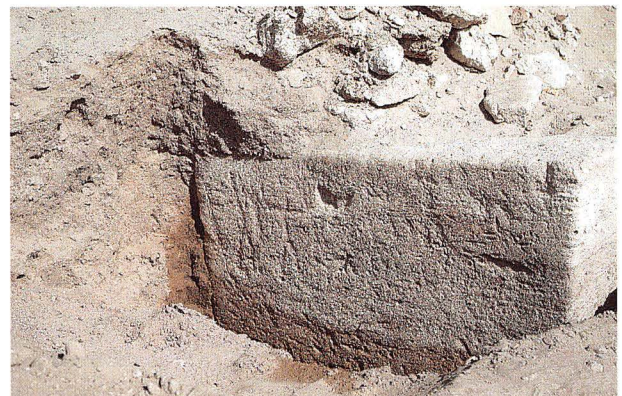
Fig. 11 C区の写真比較照合の例（図像が刻まれた石材）（左：1955年撮影 [Andersen and Højlund 2003: 168]、右：2017年12月撮影）

C区は、神殿中心部から水槽に続く通廊としての役割を果たしていた区域である。通廊の一部である階段の縁石は倒れ、石材の配置には大きな変化が確認される。また、上面に四角い二つの穴があいた立方体の石材が複数配置されているが、現状ではいくつか土砂に埋もれており、全体像を把握することはできない（本報告書序章 Fig. 9）。特に、立方体の石材の一つには、人などを象ったとされる図像が記されていることが報告されているが、その石材も特定することはできなかった（Fig. 11、Fig. 12） [Andersen and Højlund 2003: 168]。そこで、報告書の写真から図像が記された石材の位置を推定し、図像の現状を確認するために、一時的に土砂を取り除いたところ、図像を確認することができた（Fig. 11）。発掘時の記録と比べ、現在は右側の2つの記号を確認しにくい状態にあり、また、石材の中央には窪みが形成されていた。窪み部分には、非常に粒度の細かい白色の物質が観察されたことから、石材が損傷したのではなく、窪みを埋めていたプラスタなどの当時の後補材が脱落したものではないかと推察し

ている。発掘当時の写真を見る限り、四つの図像の窪み部分も、石材の色よりも明るく看取されることから、図像にも後補材が施されていた可能性がある⁸⁾。

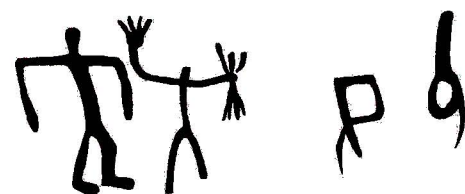
Fig. 12 石材に刻まれた図像 [Andersen and Højlund 2003: 168]

Fig. 12 The imagery engraved on the stone [Andersen and Højlund 2003: 168]

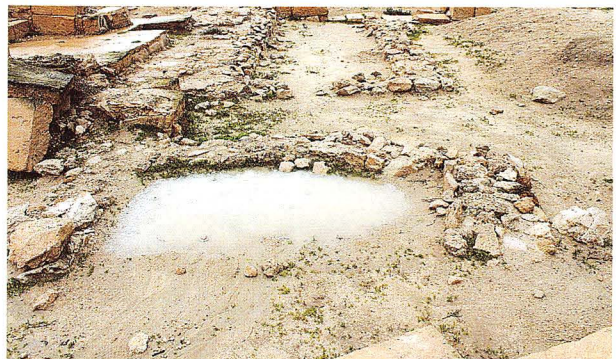
Fig. 13 降雨後のバルバル神殿の様子 (2017年3月撮影)

が砂漠と石灰岩で覆われているが、海に囲まれているため、年間を通して比較的湿潤な環境である (Table 2)⁹⁾。季節は、高温多湿の夏季 (6月~9月) と比較的温暖な冬季 (12月~3月) の二つに区分されるが、冬季においても月の平均気温は18℃以上ある。夏季にはほとんど雨は降らないが、11月から3月頃にかけてはまとまった雨が降る場合がある。CHCが2017年3月に実施した調査においても、一時的に雨が強く降り、遺跡内の各所に水たまりが形成された (Fig.14)。

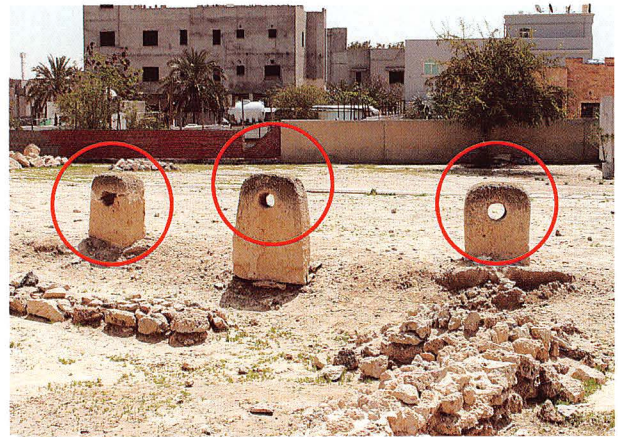
Fig. 5 Comparison to the photograph published in the excavation report.
(Left: Photographed in 1955 [Andersen and Højlund 2003: 99], Right: March 2017)

- 1) From each photograph in the report and its descriptions, approximate the position recorded in the photographs.
- 2) Based on the approximated position, identify multiple points (the arrangements and appearance of the building stone) that are commonly observed in past photographs and the current condition.
- 3) From the designated point and from the relationship of the distance and range in the photographs, designate a location to take resembling photographs for the comparative analysis.
- 4) Record the locations on the map.
- 5) Compare the photographs taken with the photographs within the previous report, examine the change of appearance (Fig. 5).

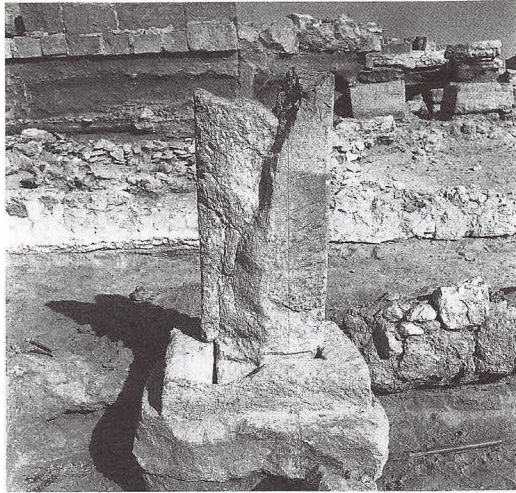
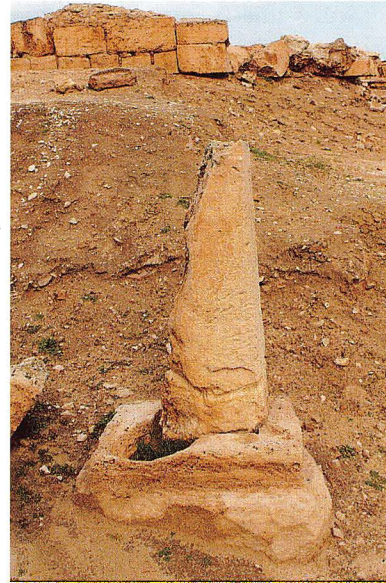
Fig. 7 Example from the photographic comparison(stone pillar from II period)(Left: Photographed in 1961 [Andersen and Højlund 2003: 139] , Right: March 2017)

taken in 1961 (Fig. 7).

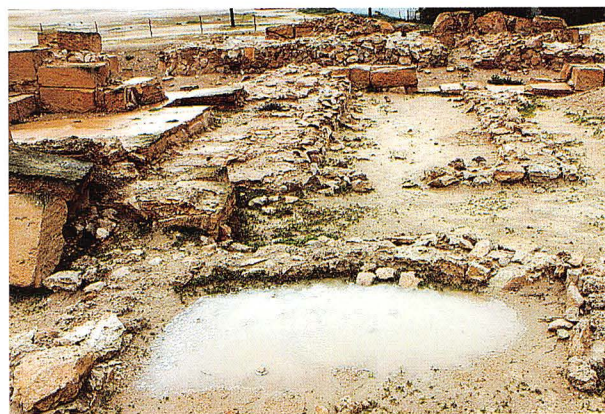
Fig. 13 Condition of Barbar Temple after rain (Shot in March 2017)

Barbar Temple which is the target of the CHC’s research, is located on the north western part of the Bahrain island. The Island of Bahrain holds an arid climate, with the majority of the country being covered in desert and limestone, and as a result of being surrounded by the sea, it has a relatively humid climate year round (Table 2). It’s seasons are divided into, a hot and humid summer (June to September) and a relatively mild winter (December to March), however its winter’s monthly temperature still averages above 18° C. Although it rarely rains during its summer, there are occasions when it rains heavily between November and March. Even when the CHC performed its survey in March 2017, it heavily rained at one point, with water accumulating in various parts of the site (Fig 13).

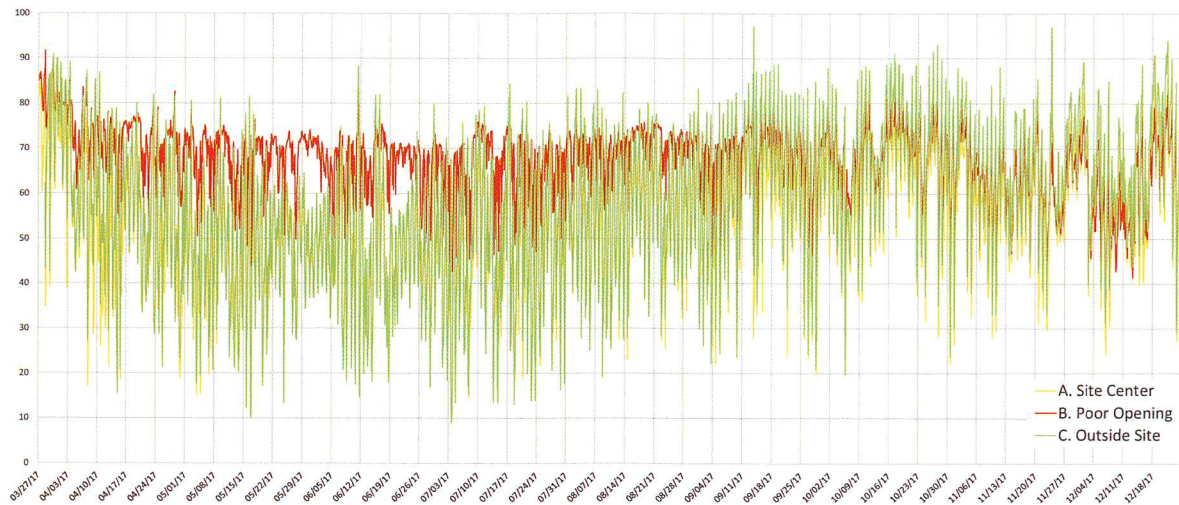
Fig. 17 Humidity changes (%RH) in Barbar Temple (March 27 to December 24, 2017)

The average relative humidity of the areas are as follows: 54.2% RH in the central area of the site, 67.3% RH in the opening of the Temple pool area and 57.5% RH in the area outside the site. Although situated in an arid climate, they are in a relatively humid environment. The highest humidity level in the central part of the site was 85% RH and in the rock parting of the Temple pool was recorded at 97.2% RH, this may be caused due to the influence of rain etc. or perhaps it is simply a case of an extremely humid environment. Depending on the day, dew condensation may have occurred on the surface of the stone, due to molds and lichens that have been observed to have grown (Refer to 2 - 5 of this report). Furthermore, from May to July, relative humidity fell to below 20% RH in the central part of the site and outside the site showing there to also be extremely dry days in the area. In the central part of the site and the outside of the site, there are extremely harsh changes in humidity, similar to that of the temperature, with some days recording changes from 50% to 60% (Fig. 17). Although the changes in humidity in the stone opening of the Temple pool are moderate compared to the other two locations, there are occasional days where there are harsh changes during the summer season.
