Treatment of the Wooden Trunks in the Ceiling of the Burial Shaft of the Step Pyramid in Saqqara, Egypt

Ashraf Youssef Ewais*

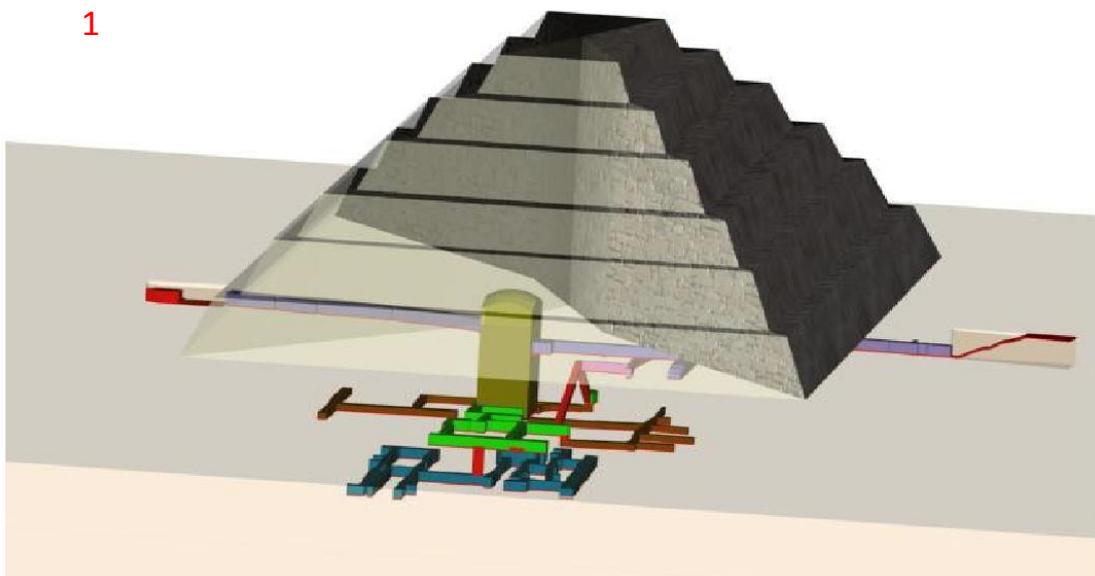
Fig 1 3D of the Step Pyramid, the burial shaft and the underground levels

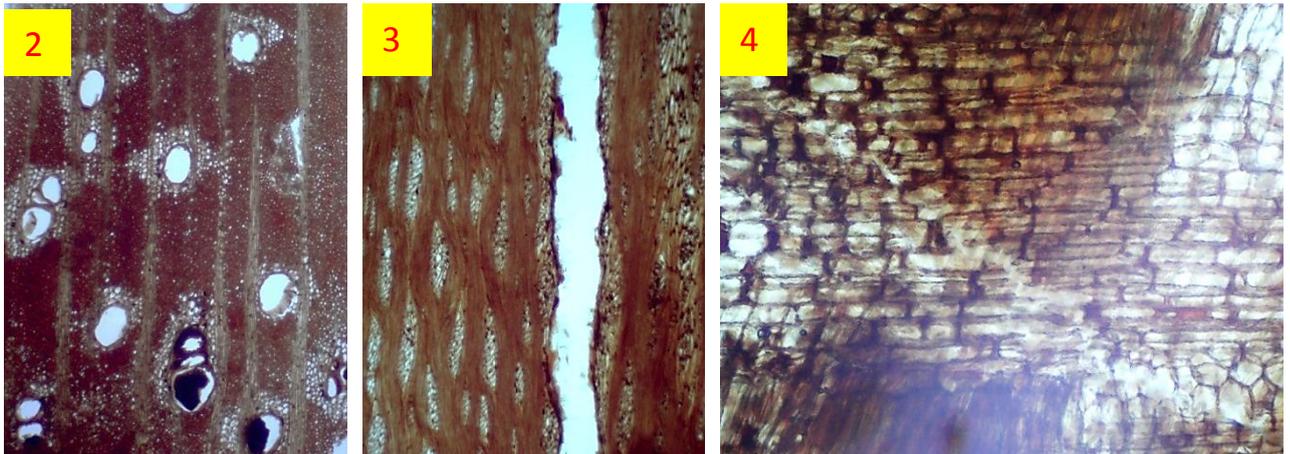
Photo 2-4 micrographic showing the diagnostic characteristics used to identify the wood of the trunks that is *Acacia nilotica*

Microscopic identification for thin sections indicated that the wooden trunks that used to support the ceiling of the burial shaft in the Step Pyramid were *Acacia nilotica*. It is a Perennial shrub or tree which grows in different parts of the world. In Africa, it is found in a lot of countries such as Egypt, Algeria, Angola, Botswana and Ethiopia. Its height ranges between 2.5–10m tall. The wood from that tree has been used since prehistory because it is strong, heavy and durable. In Sudan, it is used as railway sleepers. It is also used for heavy construction as well as tool handles and carts (Internet <http://www.weeds.crc.org.au>).

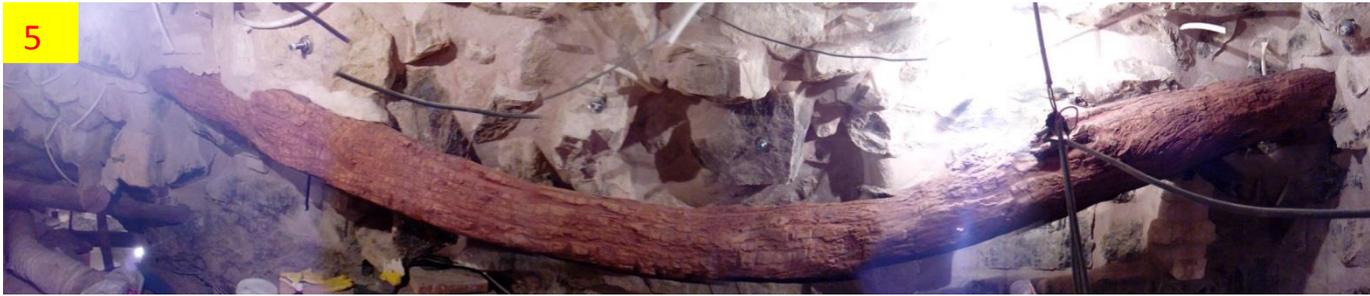
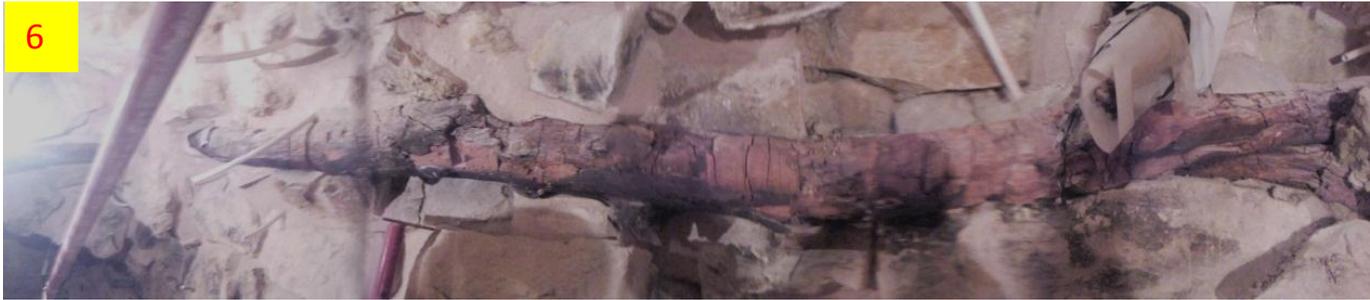
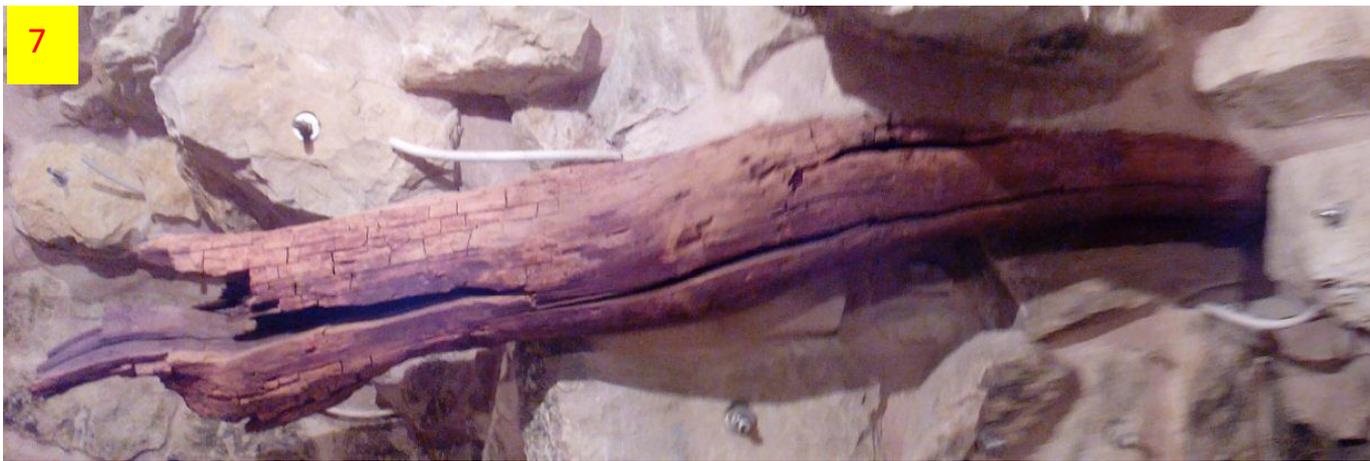
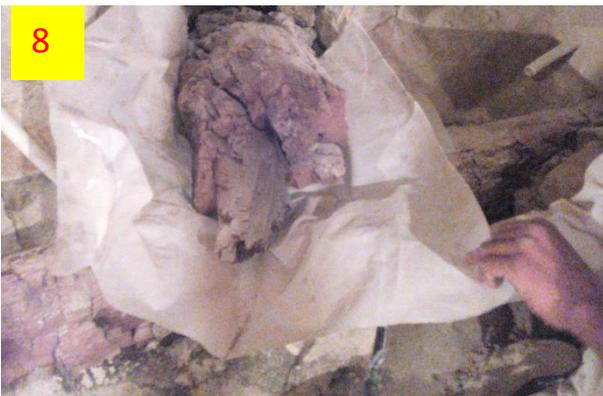
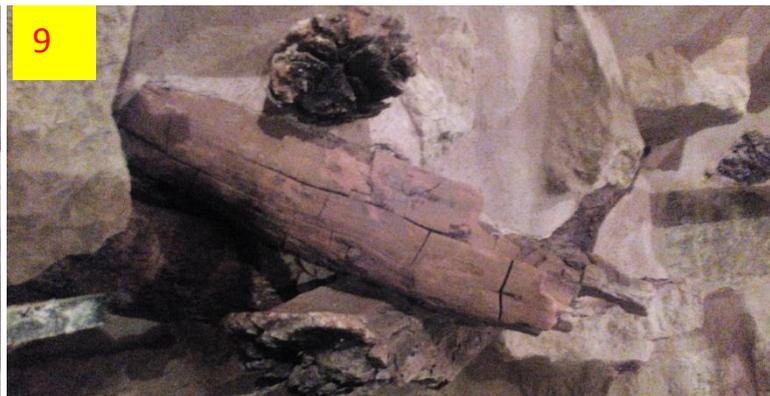
Photo 5-9 Wood trunks before restoration

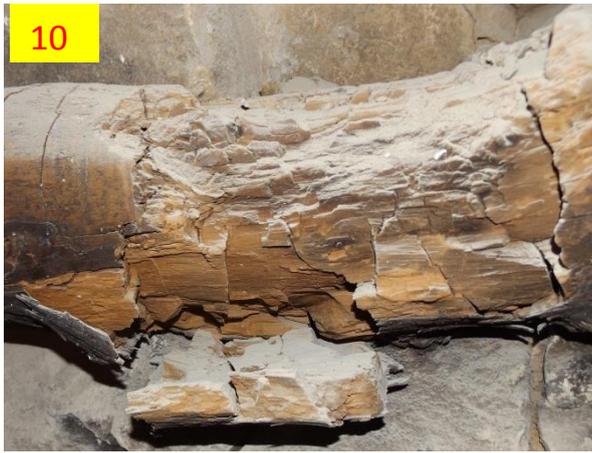
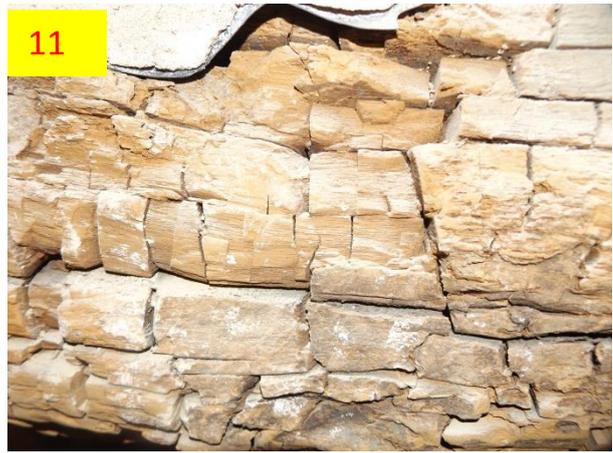
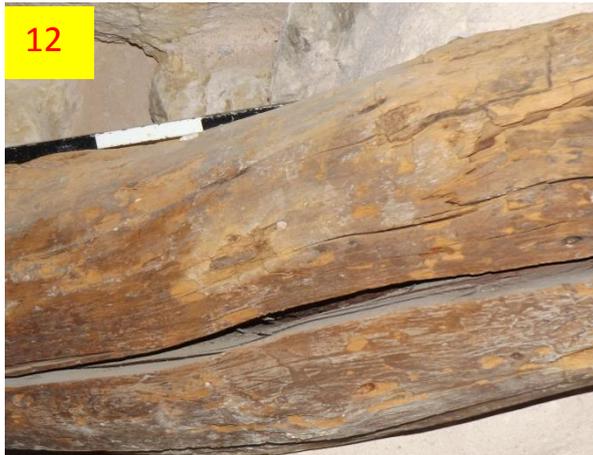
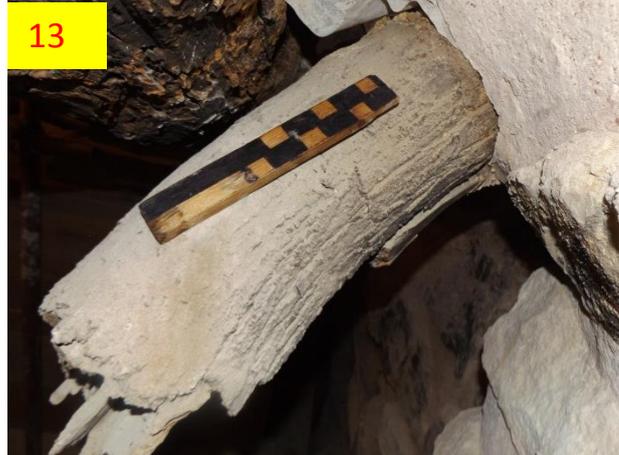
- There were some remains of mortar that covered some places of all the trunks. That mortar was used during the work of supporting the ceiling that was carried by current project. Because the mortar was lime based mortar, so it caused some places to be whitish. There were some traces of light pink color that could be used by ancient Egyptians during restoration work in the Saite time.

- there were remains of soot that might be produced by the fire which was used by ancient Egyptians during restoration work in the Saite time.

- the surface of the trunks turned into cubes in different sizes because of the brown rot fungus.

Photo 10-13 Deterioration forms on wood trunks

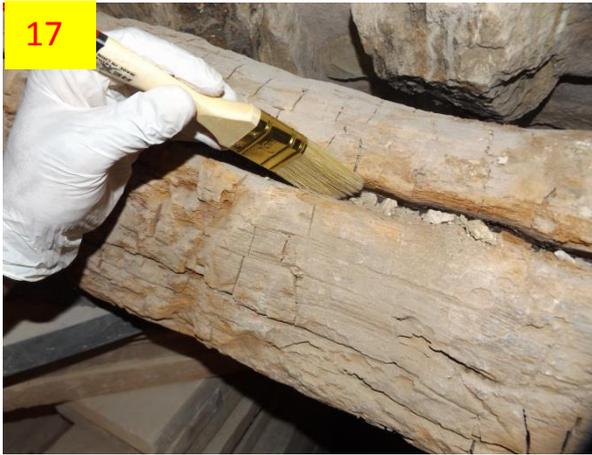
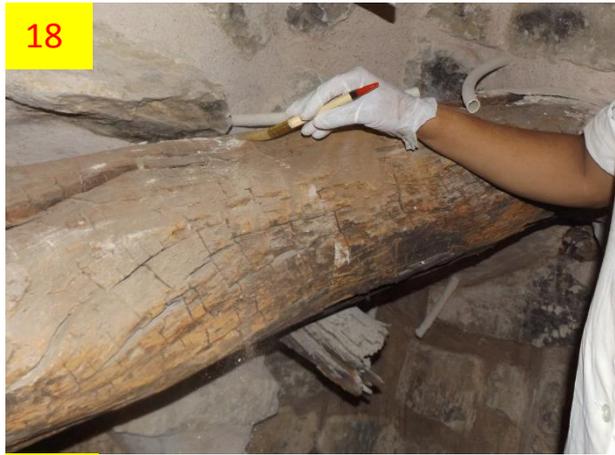
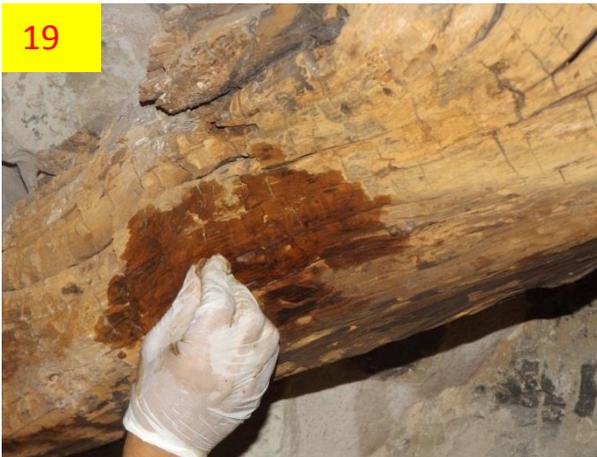
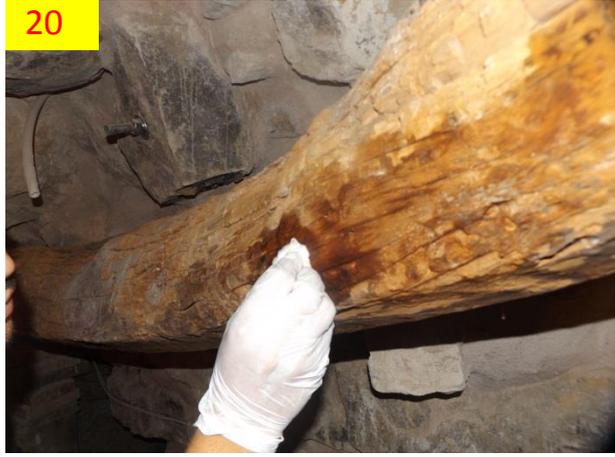
Photo 17-20 Mechanical and chemical cleaning

Cleaning is the first treatment process that is usually done to remove dirt that misshape the surface of the object and make it be ready to receive consolidants. Mechanical cleaning was done to remove dust and remains of mortar. It was necessary to be careful during removing the remains of the mortar because they were stuck to the surface of the wood firmly. It was necessary to use metal spatulas and scalpels besides using brushes.

Chemical cleaning was also important to clean and remove the remains of the mortar that were very tiny and inserted in the pores of the wood. It was also necessary not to use much water on the surface of the wood. So a mixture of ethanol and water 3-1 was used and gave a good result.

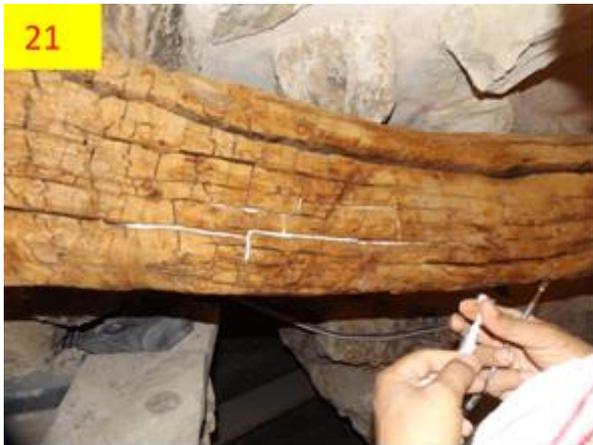
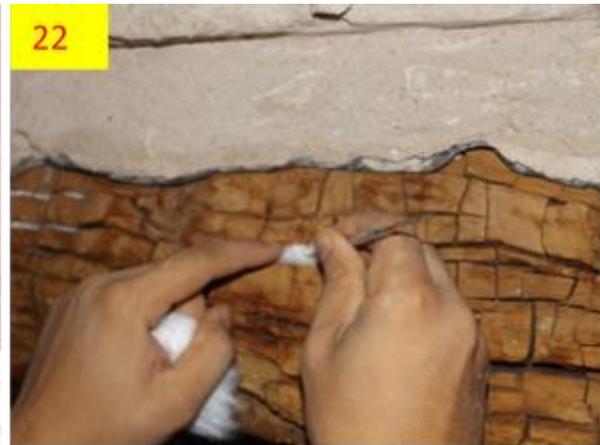
Photo 21-22 Filling among cracks by using cotton

The surface of the wood turned into separated cubes that fell one by one from time to time. It was necessary to fill among those cubes to fix them. However, when those cubes were touched anyway, they loosed off their places and fell down. It was decided to use a kind of net to fill among the cubes, on condition that the net was flexible to twist among all the cracks. So, it was decided to make that net by inserting cotton among the cracks, then it was injected by using Paraloid B72 20% to harden the cotton and make it like a net that links among the cubes. Filling with cotton was about 0.5cm under the surface of the wood. After filling by using cotton and Paraloid B72 20%, it was necessary to fill the cotton with a suitable substance with a suitable color to match the color to the original wood. Microballoon was used mixed with a suitable dust color and Paraloid B72 15%. There are some advantage of using microballoon, because it is so soft that it could be controlled well during work. It is resistant to microbiology growth. It was mixed with Paraloid B72 20% and that made it reversible. First a sample was applied to be sure if it would match the color of the original wood, then it was applied all over the trunks. It was applied to be about 2-3 mm under the surface of the original wood level.

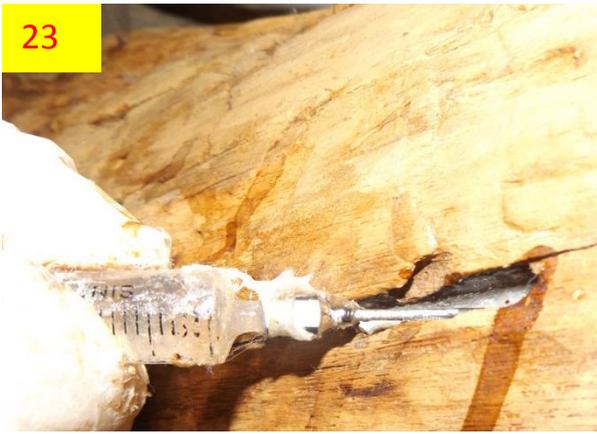
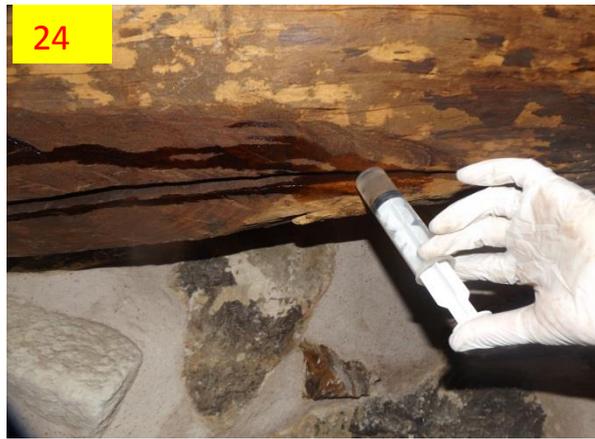
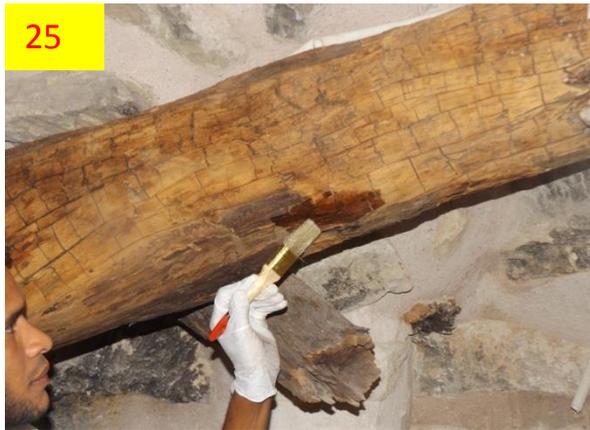
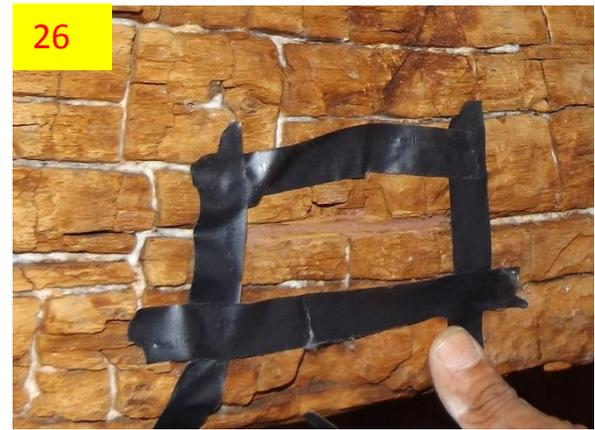
Photo 23-26 Injection by using B72 20 to harden the cotton, consolidating wood by using Plexisol P550 3-5-7% and making a test of filling on the cotton by using microballoon with a suitable color mixed with B72 15%

The second step of treatment was consolidation. As it was mentioned that wood was fragile and spongy, it needed to be consolidated more than one time and with high concentration. Although Paraloid B72 is one of the most famous and effective consolidants, it could not be used in high concentration because it could cause the surface of the wood to be darker and shiny. It was decided to use Plexisol P550 solved in toluene as a consolidant. It was necessary to start with low concentration, then to higher concentration, which allows the consolidant to penetrate into the pores of the wood. Three concentrations were used, first 3% then 5% and finally 7% that led the wood to be harder than before.

It is known that the brown rot affects the amount of cellulose in wood and that it makes wood weak and fragile. Therefore, it was necessary first to raise the amount of cellulose in the wood and second to strengthen the fragile wood by using a suitable consolidant. For raising the amount of cellulose in the wood of the trunks, a solution of Nano cellulose solved in 0.5% of Klucel G., whose solution was applied by using brushes. The most valuable merit of using Nano cellulose is that it can penetrate through the pores of wood and reach deeper inside the wood. Although Paraloid B72 is one of the most common consolidants that is used in organic and non-organic antiquities, it has some disadvantages especially when it is used in high concentrations. It causes the surface to be darker and shinier. It is decided to use Plexisol P550 solved in toluene in three different concentrations 3-5-7% to strengthen fragile wood. One of the most important advantage of Plexisol is that it doesn't cause the surface to be

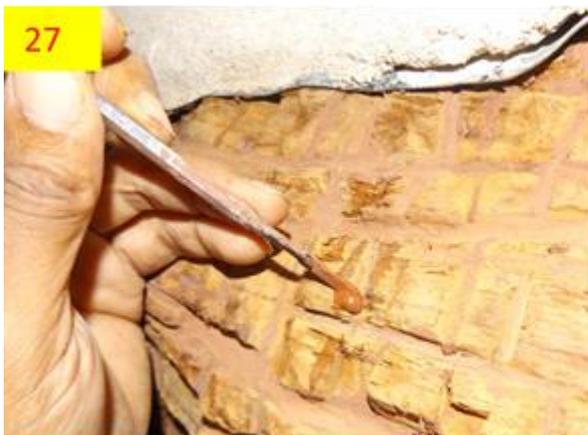
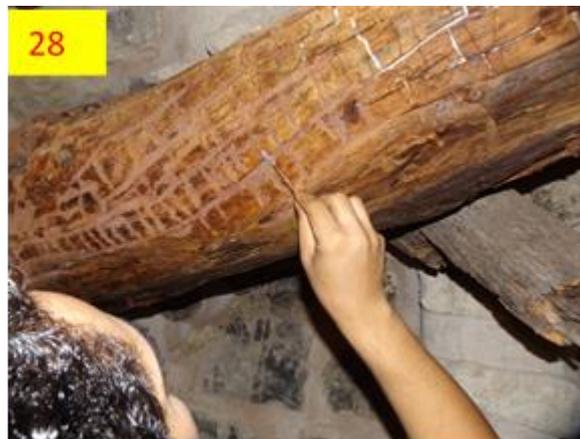
Photo 27-28 Filling on the cotton by using microballoon with a suitable color mixed with B72 15% after ensuring that the color of the filling matches the wood

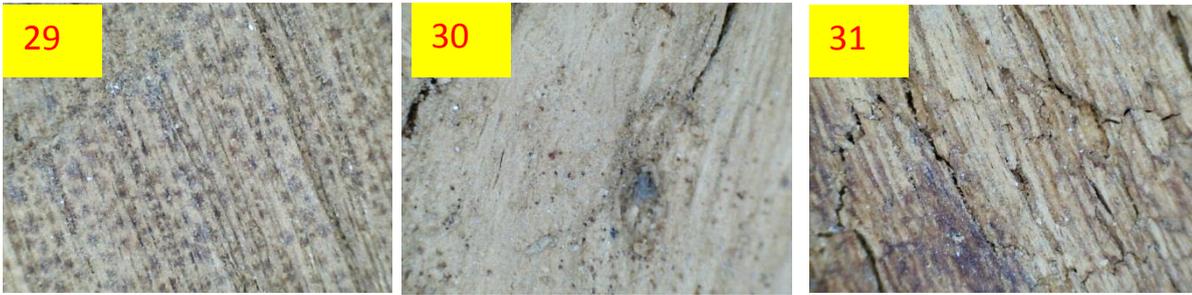
Photo 29-31 Digital microscope of the surface of the wood after mechanical and chemical cleaning

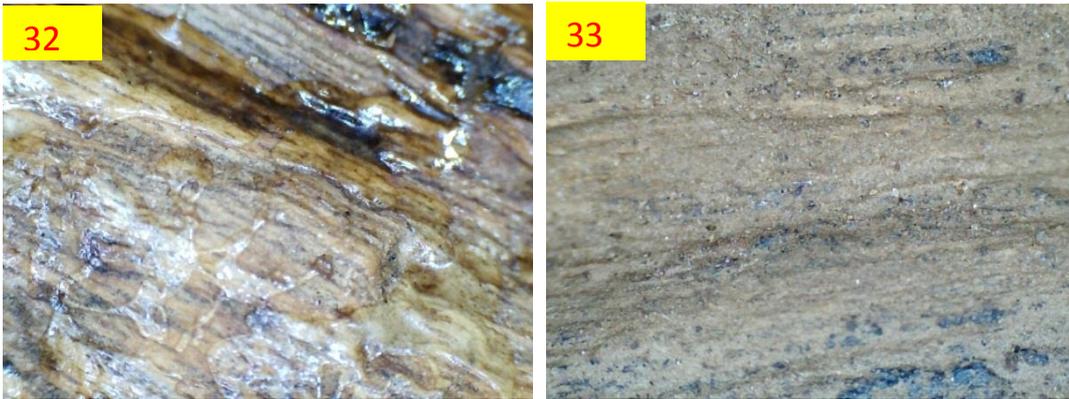
Photo 32-33 Digital microscope; 30 surface after consolidation by using Plexisol; 34 surface after consolidation and by using Nano Cellulose

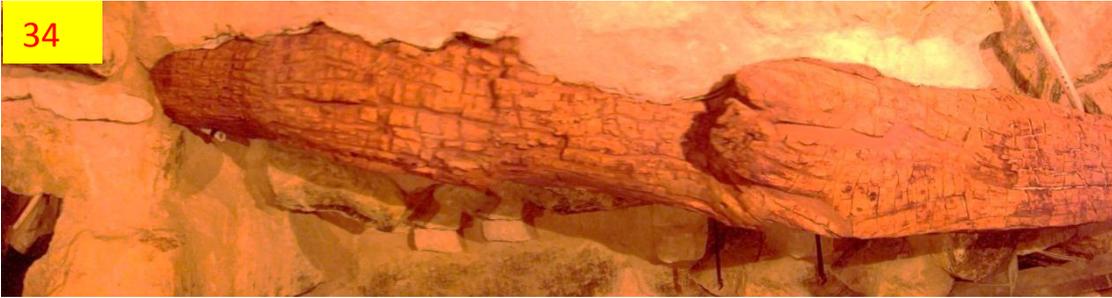
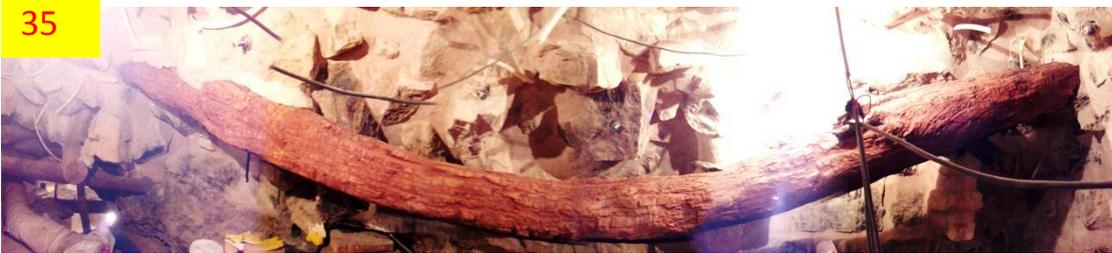
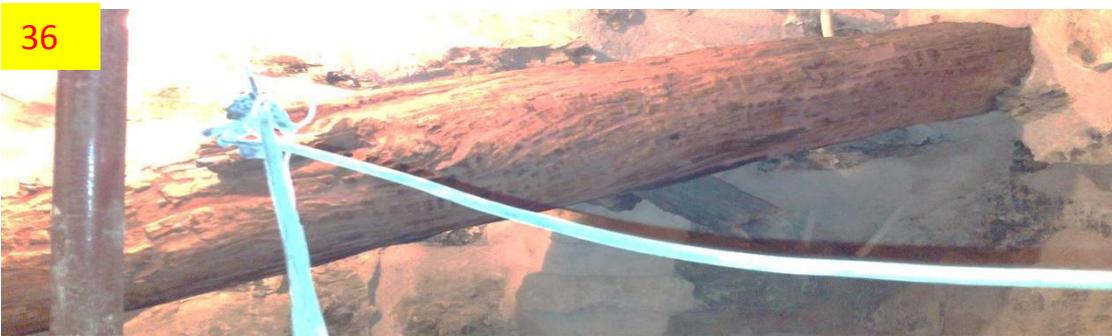
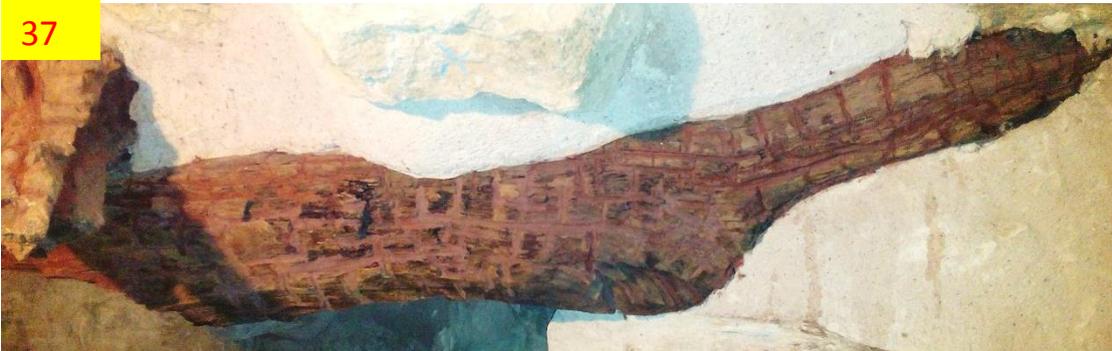
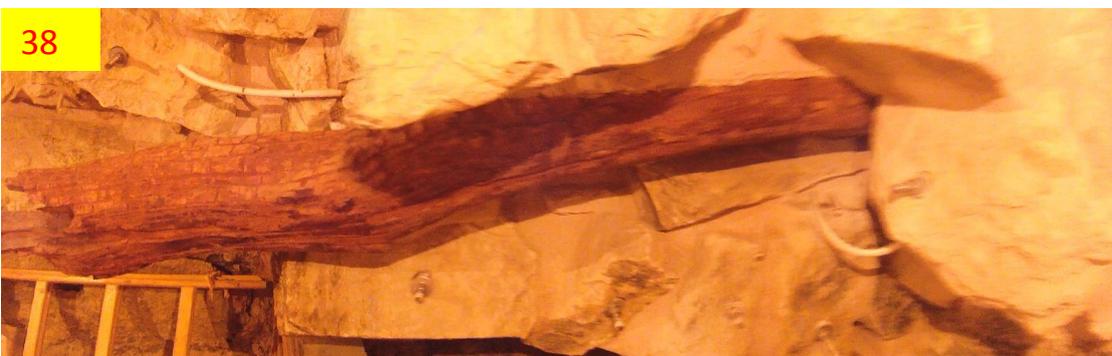
Photo 34-38 Digital microscope of the surface of the wood trunks after restoration work

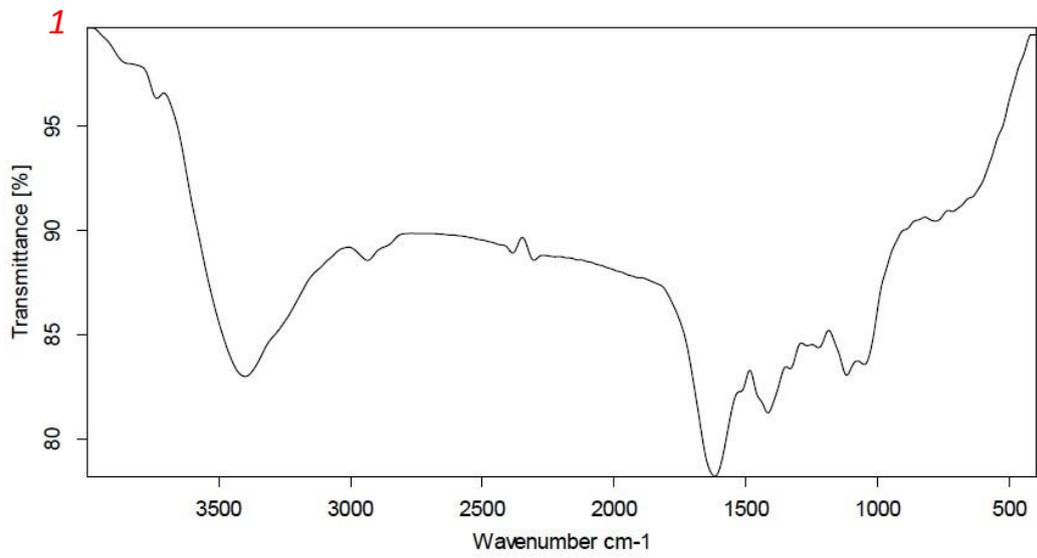
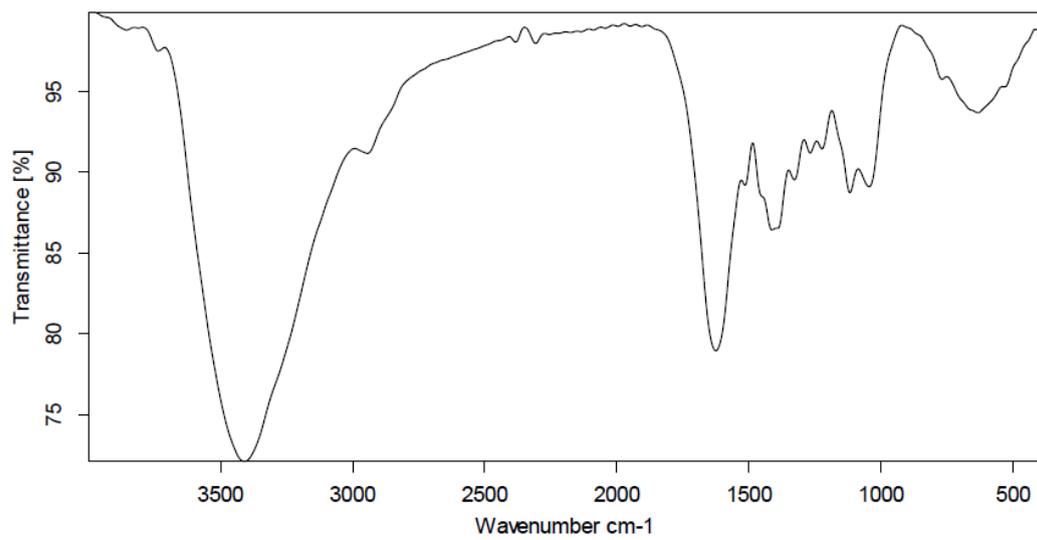
2 Spectrum

Chart 1-2 FTIR spectra showing how the peak of cellulose became higher after using Nano cellulose for consolidation
