Deterioration Factors that Affect the Mural Paintings at Memi's Burial Chamber in Saqqara, Egypt

5 Deterioration Factors inside the Burial Chamber

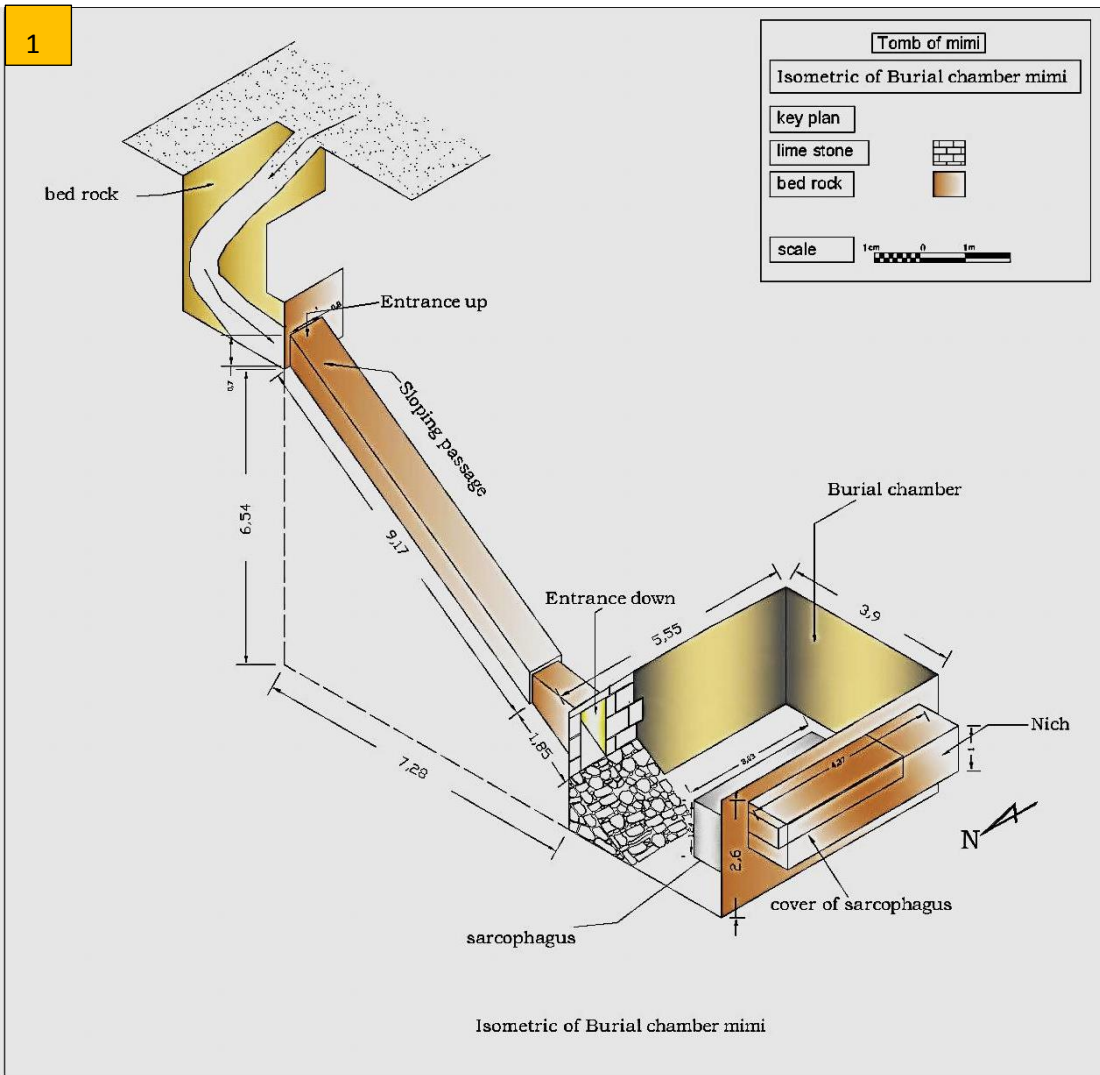
Fig 1 3D drawing of the burial chamber

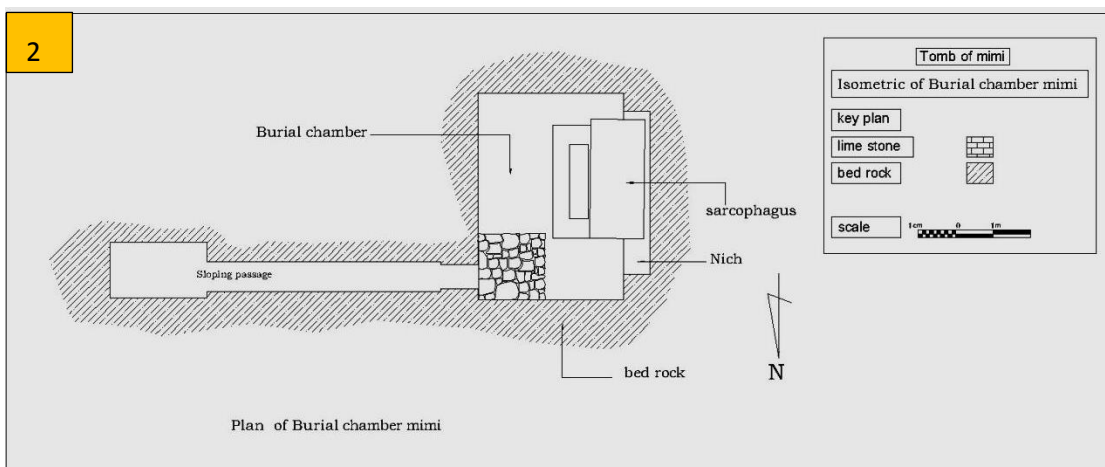
Fig 2 Plan of the burial chamber

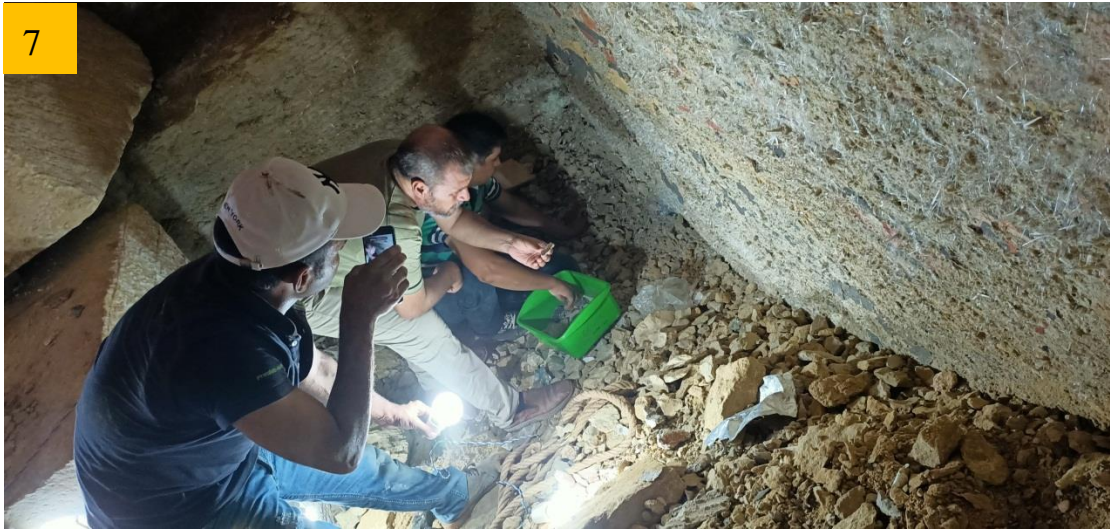
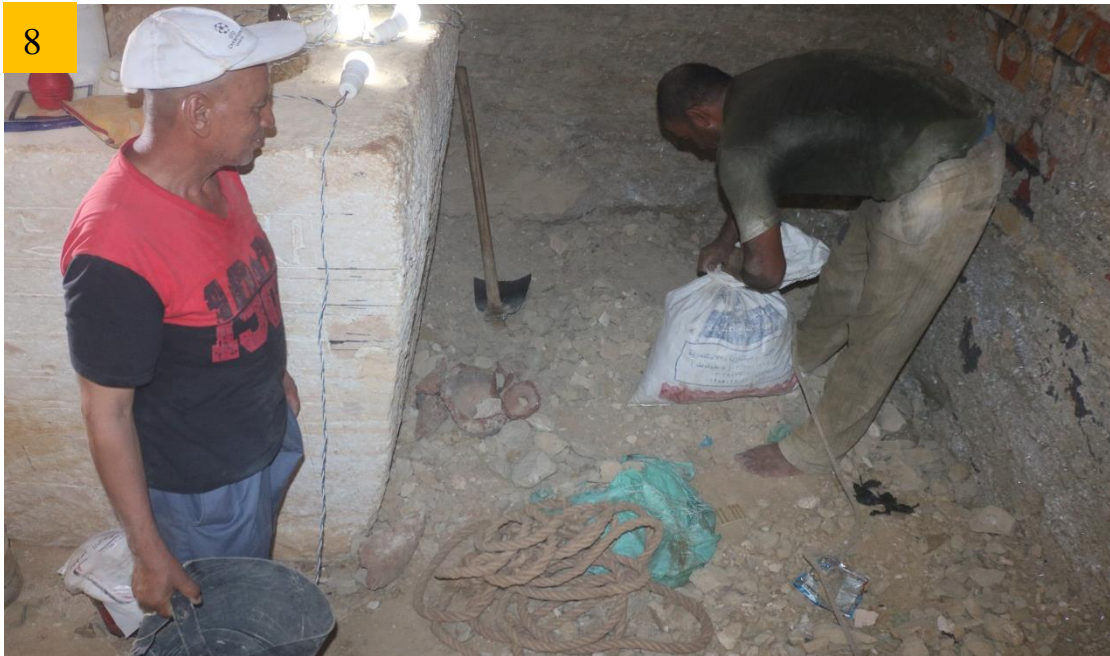
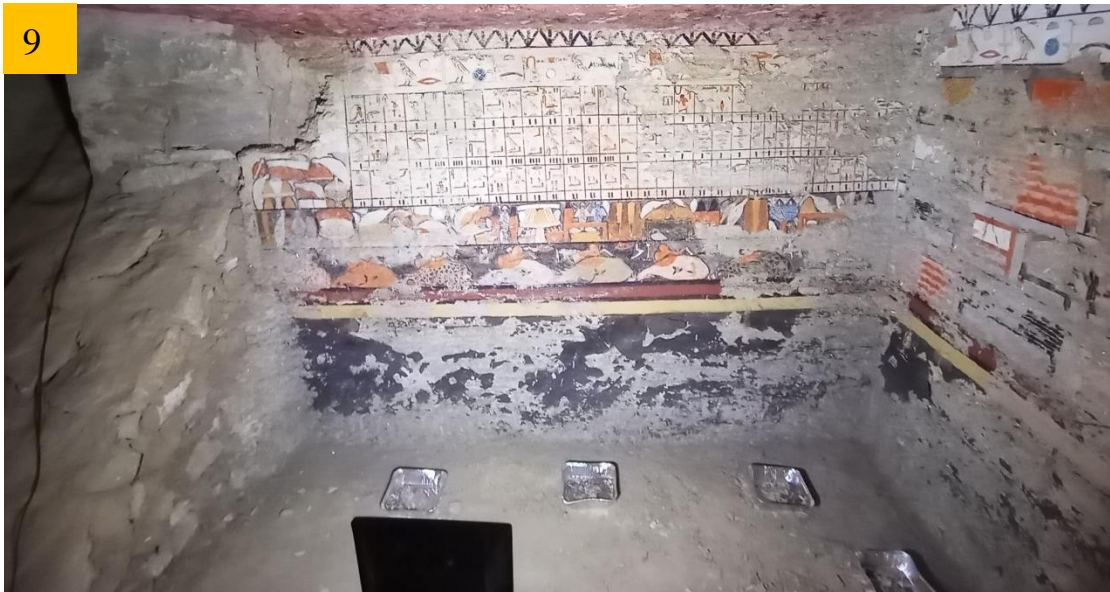
Photo 7-9 Preparing work inside Memi's burial chamber

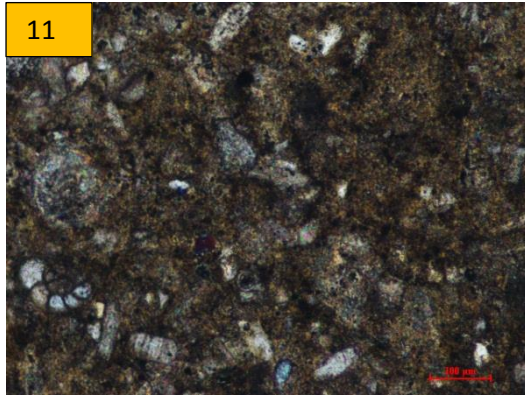
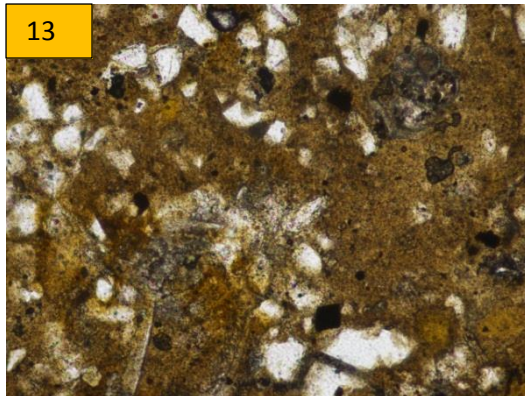
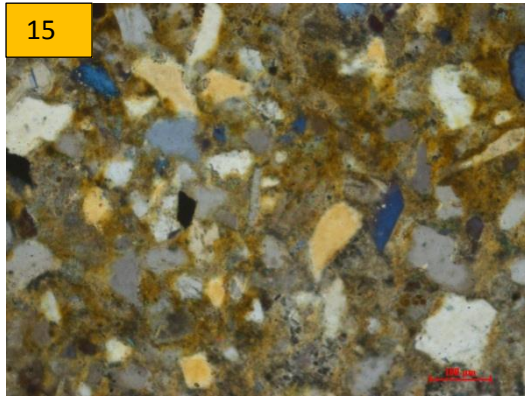
Photo 10-15 Petrographic of the main components of the bedrock inside Memi's burial chamber, calcite in white color, quartz in blue color, clay minerals in green color, marine shells seen also; the percentage of the each component differing in each sample

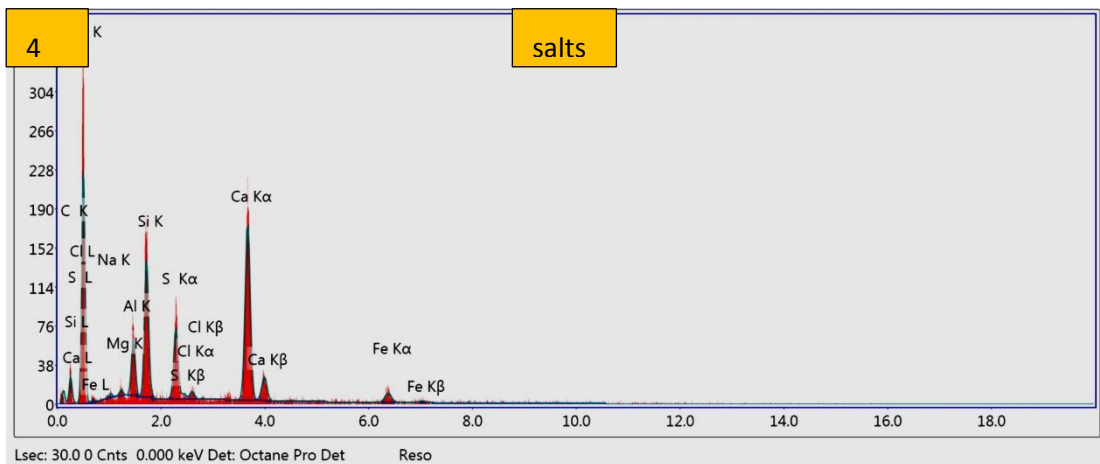
Fig 4 EDX pattern of the components of salts samples inside Memi's burial chamber; calcium and sulfur that means gypsum, sodium and chloride that means there is halite

soluble salts⁸, either dispersed within the porous materials or concentrated locally⁹. The principal salts that may affect mural paintings and other walls are carbonates, sulfates, chlorides, nitrates, and oxalates of sodium, potassium, calcium, magnesium and ammonia¹⁰. Salts may come from the bedrock or from the components of the plaster itself. As the EDX analyses shows, the presence of calcium and sulfur in large quantities, which means there is gypsum as the main source of salts at Memi's burial chamber. However, sodium and chloride, which are two elements that form halite (Na Cl), are found in little quantities.

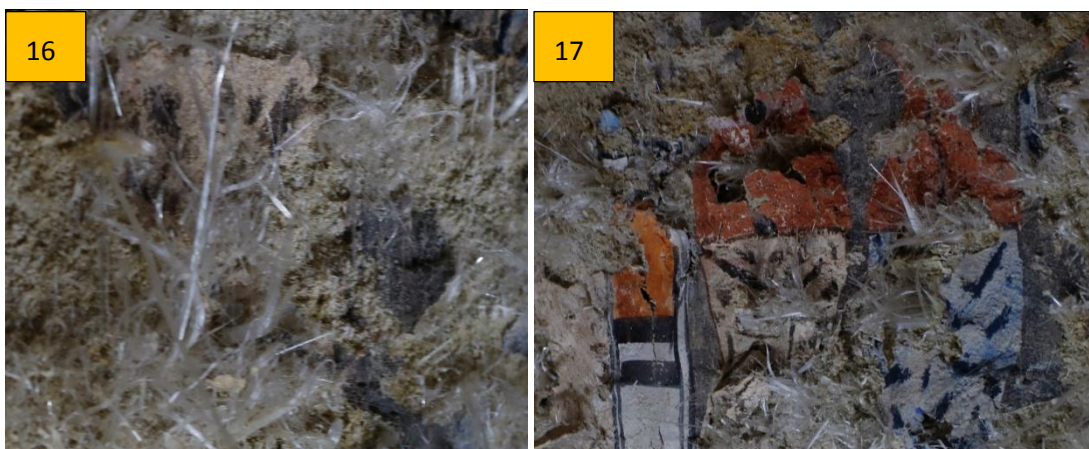
Photo 16-17 Crystallization of salts on the surface of the bedrock

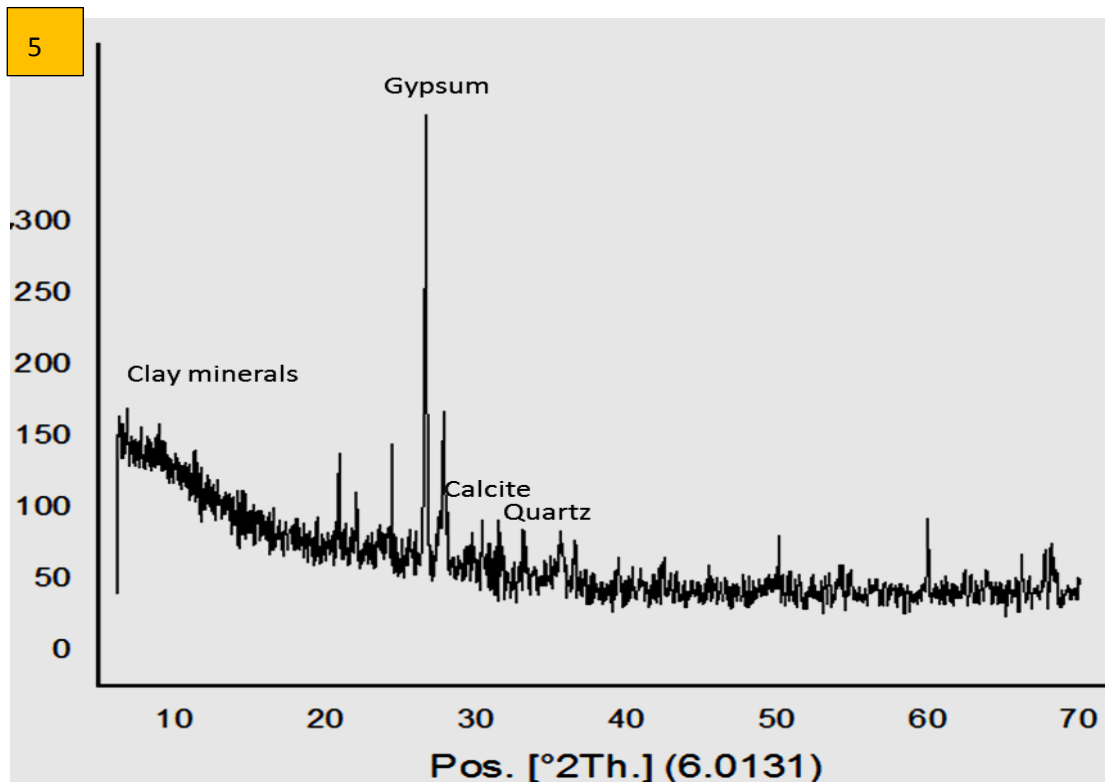
Fig 5 XRD pattern of the components of the plaster samples inside Memi's burial chamber; calcium and gypsum, quartz and clay minerals

of clay minerals in the plaster causes also deterioration as it is known that clay minerals swell by the existence of humidity and shrink again when they lose it. The presence of clay minerals also causes the occurrence of fine cracks in the plaster. The thickness of the plaster at Memi's burial chamber varies according to the regularity of the bedrock. However, in general, the thickness of the plaster is thin and it makes it easy to be cracked and broken when it falls off the walls. Photos from 22-25 by using optical Digital microscope show fine cracks in the plaster and deteriorated surface in some places

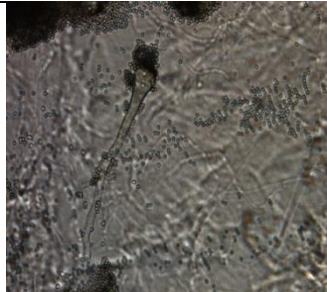
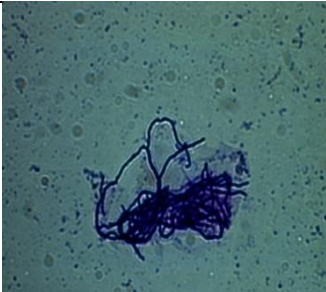
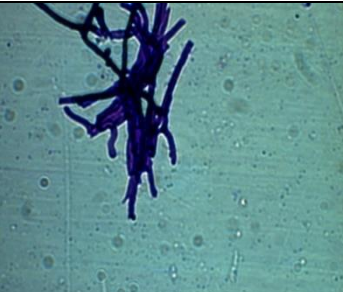
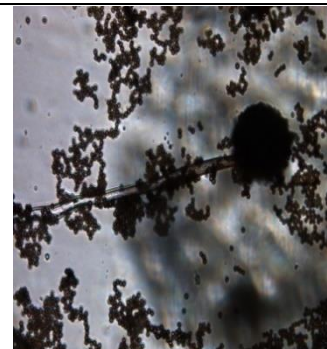
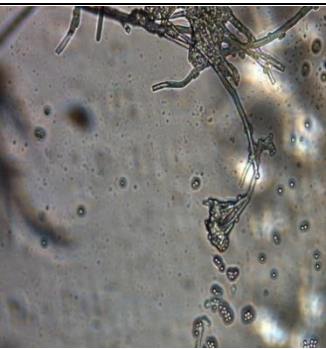
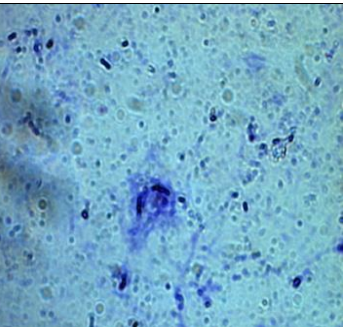
As there was high humidity levels inside Memi's burial chamber, it was clear that there would be micro biology growth on the bedrock and the plaster. Therefore, two samples were taken by using swaps from the surface of the plaster. The result was that there are six different kinds of microorganisms may lead to the degradation and deformation of the mural paintings at Memi's burial chamber. Tables No 2-3 show species of microorganisms that grow in Memi's burial chamber..

<i>Aspergillus fumigatus</i>	<i>Streptomyces vinaceus</i>	<i>Saccharopolyspora hirsute</i>

<i>Aspergillus niger</i>	<i>Penicillium janthinellum</i>	<i>G+ve short bacilli spore former</i>

Table 2 Microphotos of the microorganisms that grow at Memi's burial chamber

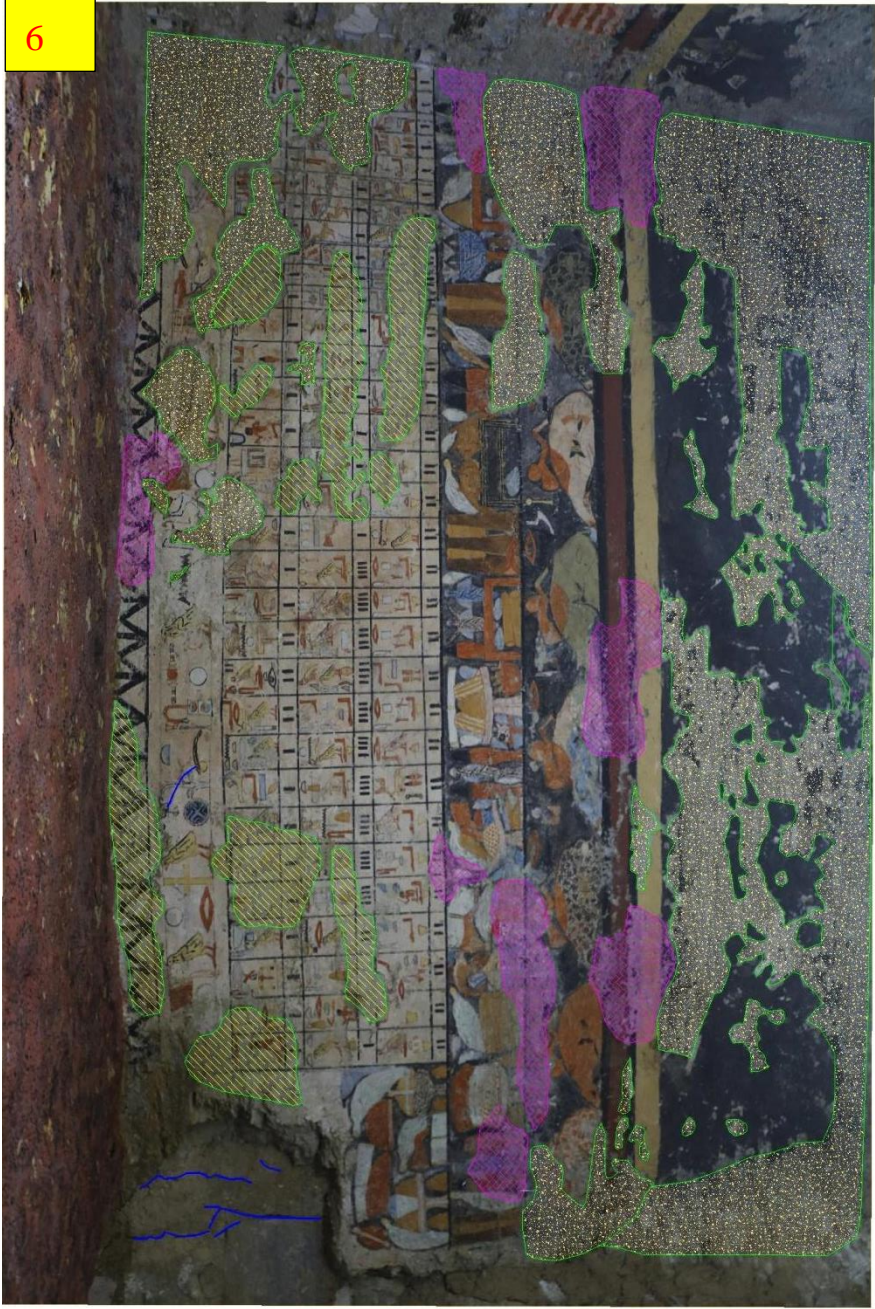
remains of colors with out plaster

missing plaster

fragile plaster remains

fine cracks

pin salts

All plaster was covered with fine salts and dust

Fig 6 Deterioration products on the eastern wall

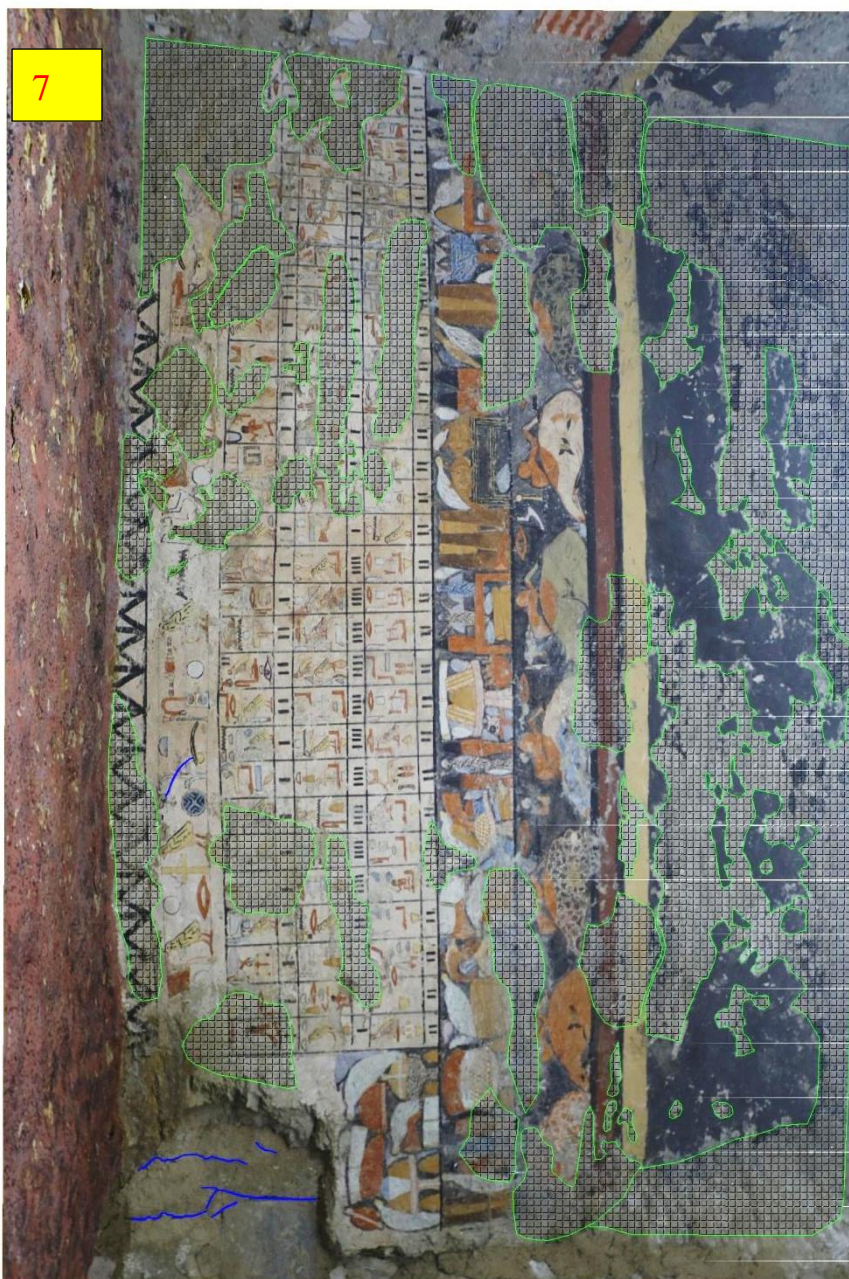
remains of colors with out plaster

missing plaster

fragile plaster remains

fine cracks

pin salts
All plaster was covered with fine salts and dust	
Mmi burial chamber

Fig 7 Deterioration products on the eastern wall

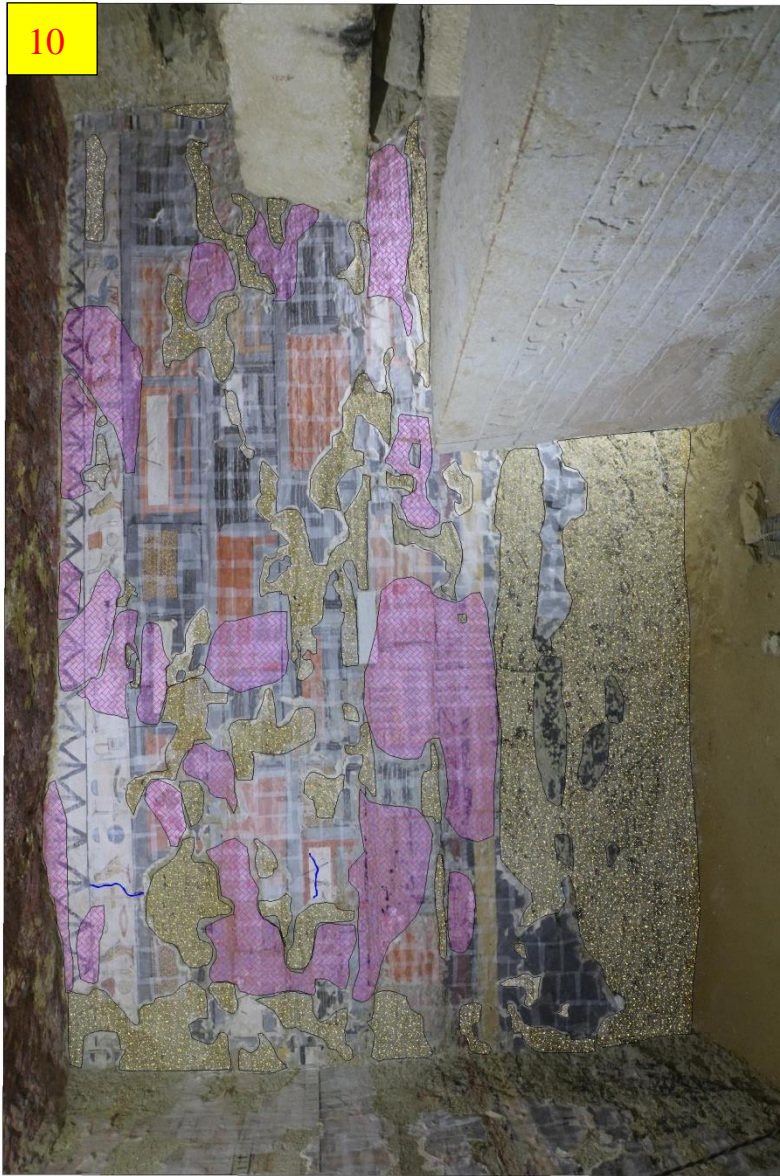
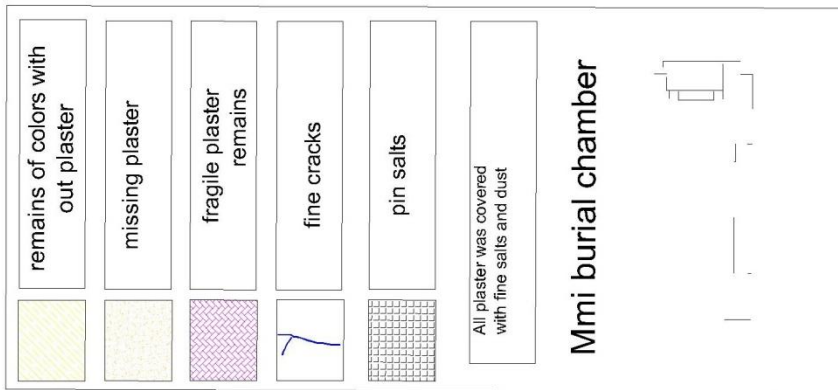
Fig 10 Deterioration products on the southern wall

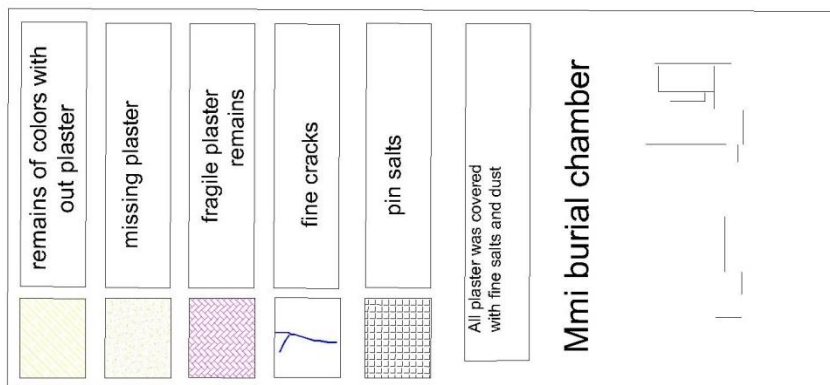
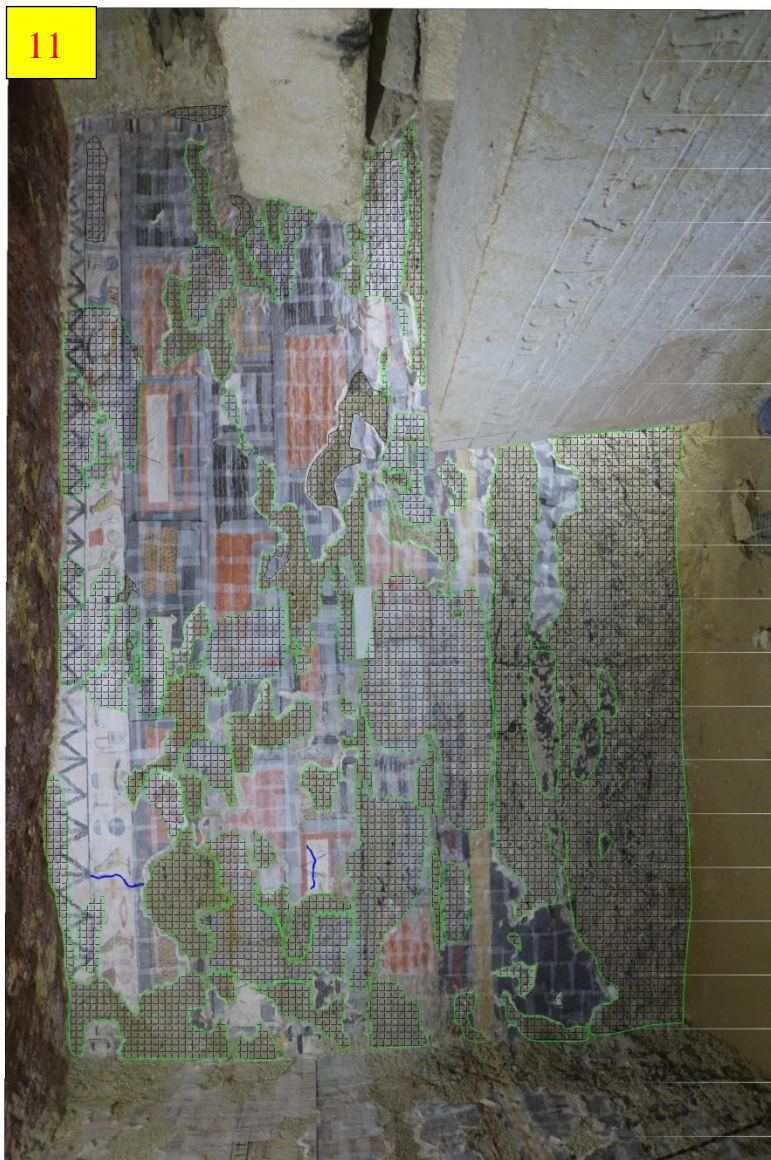
Fig11 Deterioration products on the southern wall
